**Accident** to the AIR CREATION - IFUN16 SKYPPER  
identified **974OW**  
on Friday 15 September 2023  
on Cambaie microlight strip

**Loss of control on final approach,  
collision with a hangar, fire**

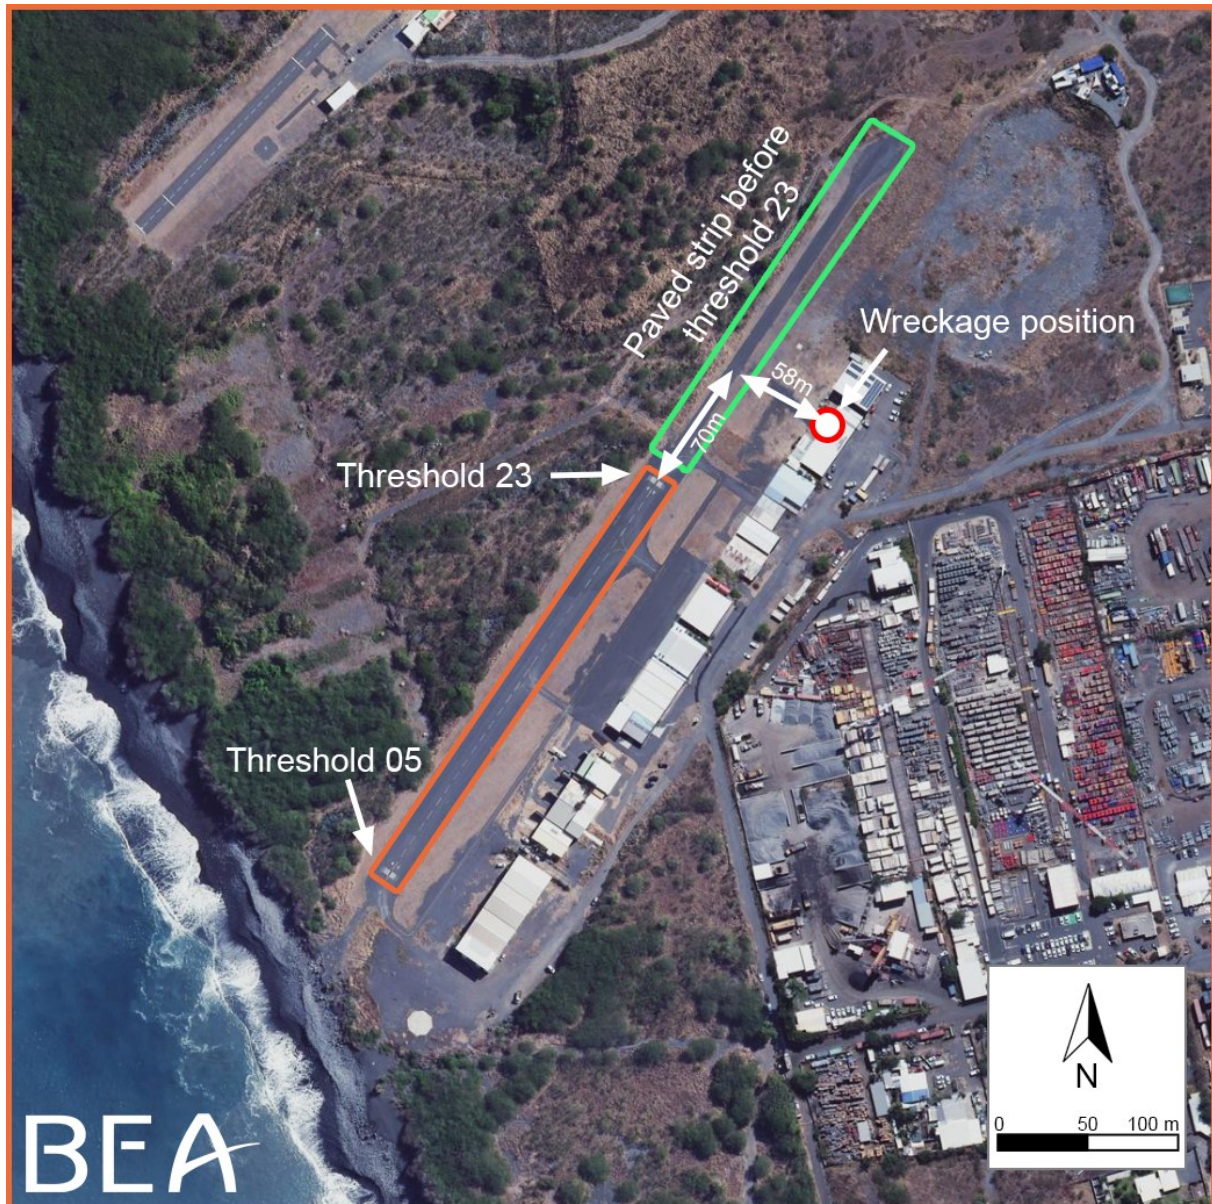
The microlight collided with the roof of a hangar, at a height of around 3 m. This hangar is situated 70 m before threshold 23 and around 50 m from the extended runway centreline. The fire rapidly spread to the hangar and high temperatures were reached.

Figure 1: position of wreckage (source: Géoportail, annotations BEA)

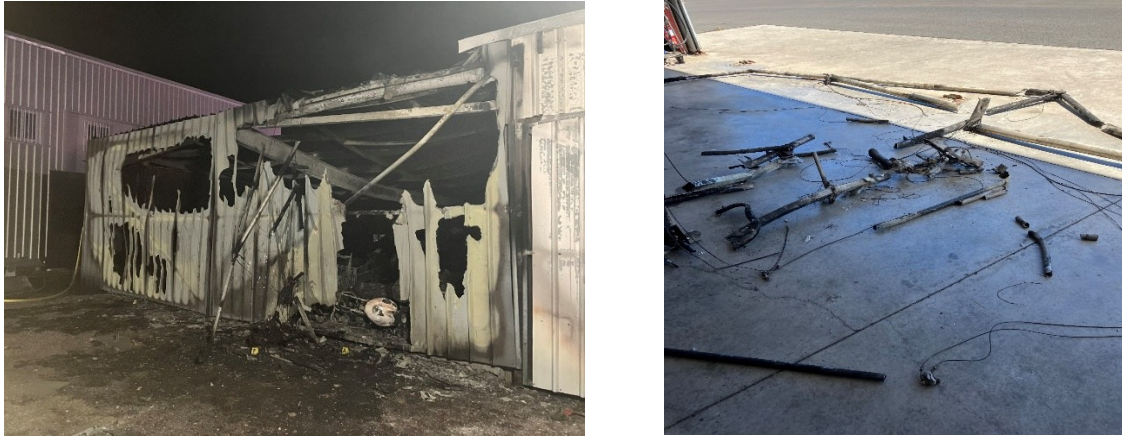
The extent of the damage caused by the fire limited the observations on the microlight. The main wing structure was present, the fabric and the battens had been destroyed by fire. All of the cables were present and most of them were still connected. The engine was found lying on the ground, separated from its frame. The two carburettors had been torn off and had melted. The four propeller blades were found with substantial fire damage.

Figure 2: photos of wreckage (source: BEA)

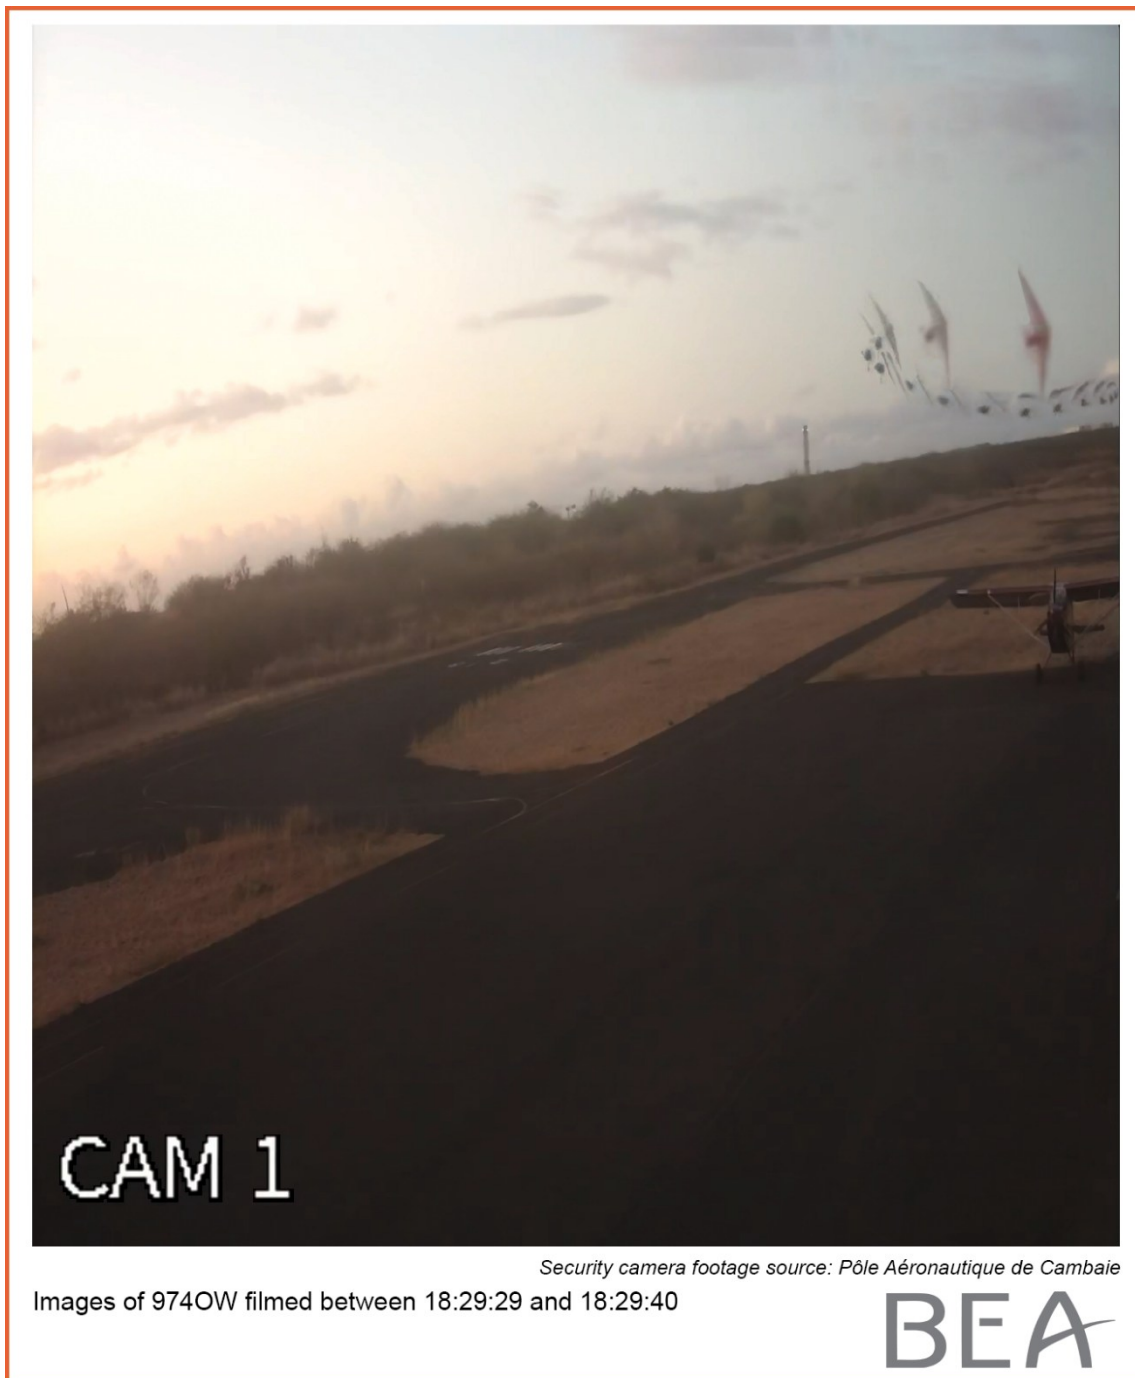
After a continuous turn of around 270°, the microlight seemed to turn right in descent towards the runway. The microlight then left the camera's field of view. When it was visible again, the microlight was roughly on the runway extended centreline, slightly banked to the right and at low height. The microlight then entered a steep left bank, without losing height, crossed the runway and left the camera's field of vision still in a steep bank.

*Figure 4: superimposed images taken from the security camera recording<sup>4</sup> showing the attitude of the microlight at the time of the loss of control (source: Pôle Aéronautique de Cambaie)*

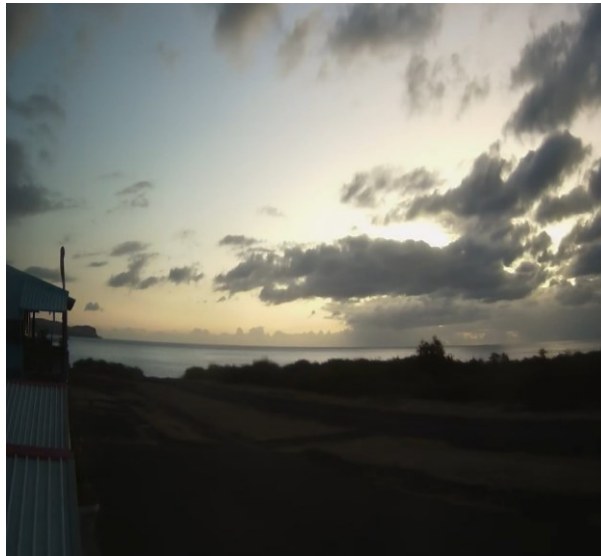
At the time of the occurrence, the azimuth of the sun was  $270^\circ$  for a height of  $-4.75^\circ$ . The sun set at 18:13 and the aeronautical night started at 18:28. The video recording by camera 3 oriented towards threshold 05, shows a sunset-like brightness, reduced by cloud cover.

*Figure 6: excerpt from video recording<sup>5</sup> of camera pointing towards threshold 05 at the end of the day (Source: Pôle Aéronautique de Cambaie)*
