Accident to the FK LIGHT PLANES FK9SW Mark VI
identified **974PQ**
on Saturday 6 August 2022
at Saint-Paul (La Réunion)

Time	Around 15:34 ¹
Operator	Papangue ULM
Type of flight	Instruction
Persons on board	Instructor and pilot
Consequences and damage	Instructor fatally injured, pilot seriously injured, microlight destroyed

Loss of control on final during a simulated engine failure exercise, collision with ground, in instruction

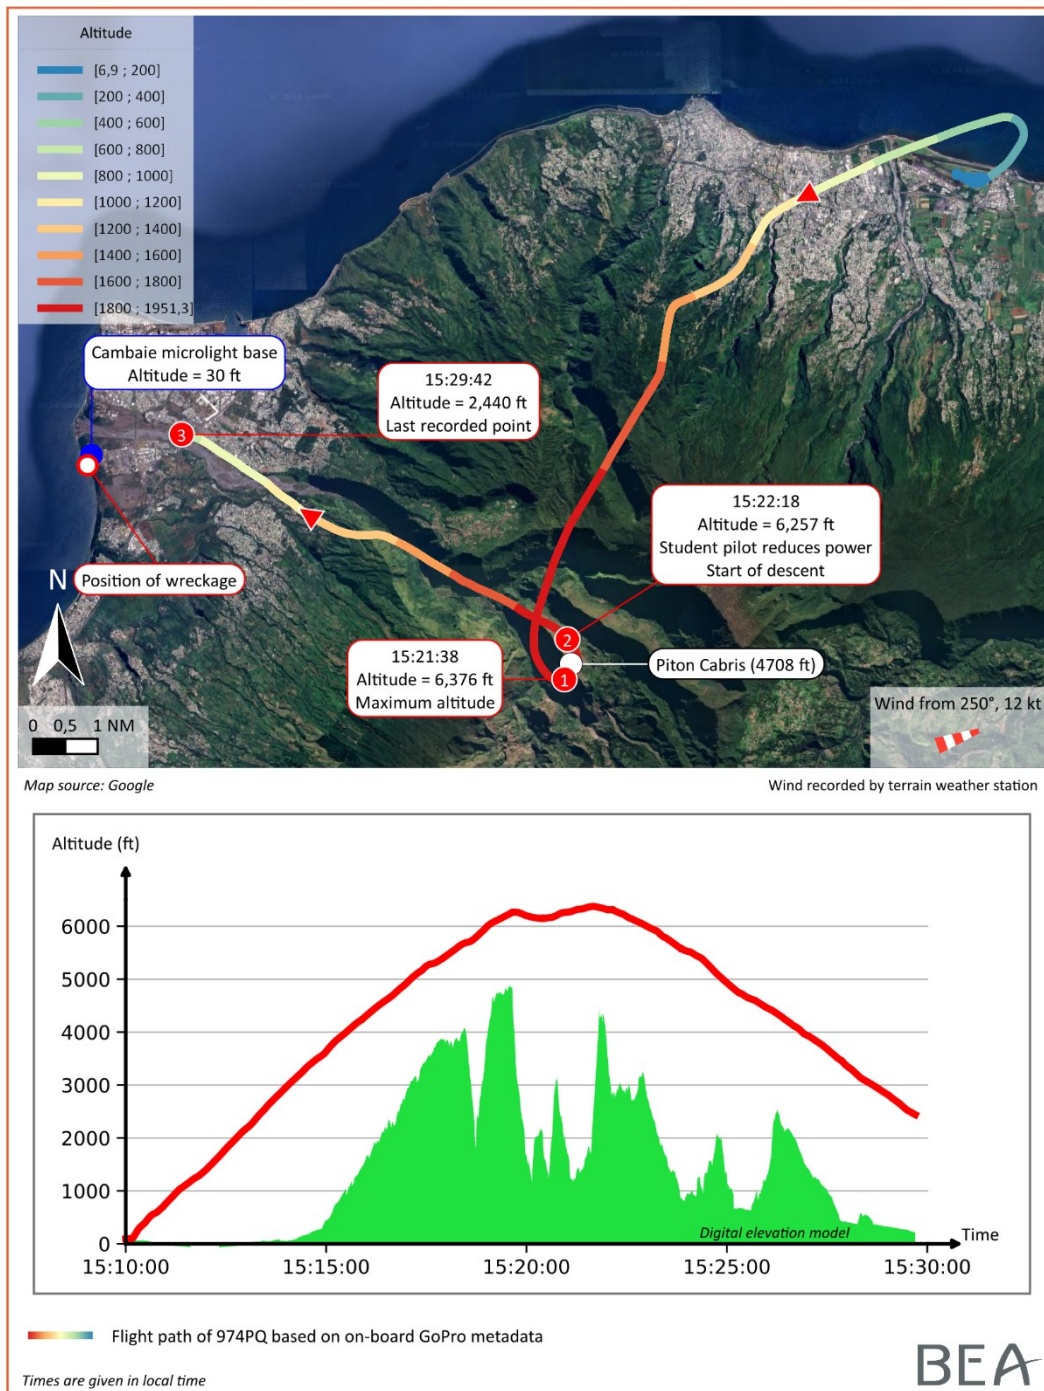
Figure 1: flight path based on onboard camera data

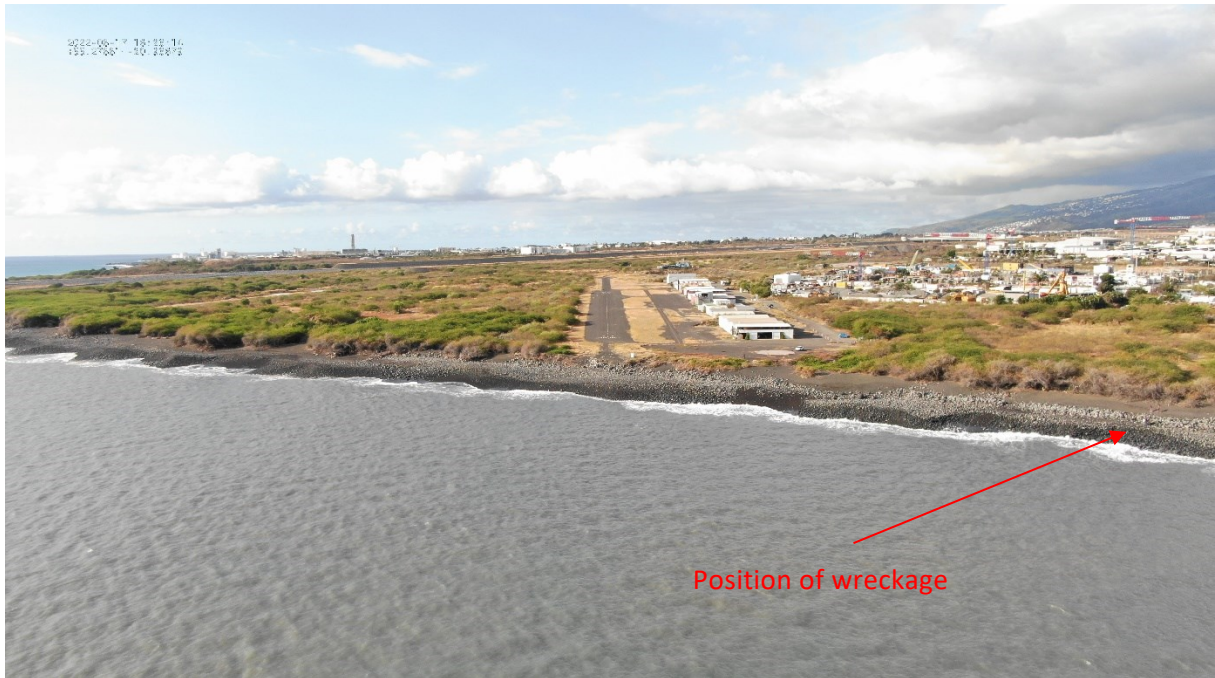
The microlight crashed onto a pebble beach close to the threshold of runway 05. The microlight was inverted, with a large part of the cockpit submerged. Several people immediately intervened to keep the microlight on the shore as it was being carried away by the swell. They then rescued the occupants of the microlight.

Figure 2: position of wreckage (source: GTA, annotations BEA)

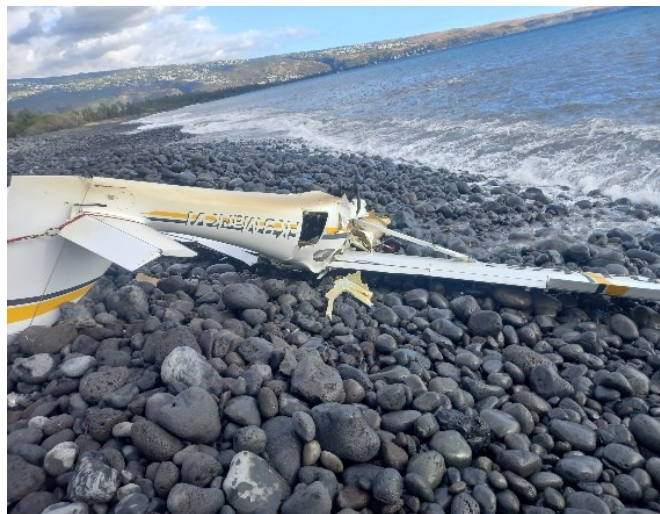
Figure 3: wreckage on accident site after being moved out of the water (source: BEA)

The microlight was found on its back at around 200 m before and to the RH side of the threshold of runway 05, at the edge of the shore. It was equipped with an airframe parachute which had not been activated.

The examination of the wreckage found that the microlight had struck the ground with a large nose-down attitude and little bank.

The examination of the flight controls did not reveal any anomaly which could have contributed to the accident. The flaps were in position but their mechanism was found broken following the impact with the ground. The deformations observed on the worm screw of the motor actuating the flaps seem to indicate that the flaps were extended to their first detent position at the time of the collision with the ground.

The engine and the propeller were substantially damaged, in particular, the two carburetors were torn off. The examination of the engine was unable to determine if it was providing power when the accident occurred.

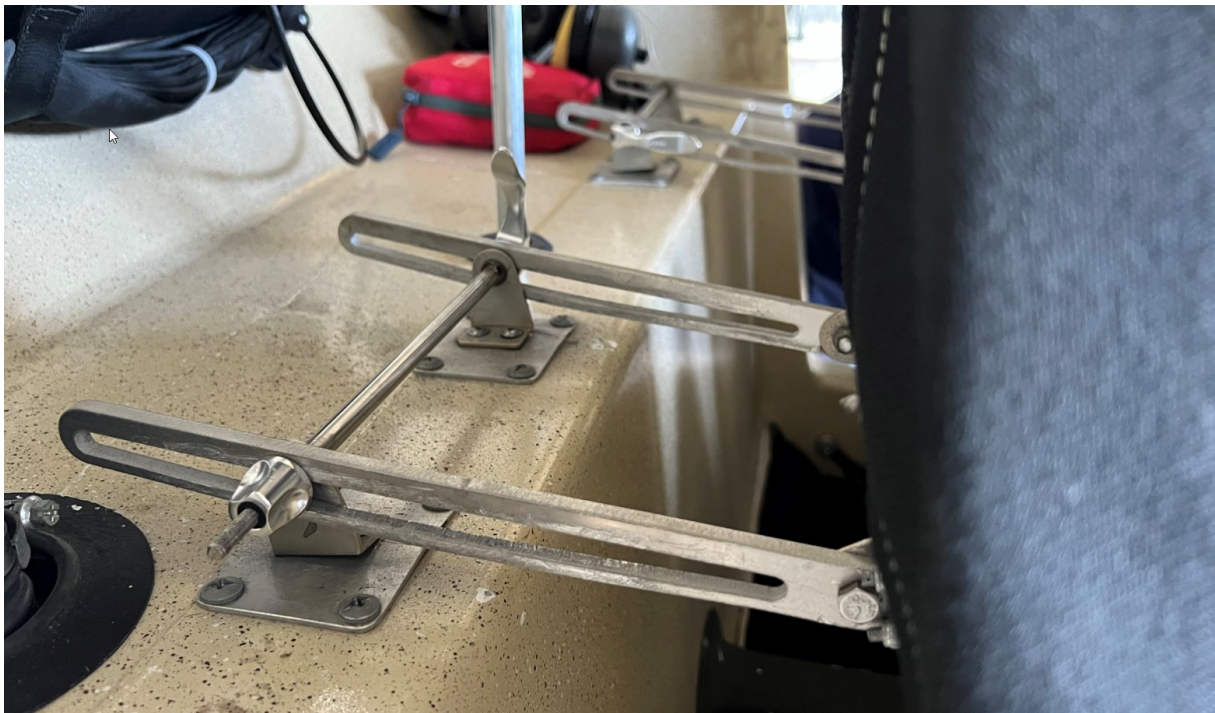
On 974PQ, the position of the seats can be adjusted longitudinally by means of a series of holes in the floor into which two pins situated under the seats are inserted. The angle of the backrest can be adjusted using a quick-release rod which, once in place, also locks all of the seat. This rod was not present on the RH seat. It was found in the hanger of the company where the two other FK9s belonging to the company were parked.

Figure 4: back rest securing system (source: BEA)

- the instructor probably only partially wearing the safety harness;
- the instructor's seat being incompletely secured due to a part having been transferred to another microlight.

A lack of stability in the pilot's seat when the aircraft experiences accelerations, as for example in turbulence, may make piloting difficult in an already demanding flight phase. Undertaking a flight with a non-operational seat can contribute to a loss of control and compromise recovery, as well as compromising the chances of survival in the event of an accident.

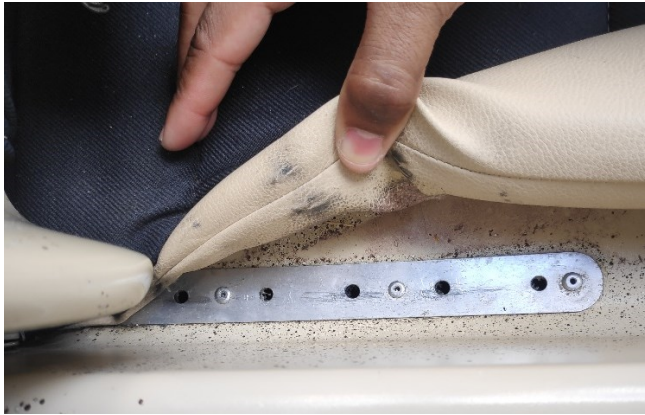
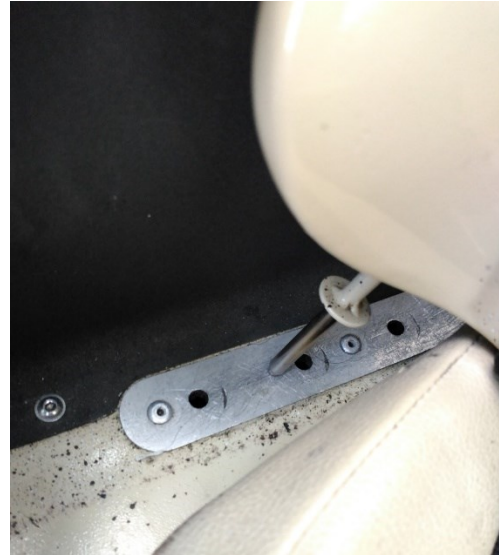
Figure 5: system for securing seat in floor (source: Papangue ULM)

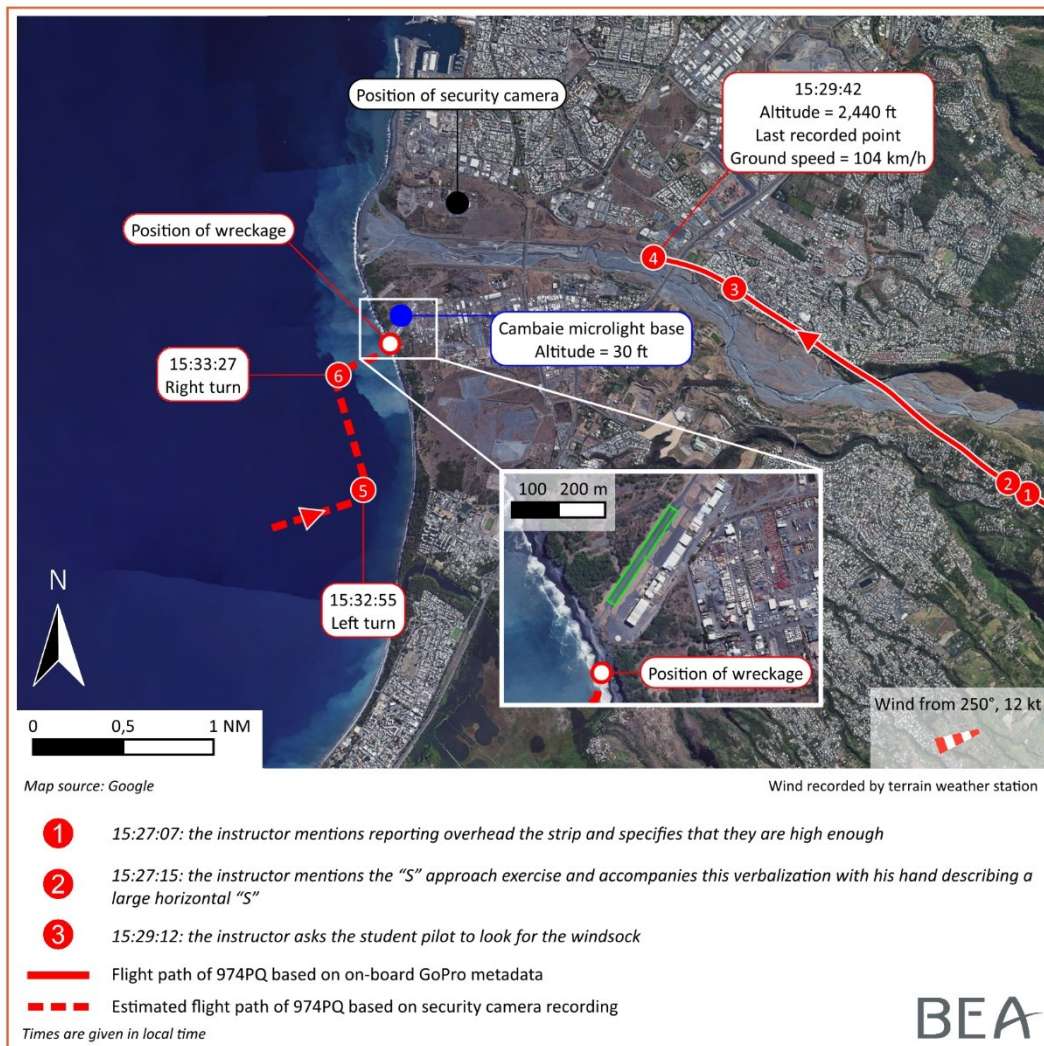
Figure 5: estimated end of flight path

- the instructor frequently intervened on the stick and his hands were regularly resting on it;
- around 12 min before the accident, the student pilot reduced power and put the microlight into descent. The engine speed was stabilized at around 2,200 rpm with variations of less than 100 rpm. This speed was stable up to the end of the recording, i.e. approximately five minutes before the accident;
- on the security camera recording, the microlight can be seen overhead the ocean in descent and approaching the runway. It can be seen first turning left and then turning right before completely losing control in a left turn. These manoeuvres are consistent with an "S" approach to runway 05.
