**Accident** to the Heli-Sport - Ranabot CH77  
identified **974PT**  
on Saturday 5 August 2023  
at Saint-Paul (La Réunion)

**Rotor blade strike with tail boom en route, collision with ground, fire**

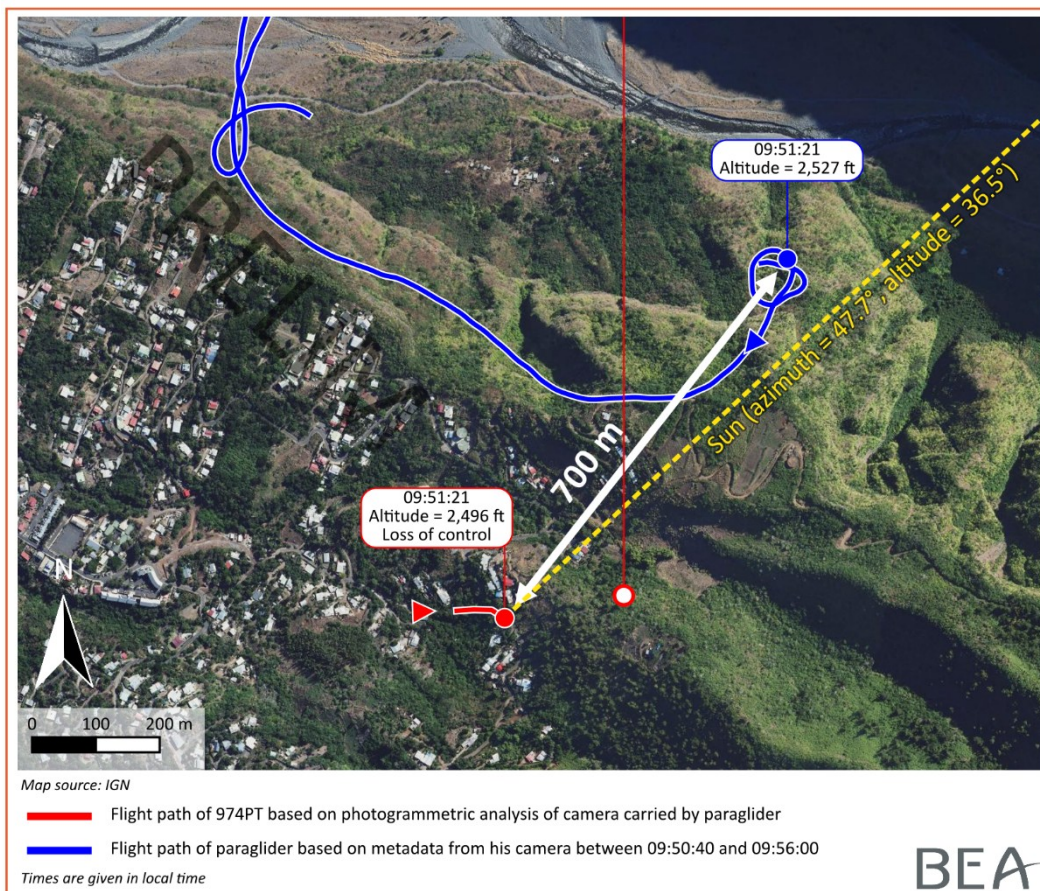
Figure 2: path of a paraglider pilot flying close to the accident site

The microlight, approaching the paraglider, appeared on the video. The microlight was in descent. In less than three seconds, it tilted forward and components detached from the airframe. The tail boom broke during the tilt. The microlight then fell vertically for approximately 6 s. A fire broke out after the collision with the ground.

At the time of the accident, the solar altitude (angle above the horizon) was 36.5° and azimuth angle was 47.7° (see **Figure 2**). The sun, the paraglider and the microlight were more or less along the same axis.

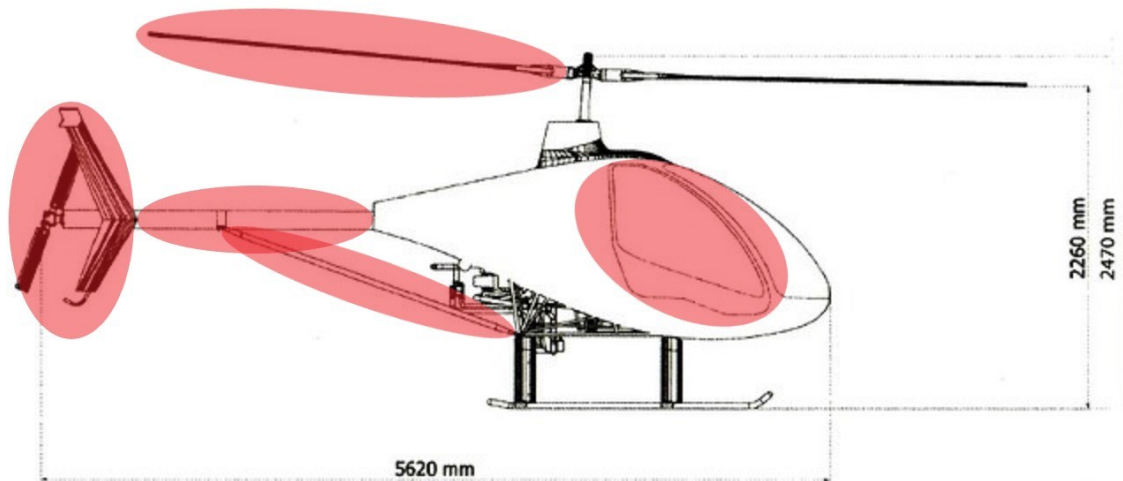
The microlight wreckage was found in a wooded terrain at an altitude of approximately 1,650 ft. The main wreckage was completely destroyed by the impact with the vegetation and the ground, as well as by the fire. The following components were found separated from the main wreckage, some of them approximately 100 m from it, with no signs of fire:

- one main rotor blade;
- the two doors;
- the tail rotor and the tailplane;
- a section of the tail boom;
- the two braces linking the tail boom and the airframe.

*Figure 3: components found separated from the main wreckage (source: User Manual).*

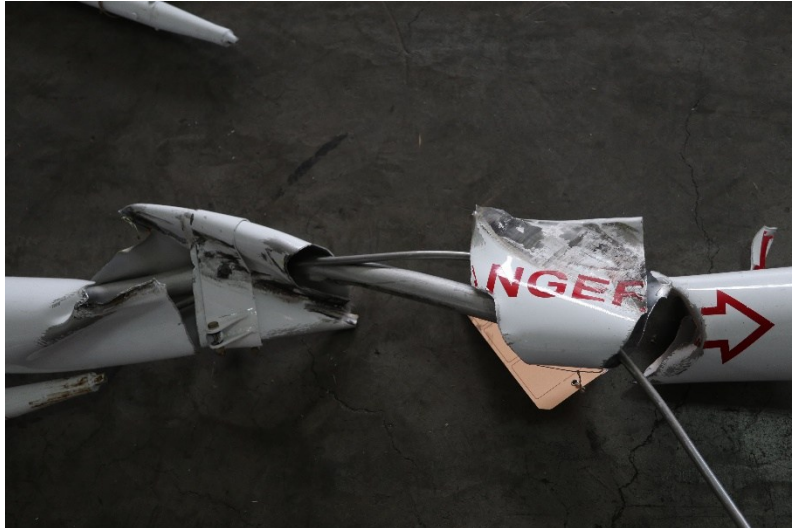
The two main rotor blades showed similar damage. The trailing edges were open and the leading edge reinforcements were torn off. All of this damage indicated that both blades made contact with a component while the main rotor was rotating. The tail boom showed two signs of impact. The blade found separated from the rotor showed traces of paint that could correspond to a strike with the tail boom at the “Danger” sign.

Figure 4: marks resulting from contact of the rotor blades with the tail boom (source: BEA)

The failures observed between the airframe and the tail boom, between the tail boom and the tailplane, as well as at the ends of each brace, were of a sudden nature. The blades' flapping stops were slightly damaged, indicating important blade flapping.

All these observations showed that the rotor blades came into contact with the tail boom, causing the components found near the main wreckage to separate.
