Accident to the Skyranger
identified **988FC**
on 18 February 2023
at Païta (New Caledonia)

**Engine failure, off-airfield forced landing, collision
with a bank, fire**

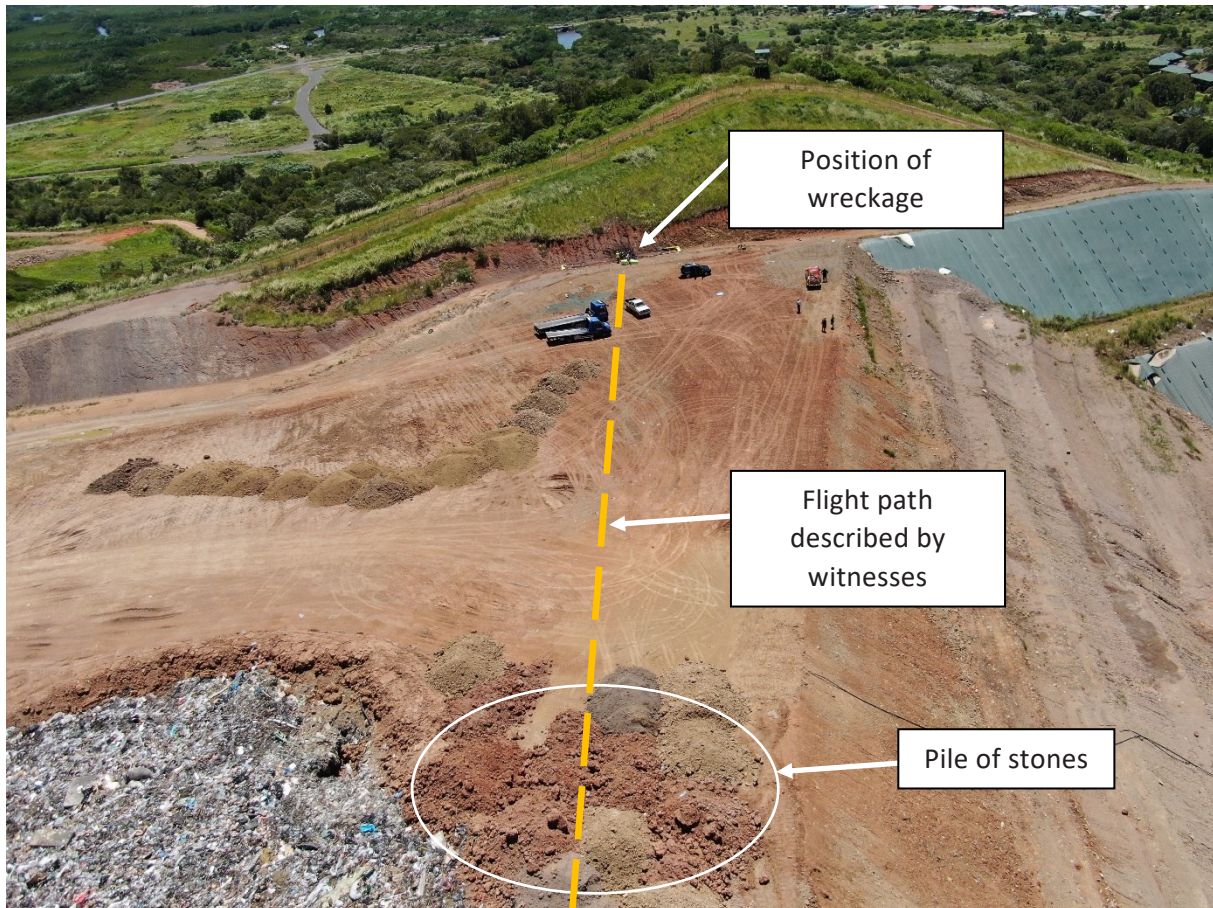
He tried to carry out a forced landing in a flat area, situated on a waste landfill site. This area had a downward slope and there was a tailwind in the direction of the flight path. The microlight flew over the site and its wheels touched down a few metres before a bank that was several metres high at the edge of the area. The microlight collided with the bank.

The accident occurred in a flat area of compact schist, measuring approximately 90 m in the direction of the microlight's flight path. It had a downward slope which varied between 5° and 10°. A pile of stones about 1.70 m high was situated before the flat part.

According to the witnesses on the site, the microlight's landing path was on a north-west heading.

Figure 1: landing area and final flight path described by witnesses (source: GTA)
