Accident to the Embraer– EMB-500
registered **9H-FAM**
on 8 February 2021
at Paris-Le Bourget

**Stall on short final in icing conditions, hard landing,
rupture of main landing gear and nose gear,
fire, runway veer-off**

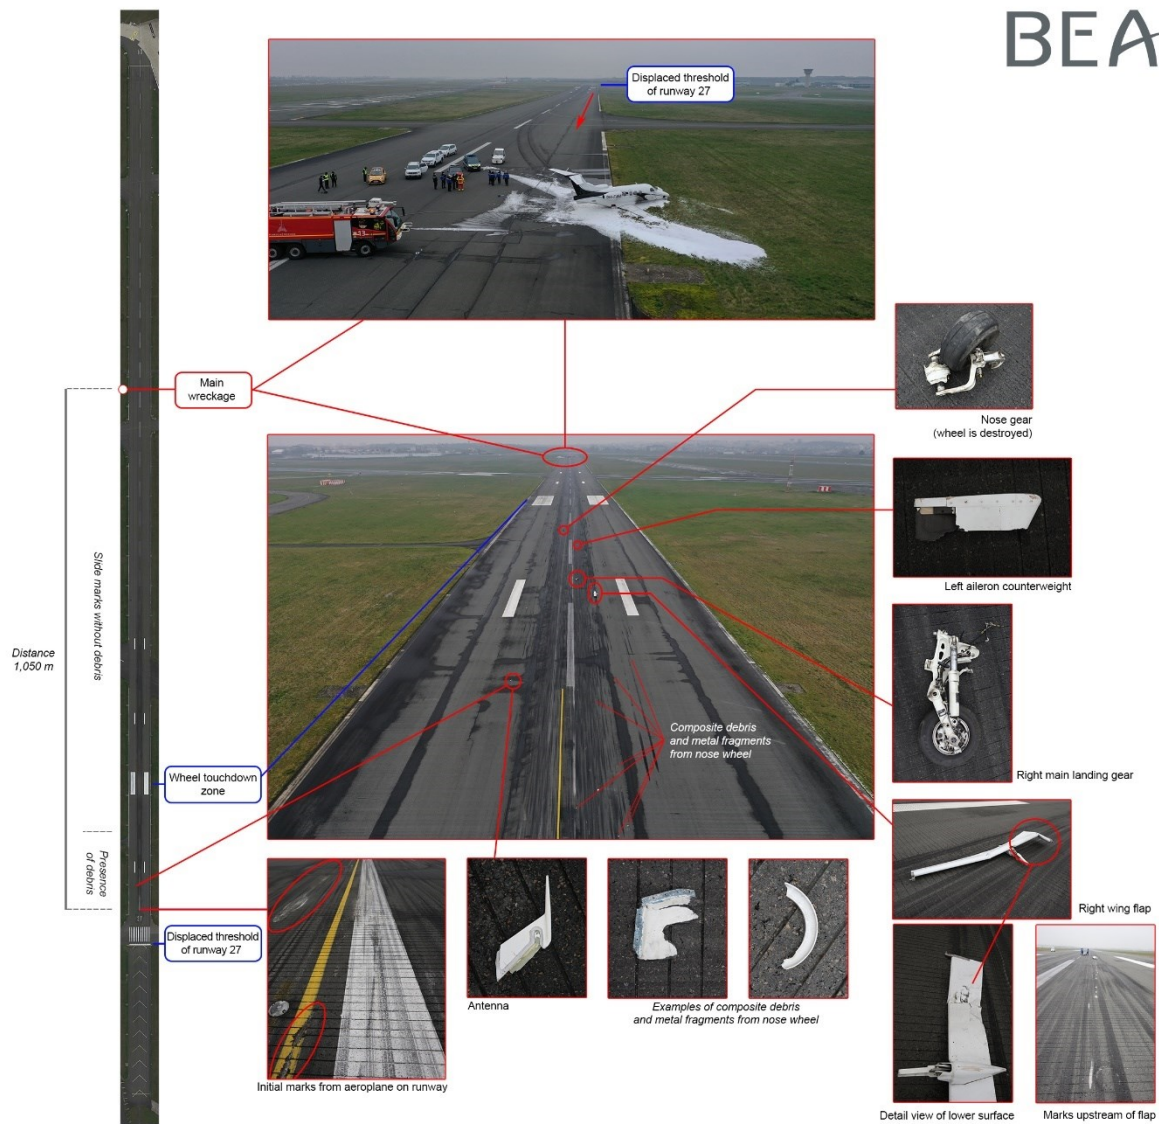
- the right landing gear broke and perforated the fuel tank when it passed through the right wing;
- the nose gear broke;
- a fire broke out near the engines and at the wing roots;
- the aeroplane slid for a distance of around 1,050 m along the runway;
- it veered off the left side of the runway by pivoting around its yaw axis and came to a halt on a heading of approximately 160°.

Figure 1: distribution of aeroplane parts on runway

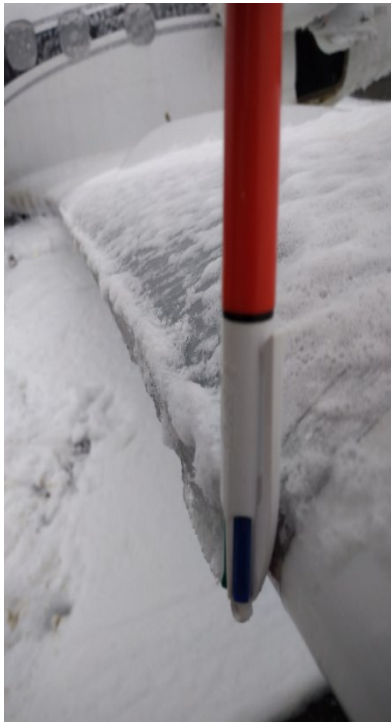
On site, the BEA investigation team observed the presence of built-up ice on the leading edges of the wings and stabilizer.

Figure 2: icing on the leading edge of the left wing still present 3 h after the accident. The white on the upper surface of the wing is the residue of the product used by the fire-fighters (source: BEA)

The presence of ice on the wing and stabilizer leading edges observed after the accident shows that ice built up on the aeroplane on final. The following hypotheses can thus be made:

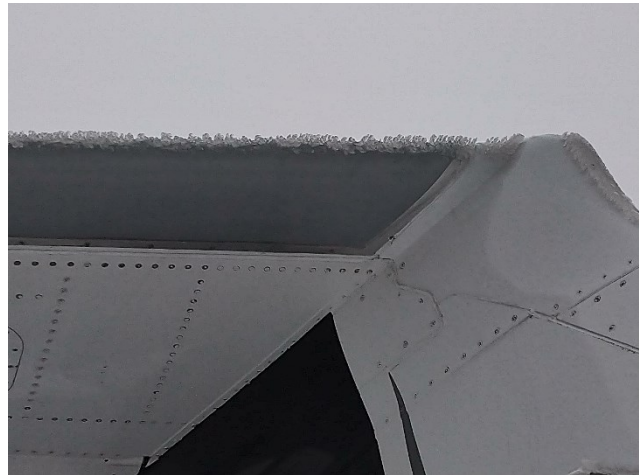
Figure 3: icing on the leading edge of the elevator still present 3 h after the accident (source: BEA)

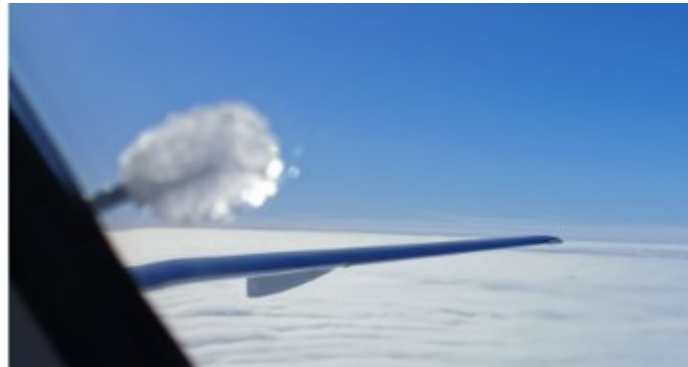
that he had rarely encountered such conditions. He specified that he was flying a Piaggio P180 equipped with a visual ice accretion probe which had accumulated so much ice that he took a photo of it, around ten minutes before the accident to 9H-FAM (see Figure 10).

Figure 10: photo taken by pilot of aeroplane on final behind 9H-FAM, ten minutes before accident
