# INVESTIGATION REPORT

**Incident** to the ATR 72-212A  
operated by Caribbean Airlines  
registered **9Y-TTC**  
on 4 May 2014  
at top of descent to **Piarco airport**  
(Republic of Trinidad and Tobago)

**BEA**

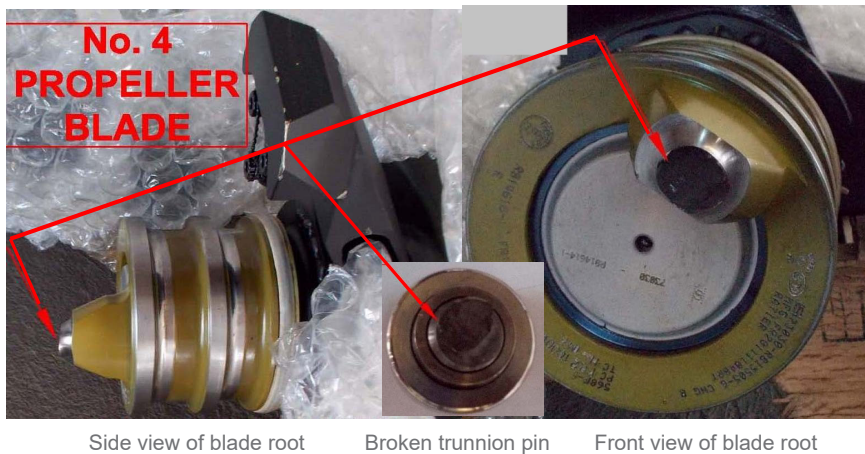
Figure 3: Root of blade 4 of right propeller

After the flight of 5 May and the tests carried out by the maintenance personnel, blades 3 and 4 of the right propeller were in a position corresponding to reverse whereas the four other blades were feathered. Blade 4 of the right propeller rotated freely around its axis. The disassembly of the right propeller blades revealed the rupture of the trunnion pin of blade 4 (Figure 3) and damage to the propeller blade actuator yoke plate (Figure 4).

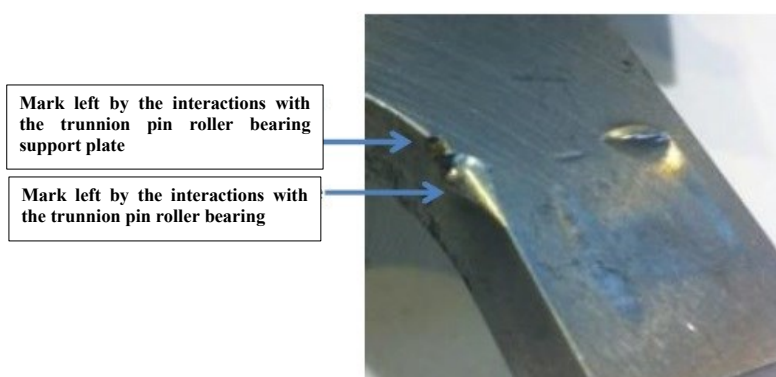
Figure 17: Marks on side of ear of forward yoke plate of blade 3

Taking into account the geometry of the pitch change actuator, the minimum deflection<sup>(28)</sup> of the ear of the forward yoke plate of blade 3 needed for the trunnion pin to pass onto the other side of the yoke plate is:

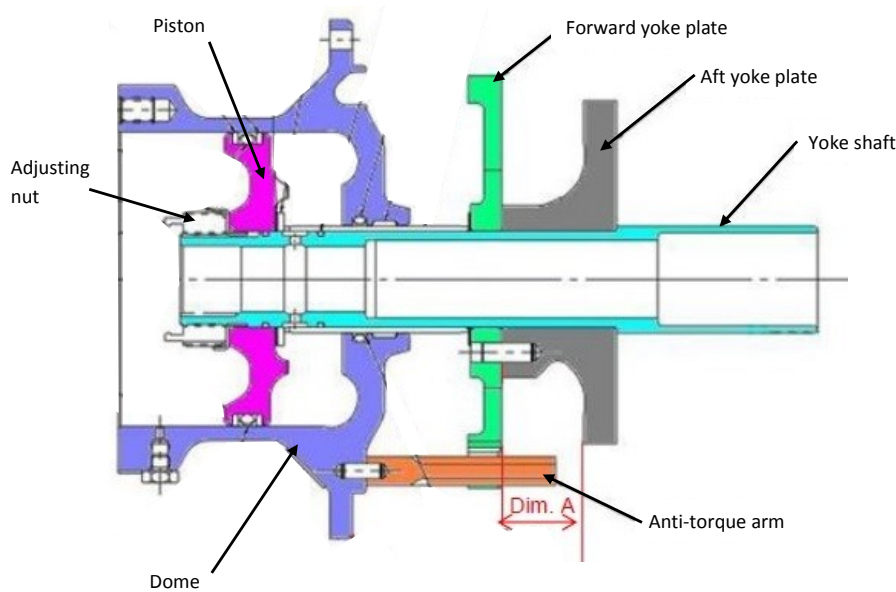
Figure 18: Measurement of distance Dim A between forward yoke plate (green) and aft yoke plate (grey)

According to the maintenance manual (CMM 61-13-12), the maximum distance between the forward and aft yoke plates is 41.43 mm.

The following table shows the maximum distance measured (Figure 18) separating each of the six ears of the two yoke plates associated with each blade of the right propeller.

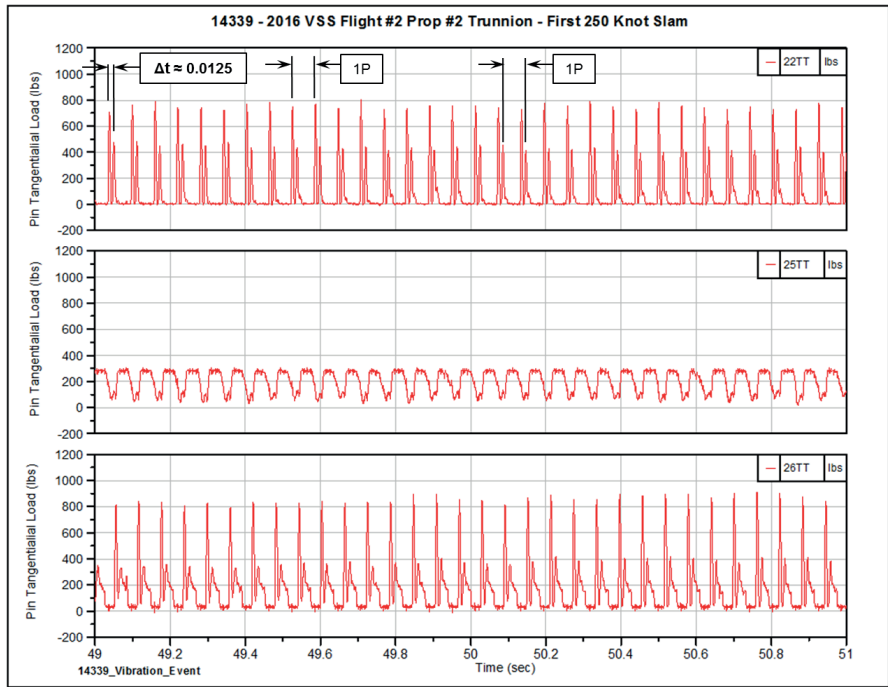
At this resolution, two distinct load peaks occurring at 1P intervals are visible in the 22TT and 26TT signals. The first peak is the higher load on the aft plate. The second peak occurs 0.0125 seconds after the first peak, also on the aft plate. This implies a double impact load on the aft plate. No double impact was observed for the forward plate for any case. Since the air data is only sampled at 0.125 second intervals, it cannot be directly correlated to the load data to identify drivers of such a double impact load. Additionally, blade angle is derived from actuator position, which disallows identification of different blade angles for different blades.

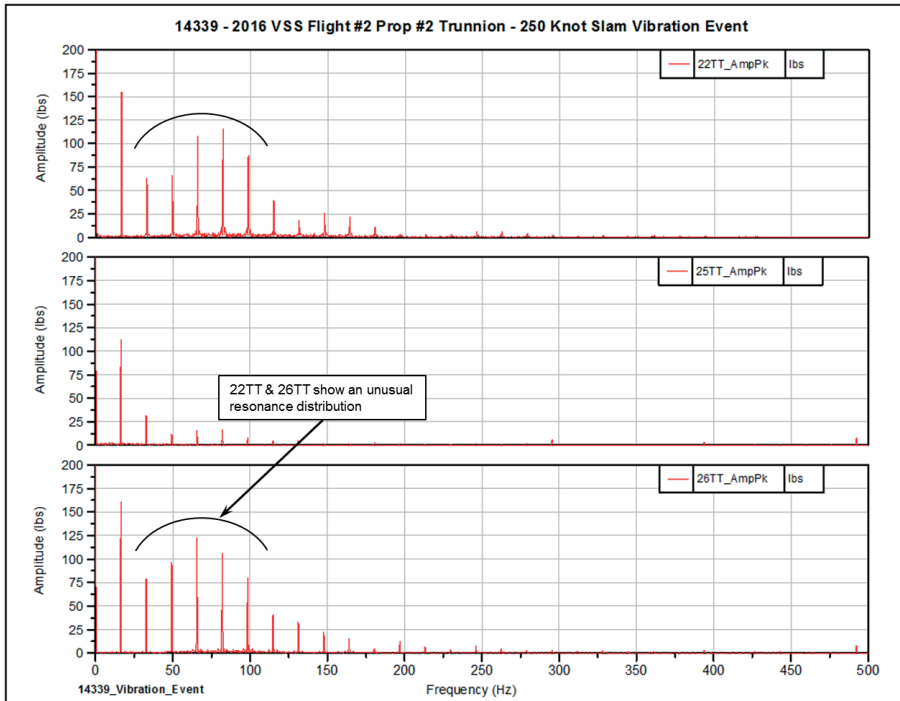
FFT plots for 22TT and 26TT show an unusual peak pattern. Typically 1P and 2P predominate. But in this case 1P is dominant while 2P through 6P are also major contributors to trunnion loading. A physical explanation for this ‘ringing’ phenomenon would be similar to a response observed after an impact load. The obvious candidate for such an impact would be the cyclic load of the trunnion loading and unloading the yoke plate. The 25TT FFT appears normal in that 1P dominates.

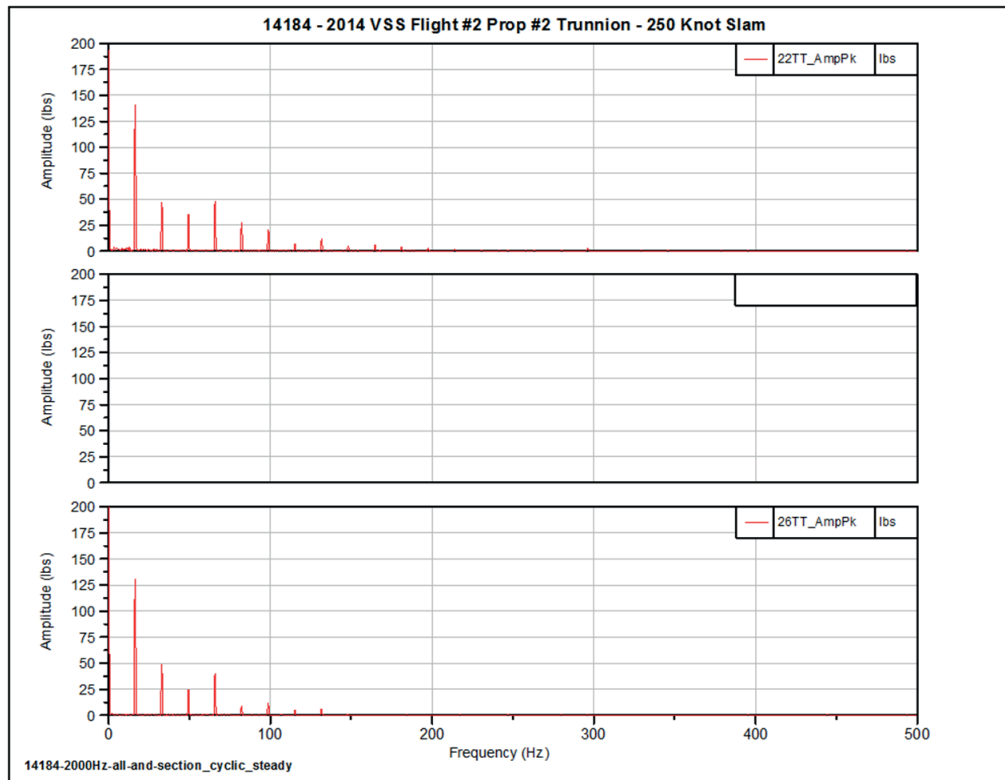
It reveals a broadband frequency response similar to that of 2016 VSS (250 knot slam.).
