Incident to the AIRBUS A380-800
registered **A6-EOM**
on Friday 18 August 2023
on approach to Nice-Côte d'Azur

Time	Around 11:00 ¹
Operator	Emirates
Type of flight	Passenger commercial air transport
Persons on board	2 flight crew, 23 cabin crew, 432 passengers
Consequences and damage	Leading edge slat No 2 of RH wing damaged
This is a courtesy translation by the BEA of the Final Report on the Safety Investigation. As accurate as the translation may be, the original text in French is the work of reference.

Damage to leading edge slat during approach

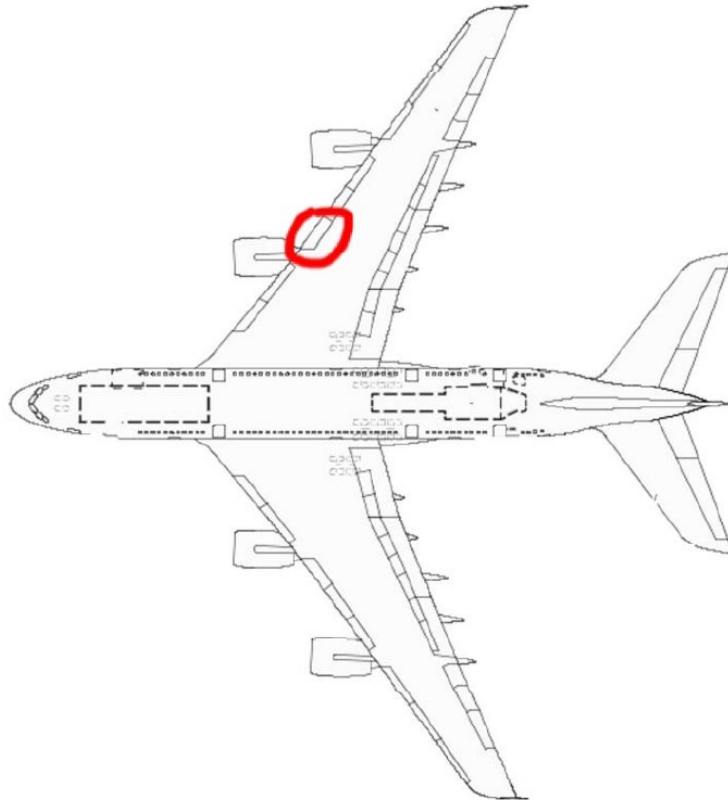
Figure 1: position of leading edge slat No 2 (source: ASR Emirates)

On the ground, an inspection revealed that leading edge slat No 2 of the RH wing was significantly damaged: the upper and lower skin of the trailing edge was torn over around two-thirds of the slat and the honeycomb structure was partially missing.

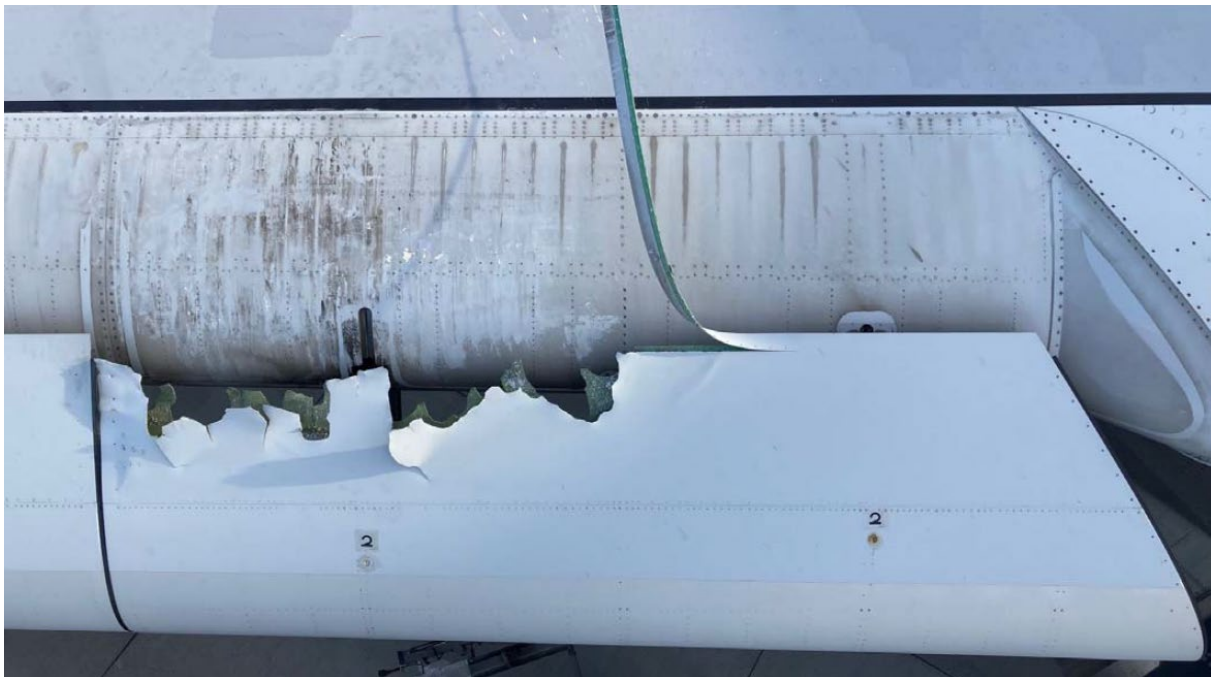
Figure 2: leading edge slat No 2 before disassembly (source: Airbus)

The damaged leading edge slat from the A380 A6-EOM and the slat from the first of the three following occurrences were removed and examined. These examinations, notably under UV light, did not identify signs of a bird strike. Furthermore, the deformations observed did not indicate that an impact might have caused the damage. The hypothesis of a mid-air collision with a bird or drone was therefore excluded.

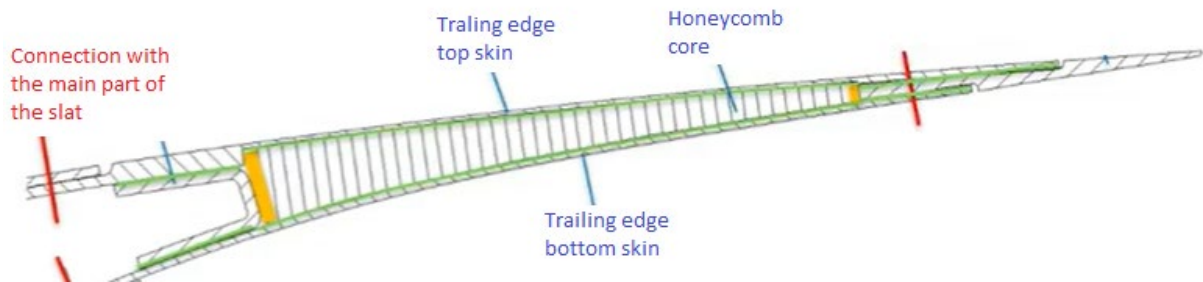
Figure 3: diagram of composite structure of trailing edge of Airbus A380 leading edge slat (source: Airbus, annotations: BEA)

- a metal box including the slat leading edge, is directly connected to the wing structure by the extension/retraction mechanism and constitutes the main part of the slat;
- a trailing edge composed of a metal sandwich composite structure is riveted to the metal box.

In the event of major damage to the trailing edge as was the case in the four occurrences brought to the BEA’s knowledge, the main part of the slat remains intact and the risk of a total dislocation

and/or slat loss does not exist. Only fragments from the trailing edge can separate from the rest of the structure.

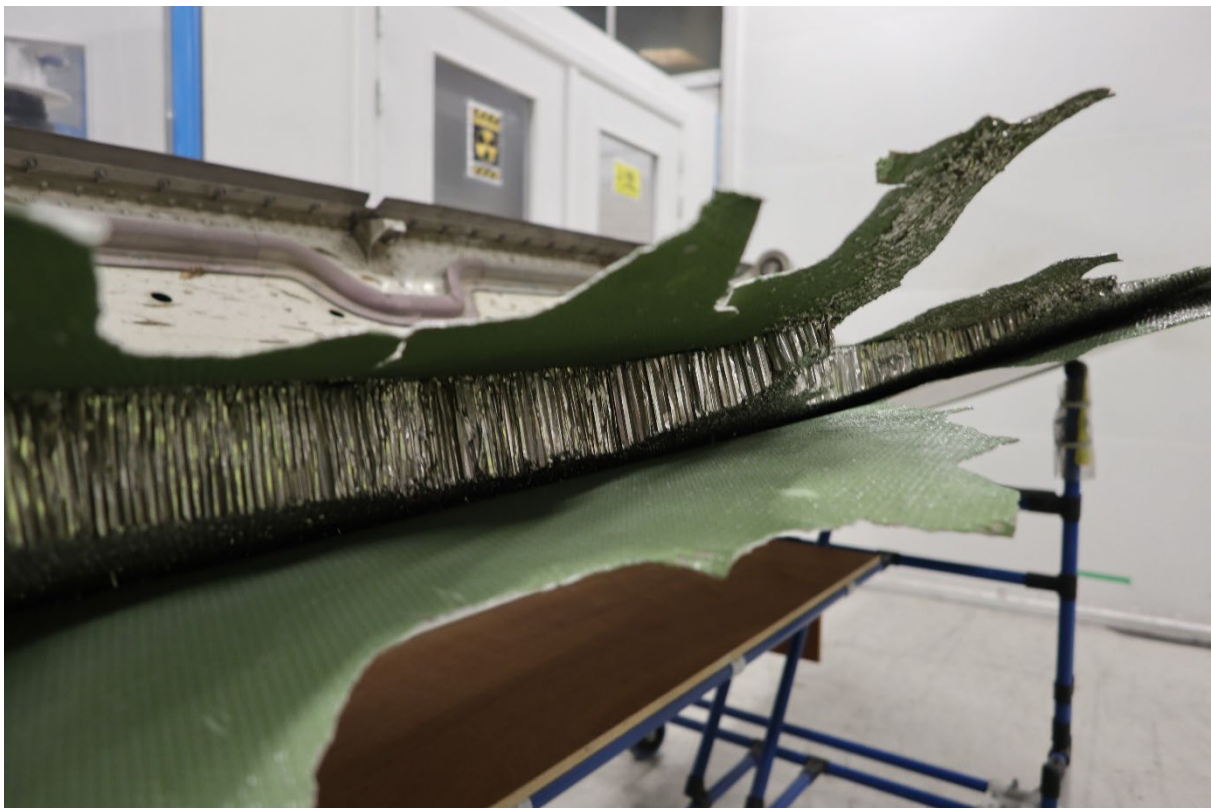
Figure 4: trailing edge of Slat No 2 of the A380 A6-EOM (source: BEA)

The examinations of the two removed leading edge slats identified different types of bonding rupture between the honeycomb and the skin of the slat trailing edge. Some of these ruptures were the result of the occurrence while others can be associated with bonding defects. The cause of these bonding defects has not yet been identified and Airbus informed the BEA that it was continuing to search for it as part of the continuing airworthiness, under the supervision of EASA.

On changing to configuration 1 with a view to landing, when the airflow around the leading edge slats was modified, the pilots perceived a muffled noise followed by slight vibrations. They continued the approach and landed without any further incident. On the ground, an inspection revealed significant damage to the metal composite structure of the trailing edge of slat No 2 on the RH wing. The investigation established that this damage was not the consequence of a mid-air collision. It was also established that there were pre-existing bonding defects between the upper and lower skin and the honeycomb core. They may have weakened the structure.

Airbus recorded three other similar occurrences on the A380 in the following seven months. The manufacturer carried out examinations on the damaged slats, revealing internal structural defects which may have led to these incidents. Airbus is continuing its analysis to determine the cause of these defects. Pending conclusions, an inspection was carried out on all the A380s operated by the two operators concerned: no similar damage was observed.

Airbus plans to issue two service bulletins to all A380 operators in January 2026, to introduce repetitive inspections during A and C checks in order to identify possible cracks or delamination on a trailing edge of a leading edge slat.
