Accident to the EKOLOT JK 05 identified 71LO

on 30 July 2021

at Vesoul-Frotey

Technical problem reported during initial climb, turn-around, loss of control, collision with the ground

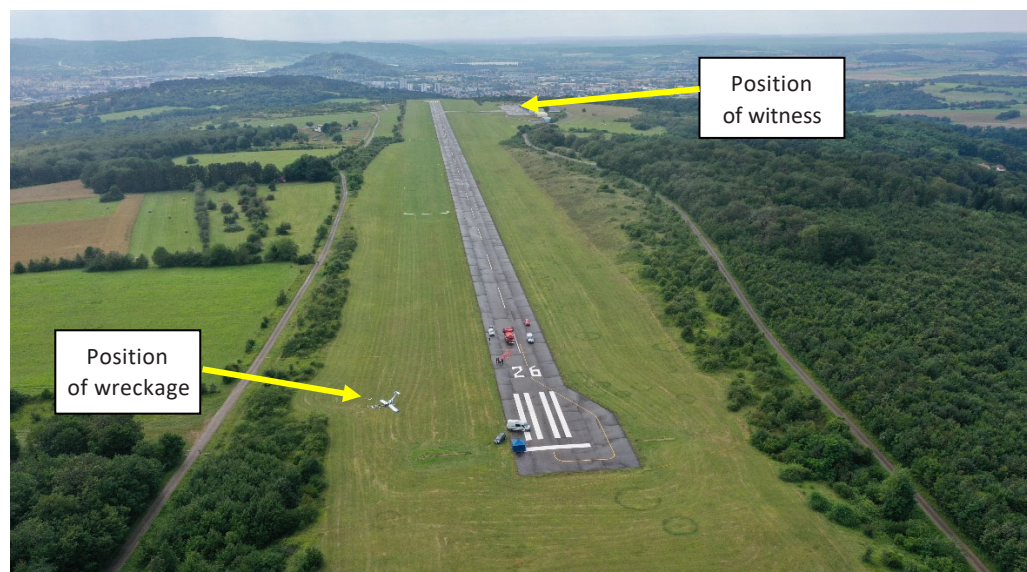
The wreckage was complete and located next to the end of runway 08. The examination of the wreckage showed that the microlight collided with the ground with a nose-down attitude, following a flight path close to vertical and with strong energy. The airframe parachute was not deployed.

Figure 1: aerial view of site and wreckage

The front section of the microlight's airframe was destroyed by the impact. The examination of the flight control surfaces and their controls did not reveal any anomaly. The deformations and failures observed were all caused by the accident or by the rescue operations.

One of the propeller blades was broken at its base on being bent backwards. Apart from this failure, it suffered little damage. The two other blades showed only slight damage. The examination of the propeller indicated low rotation energy during the collision with the ground.

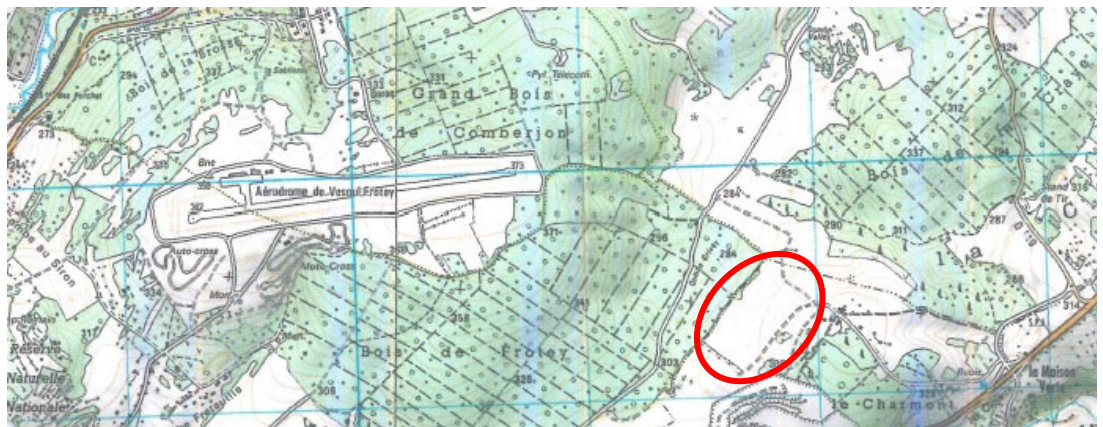
The Aéroclub de la Haute Saône is located on the aerodrome. The club's instructors teach their students the areas suitable for an emergency landing in case of problem during the initial climb. These areas are not on the take-off axis and do not appear on the Visual Approach Chart.

Figure 2: area taught by the club instructors to be used for an emergency landing in case of problem during the initial climb after take-off from runway 08 (excerpt from IGN map)

A knowledge of the areas suitable for an emergency landing might have resulted in the pilot adopting a different strategy and not attempting a turn around.
