Accident to the PIPER PA23 "Aztec" registered N539EG

on 22 February 2016
at Saint-François (Guadeloupe)

Loss of control in initial climb during a post-maintenance ferry flight

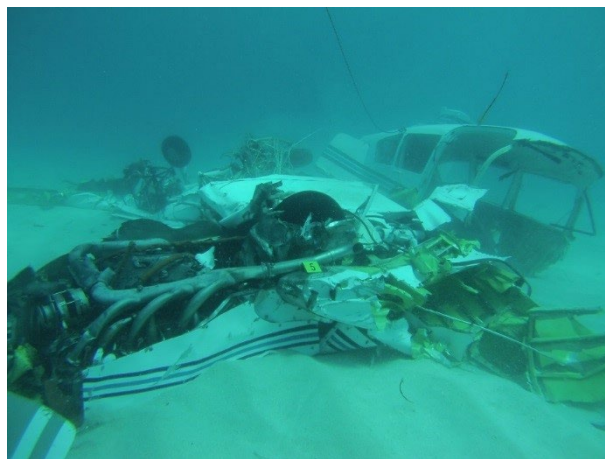
Figure 1: main group of debris

The wreckage was found in the sea, on a bed of sand, at a depth of around nine metres. It was lying at the bottom of a channel around 1,200 m from the threshold of runway 29 of Saint-François airport.

It was composed of four main groups of debris:

- The tip of the right wing (see [Figure 2](#), point **a**).
- The left engine (see [Figure 2](#), point **b**) 14 m to the east of point **a**.
- The main group of debris 28 m to the north-east of point **b** (see [Figure 2](#), point **c**). It was composed of the upper part of the fuselage including the seats and rear bench-seat, the tail unit, the right wing root with its main landing gear and its power plant, the left wing root with its main landing gear and just the engine mount, part of the left wing tip and the cockpit.
- Part of the right instrument panel was found at mid-distance between point **b** and point **c**.

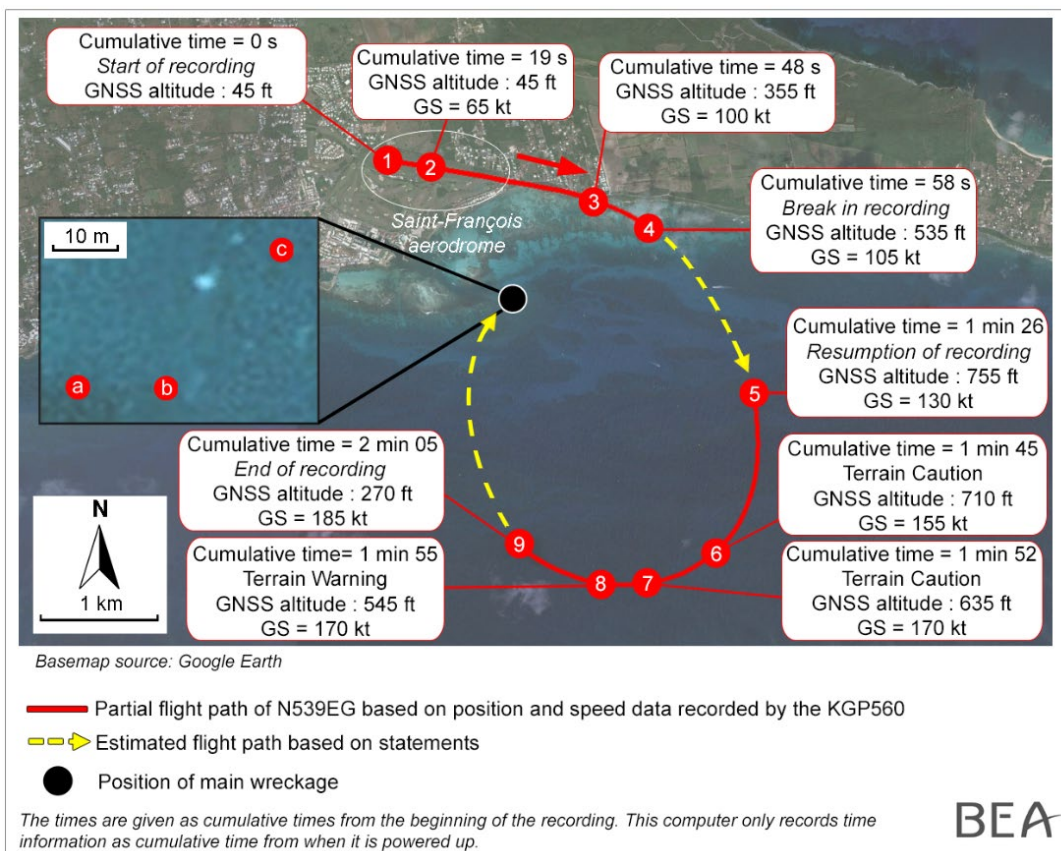
Figure 2: flight path of N539EG and distribution of debris (insert)

The flight path based on this data and supplemented by statements, was produced (see [Figure 2](#)).

The computer recordings show that shortly before the impact with the sea, the ground speed exceeded 180 kt (330 km/h).

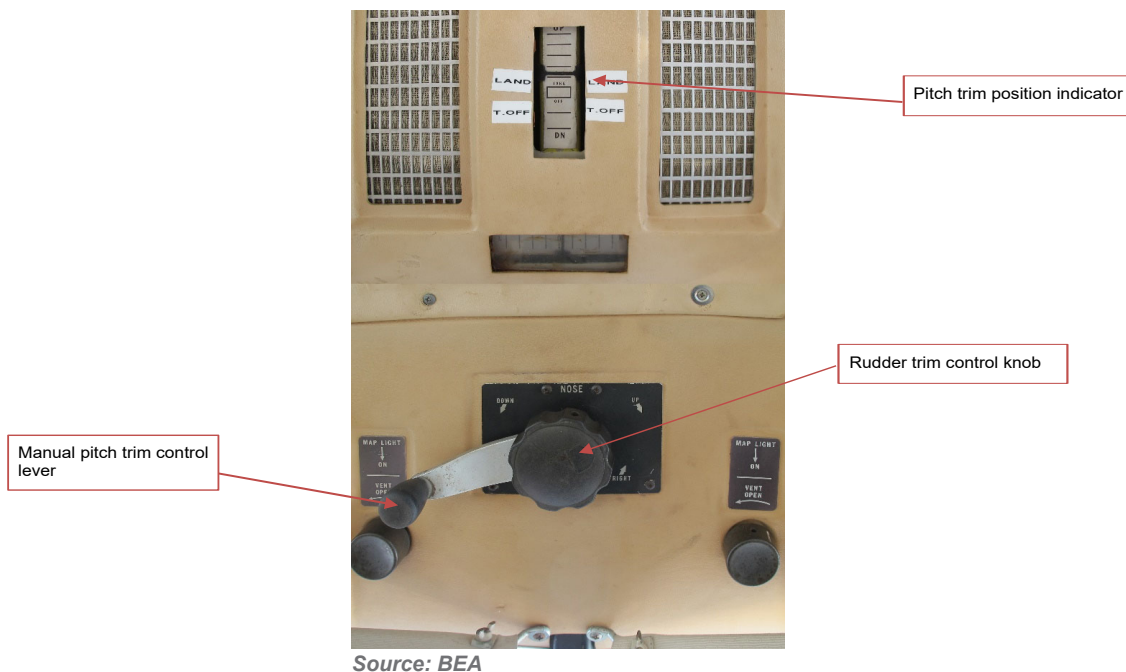
Figure 3: manual pitch and rudder trim controls and position indicator on cockpit overhead panel on a PA23

On the PA23, the manual rudder and pitch trim controls are composed of a handle and a central knob on the handle. These controls are located on the overhead panel of the cockpit (see [Figure 3](#)).

On light, piston-powered aeroplanes, the pitch trim control is generally placed in the centre of the cockpit, at the bottom of the instrument panel. Nevertheless, on certain models, it can be located on the cockpit overhead panel as is the case with the Piper PA23.

The pilot, concerned about ferrying the aeroplane to its base on time and swiftly vacating the aerodrome taxiway, quickly started the take-off without taking the time to check the pitch trim position indicator on the overhead panel, or get out the check-list from the flight manual which was placed on the passenger seat. The pitch trim was probably in a nose-down position on taking off.

The pitch trim setting is of major importance for take-off safety. Carrying out the check-lists recommended by the manufacturer using the paper copy enables the pilot, among other things, to detect an inappropriate configuration before take-off.
