## Serious incident between the Diamond DA42 registered F-HCTA and the Rolladen Schneider LS8 registered HB-3284 on 27 July 2016 at Pont-sur-Yonne (Yonne)

## Near midair collision between an aeroplane and a glider in class E airspace, evasive action

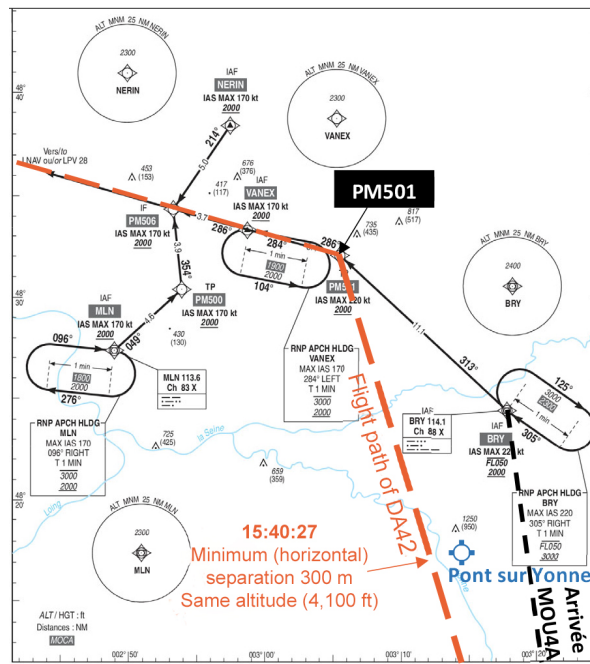
Figure 1: Path of DA42 on the GNSS approach chart for runway 28 at Melun-Villaroche aerodrome

At 17:30, following a 352°<sup>(2)</sup> route towards the VOR-DME of Bray sur Seine (BRY), the pilot of the DA42 continued descending from FL090 to FL050 as requested by the air traffic controller. The latter then asked the pilot to head directly towards point PM501 of the RNAV Y approach to Melun-Villaroche aerodrome to make a landing on runway 28.

At 17:38, he asked the pilot to descend to 4,000 ft (QNH1018) and he cleared the pilot for the RNAV Y approach to Melun-Villaroche. At 17:40, he asked him to descend to 3,000 ft.

The initiation of descent from FL090 was requested by the approach controller much earlier than the pilot had planned. The instruction to head directly towards point PM501 shortened the path of the DA42 while setting up for the approach and resulted in it passing not far from the west of Pont-sur-Yonne aerodrome.

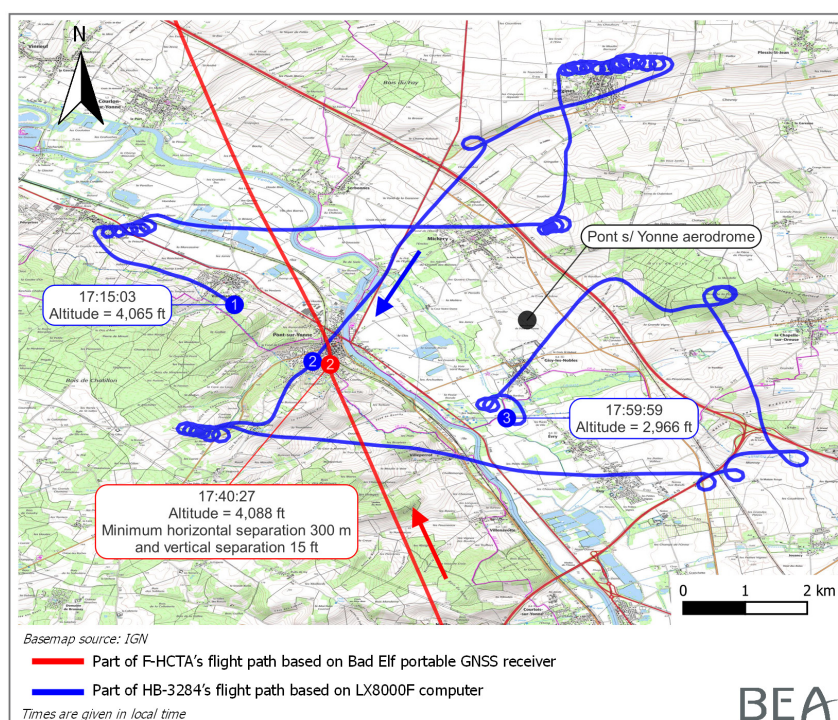
Figure 2: Paths of the glider and the aeroplane in the vicinity of Pont-sur-Yonne aerodrome

Shortly after this descent instruction, the passenger sat in the front right seat shouted "glider" three times. The pilot then, with difficulty, detected the glider that was following a path going from the right to the left of the aeroplane, at the same altitude. He disconnected the autopilot and turned right making a full right input on the stick to move behind the glider. He also increased the aeroplane's rate of descent before returning to his approach path and landing at Melun-Villaroche aerodrome at 17:55. The glider pilot continued his route without having seen the aeroplane. He landed at Pont-sur-Yonne aerodrome at 18:42.

The minimum separations between the glider and the aeroplane, at an altitude of 4,100 ft, were around 300 m in the horizontal plane and 15 ft in the vertical plane<sup>(3)</sup>, reached at 17:40:27.

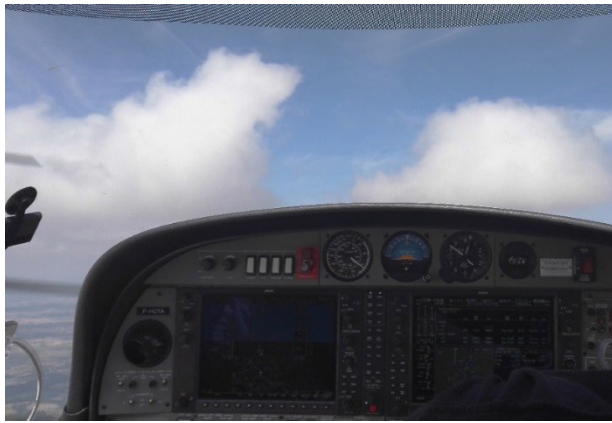
Figure 3: Photograph taken by the rear passenger shortly after the evasive action

The passenger in the rear seat took several photographs during the flight. The photograph in [Figure 3](#) was taken shortly after the evasive action.

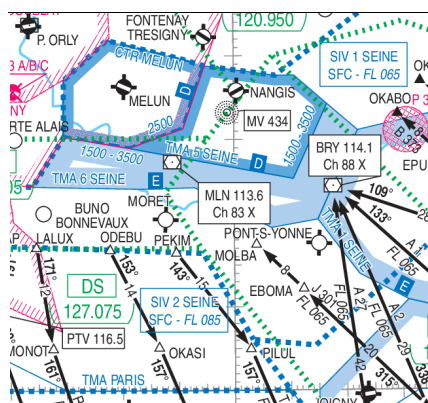
Figure 4: Extract from the Melun-Villaroche regional chart

The AIP regional chart for Melun-Villaroche aerodrome shows the routes inside the control zone (CTR) and the TMA managed by the SEINE approach control centre, as well as their airspace classes (see Figure 4). The approach control centre (SEINE) uses the Vectoring, Radar Surveillance and Radar Assistance functions to provide control, information and alert services. Pont-sur-Yonne aerodrome is located under the PARIS TMAs. As a consequence, the class and the altitudes of the airspace flown through by the DA42 heading for point PM501 of the GNSS approach to Melun-Villaroche aerodrome are not indicated.

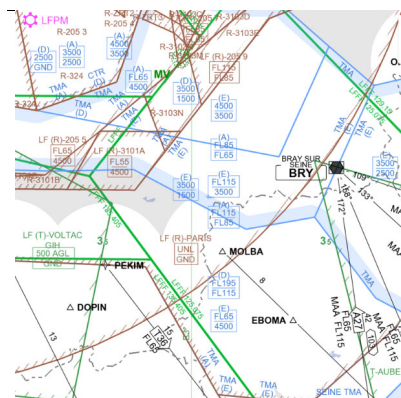
Figure 5: Extract from the LOWIFR chart

The charts in the Jeppesen printed atlas do not show the various airspaces with their associated classes. Conversely, the Jeppesen tablet application shows them on the en route chart (LOWIFR in particular) and indicates their floor and ceiling altitudes (see Figure 5). However, not all aerodromes are shown.
