## Accident to the Jodel D140 C Mousquetaire<sup>(1)</sup> registered F-BMBX

on 10 August 2016

at Salles-d'Argelès mountain landing area (Hautes-Pyrénées)

## Failure of wing during landing run on a mountain landing area

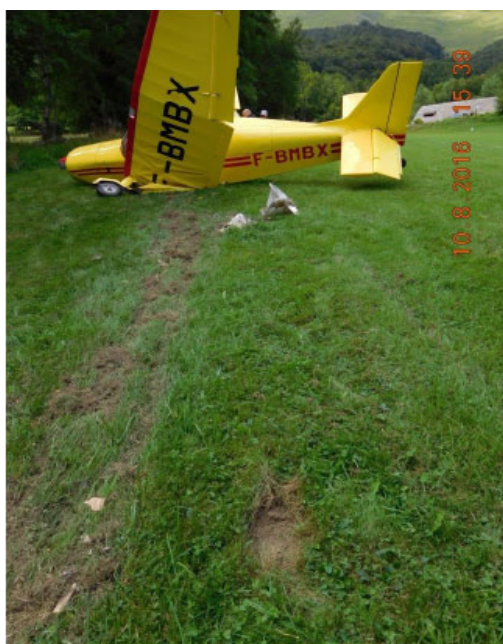
The owner of the mountain landing area saw the landing, which he felt was fine and not particularly hard. He saw the left wing break.

Figure 1: Wreckage of F-BMBX

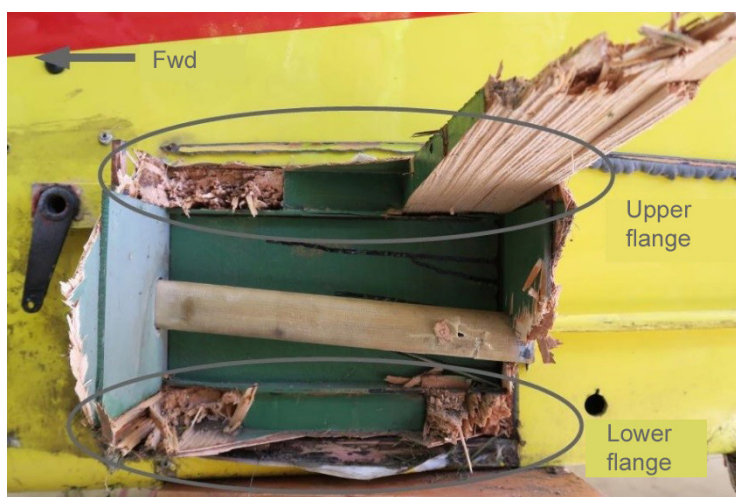
An initial examination of the wing was carried out on site. The failure of the left wing was located between the main landing gear and the wing-fuselage junction.

Figure 2: View of the area of the wing spar failure, photo taken facing the fuselage

- ❑ The wing spar had failed in two places: at the left wing root and at the left landing gear attachment.
- ❑ The construction of the wing spar (wood used, gluing) did not show any anomalies that could explain the accident. No significant gluing defects were found.

The observations of the fracture faces suggest that the initial failure occurred on the lower left rear flange, in the area of the landing gear attachment.

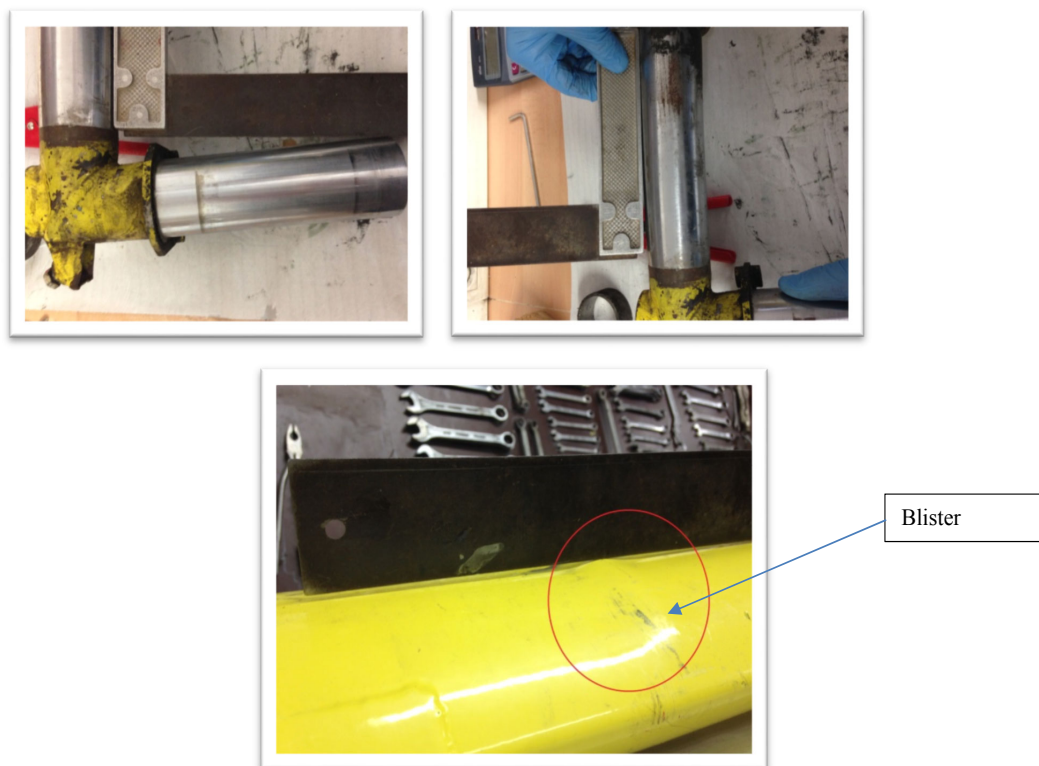
- ❑ Both legs were deformed, indicating that they had been subjected to significant upward stresses. Some of these deformations could be seen with the naked eye or by touch (blisters on the lower attachment plate), or could be identified by pressing a square or ruler against the surface of the shock absorber. Deflection of the lower part of the shock absorbers and deflection in the area where the wheel axles fit into the legs were observed. The angles between the axis of the axles and the axis of the shock absorbers, which are normally 90°, were significantly reduced.

Figure 3: Deformations on the right landing gear

- ❑ The shock absorption quality was significantly degraded for both legs (significant friction, or even blockages, little or no lubricant). The permanent deformations observed on the landing gear legs were characteristic of abnormally high stresses. The impaired operation of the sliding rods probably contributed to this.
- ❑ The absence of a lubricator in the upper part of the shock absorbers was noted in relation to the manufacturer's drawing available from the workshop that carried out these examinations<sup>(5)</sup>. The threaded holes designed for the lower lubricators were present, but there were no lubricators. The deposits observed suggested that the absence of lubricators was not recent.
