INVESTIGATION REPORT

**Serious incident to the Boeing 737- 800
registered CN-ROJ**

operated by Royal Air Maroc

on 30 December 2016

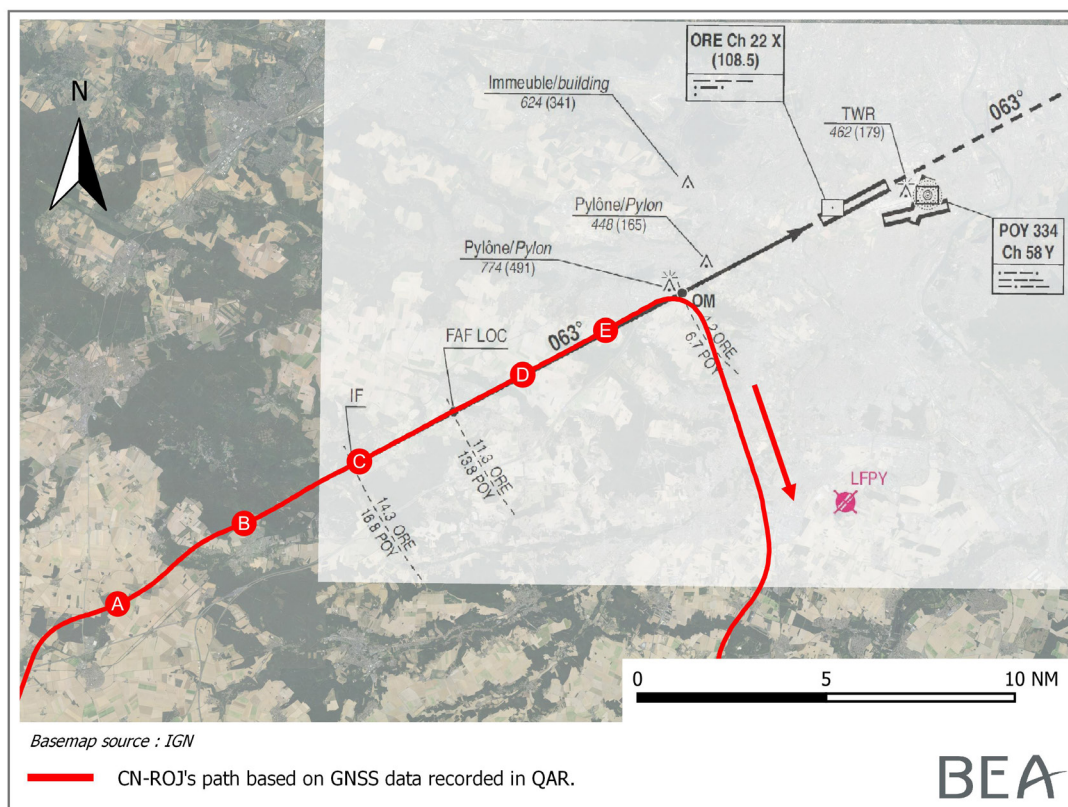
Figure 1: Approach path to Paris-Orly

The crew twice tried to engage A/P B. The latter would not engage and caused A/P A to disengage. The crew successfully engaged A/P A each time⁽⁹⁾.

(9) The examinations of the two FCC brought to light that at this point, the disengagement of A/P B was due to the FCC B not receiving RA 2 data.

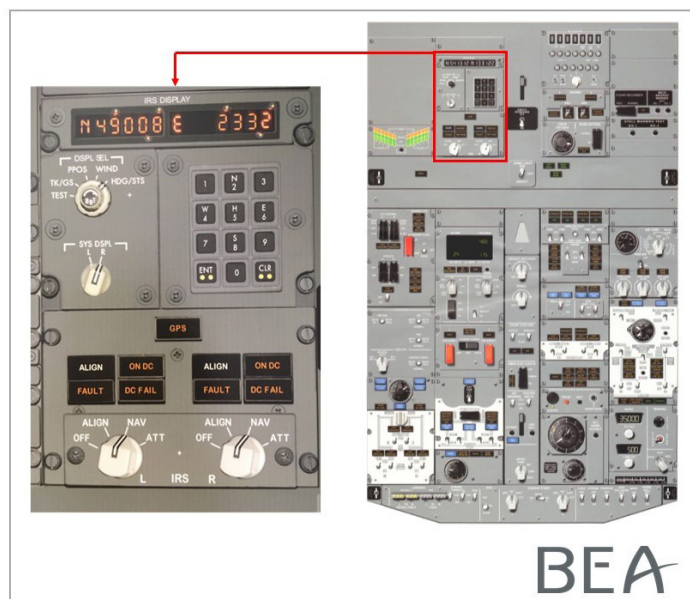
Figure 6: IRS FAULT light on IRS Mode Selector Unit on overhead panel

When such a fault is detected by the ADIRU built-in test, the IRS FAULT light associated with the faulty ADIRU, situated on the overhead panel, lights up along with the Master Caution lights on the instrument panel and the IRS light on the annunciator, on the left side (see [Figure 5](#) and [Figure 6](#)). The Master Caution lights remain lit until a pilot presses one of them or until the conditions for their extinction are met. Furthermore, all the data supplied by an IR sub-assembly with a critical fault is declared invalid and will therefore no longer be used by the other systems.

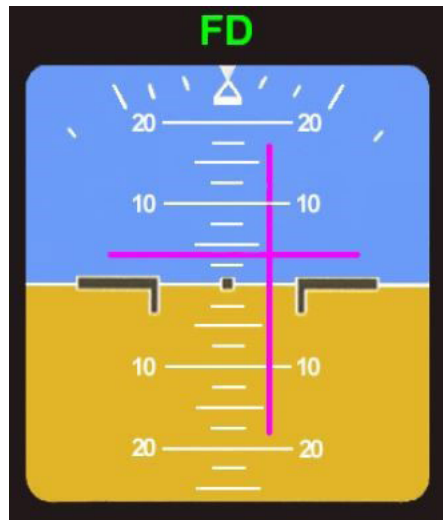
Figure 7: Magenta flight director command bars

At 10:11:33, the VOR/LOC mode was engaged and the aeroplane turned right. At that moment, the F/D roll command bar (vertical command bar) disappeared from the right PFD (cause 1).

At 10:14:53, the crew were cleared for the CAT III ILS approach. At that moment, the crew selected the Approach mode which had the effect of arming the G/S mode. The G/S mode was engaged, the F/D pitch command bar (horizontal command bar) disappeared from the right PFD (cause 3).

At 11:08:09, the VOR/LOC mode was engaged. At that moment, the F/D roll command bar disappeared from the right PFD (cause 3). The crew activated the APP mode three seconds later which had the effect of arming the G/S mode.

At 11:08:28, the G/S mode was engaged. At that moment, A/P B was automatically disengaged and the F/D pitch command bar disappeared from the right PFD (cause 3). At that moment, the F/D roll and pitch command bars also disappeared from the left PFD for a reason which could not be explained during the investigation.

It appeared that the majority of the disappearances of the F/D bars was due to FCC B not receiving RA 2 data (cause 3).
