Serious incident to the Gulfstream G550 registered M-SAWO

on 10 September 2017

at Paris-Le Bourget (Seine-Saint-Denis)

Erroneous identification of the landing runway, path change at low height, activation of angle-of-attack protections, left wing strike with the runway right side lighting during the missed approach

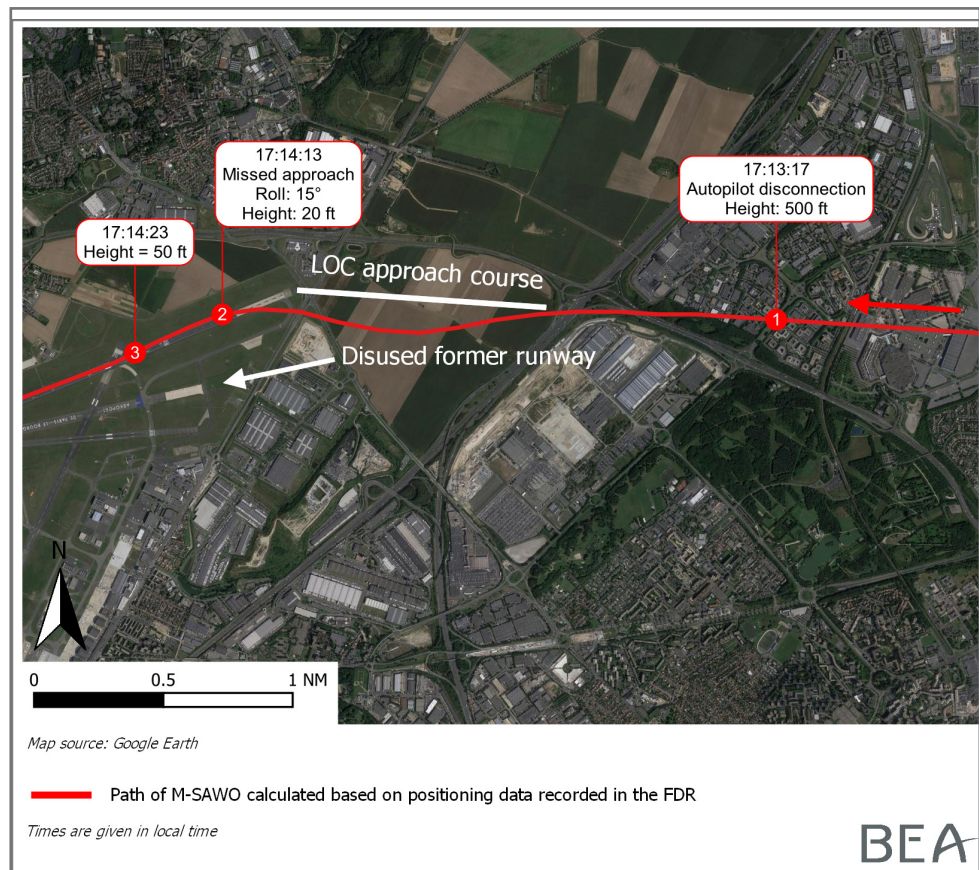
Figure 1: Approach path

At 17:13:17, the crew announced they had sight of the runway and disengaged the AutoPilot (AP) (see Figure 1, point ①). They were cleared to land. The radio-altimeter height was 500 ft and the altitude was slightly above 700 ft. Due to the QNH error, the altitude displayed in the aeroplane was around 1000 ft.

At 17:14:13, the PF aborted the approach (see [Figure 1](#), point ②) and made an input on the engine power control: maximum thrust was reached seven seconds later. The aeroplane was at a height of around 20 ft, offset by 35 m to the right of the runway centreline. The bank angle was 15° to the left.

The left wing of the aeroplane came into contact with and damaged a light to the right of the runway. The aeroplane regained height and the PF levelled the wings (see [Figure 1](#), point ③). The CAS decreased to 131 kt before increasing again.

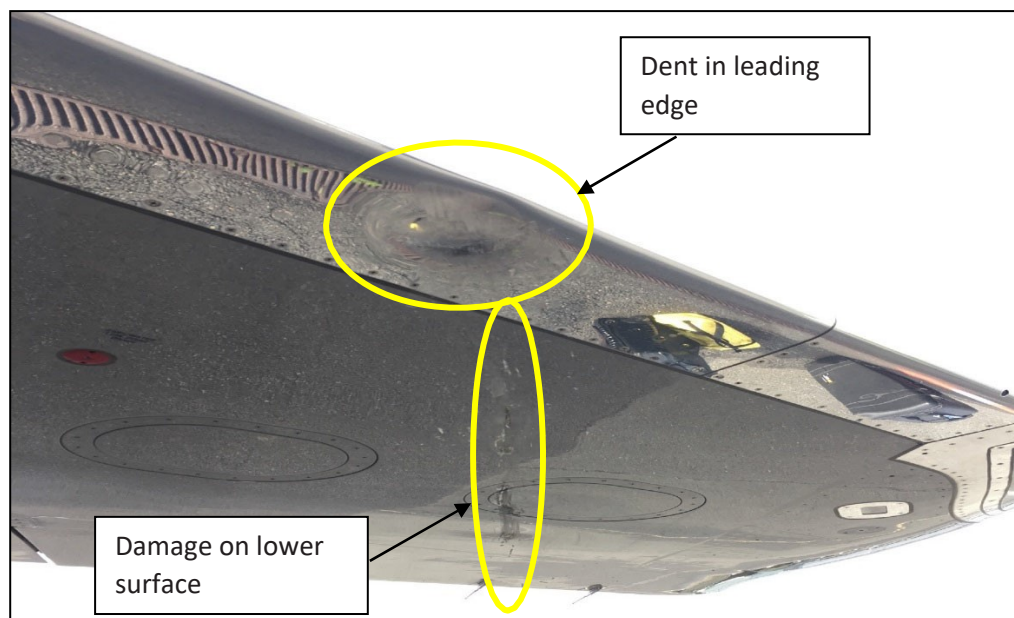
Figure 2: Left wing of M-SAWO after the incident

The inspection of the runway carried out immediately after the missed approach found a broken light to the right of the runway, 300 m before the displaced threshold. After the flight, damage was observed on the leading edge and the lower surface of the aeroplane's left wing.

The crew of M-SAWO made a second approach and landed on runway 25 at 17:43. In the parking area, a visual inspection revealed damage on the leading edge and the lower surface of the left wing, near the wing tip.
