Incidents to the Boeing 737 - 800 registered F-GZHO operated by Transavia France

on 7 February 2018 at Norwich (United Kingdom) and 8 February 2018 at Paris-Orly

Dysfunction of AOA sensor, alerts during take-off (7 February 2018)

Dysfunction of AOA sensor, alerts during take-off, turn around (8 February 2018)

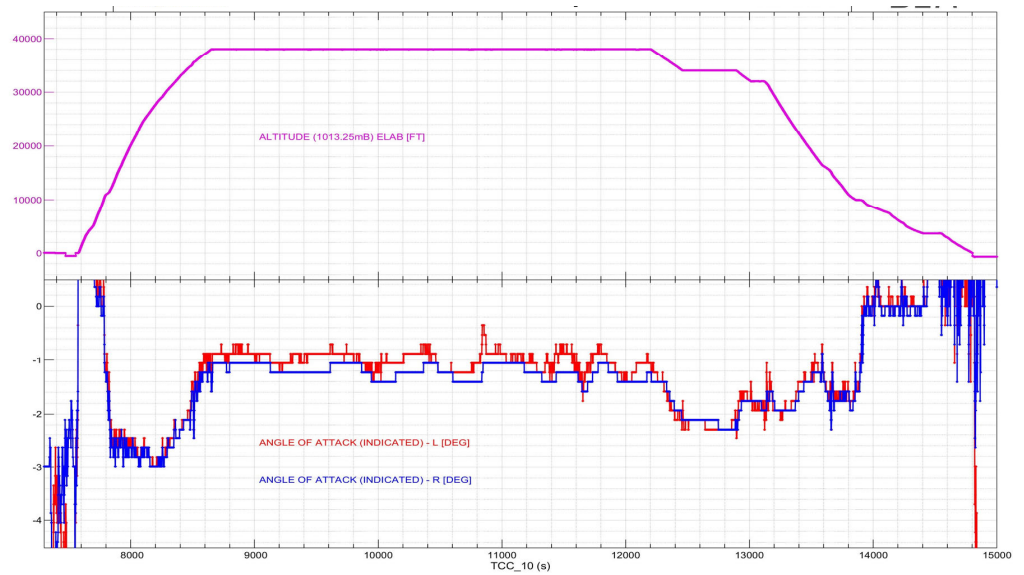
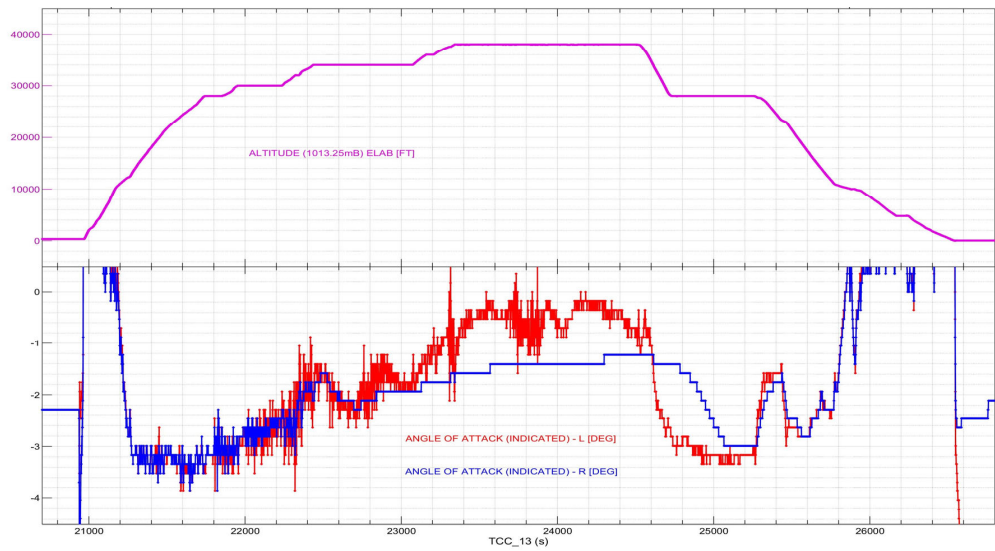
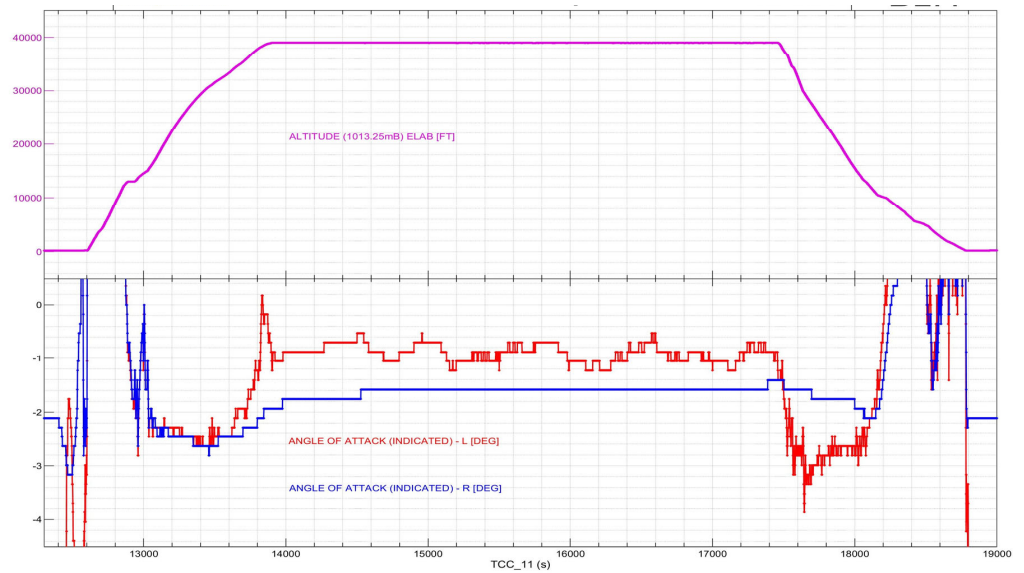
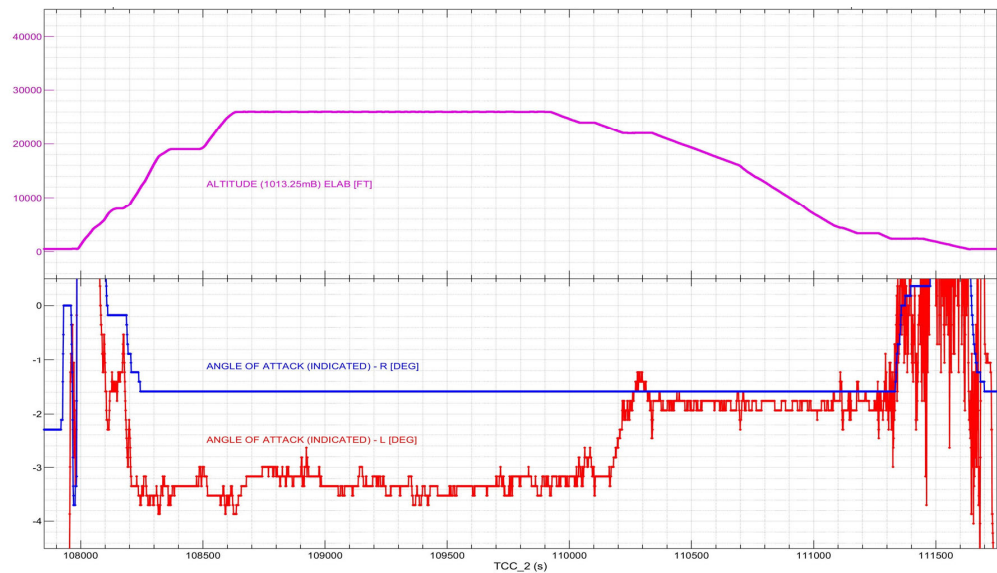
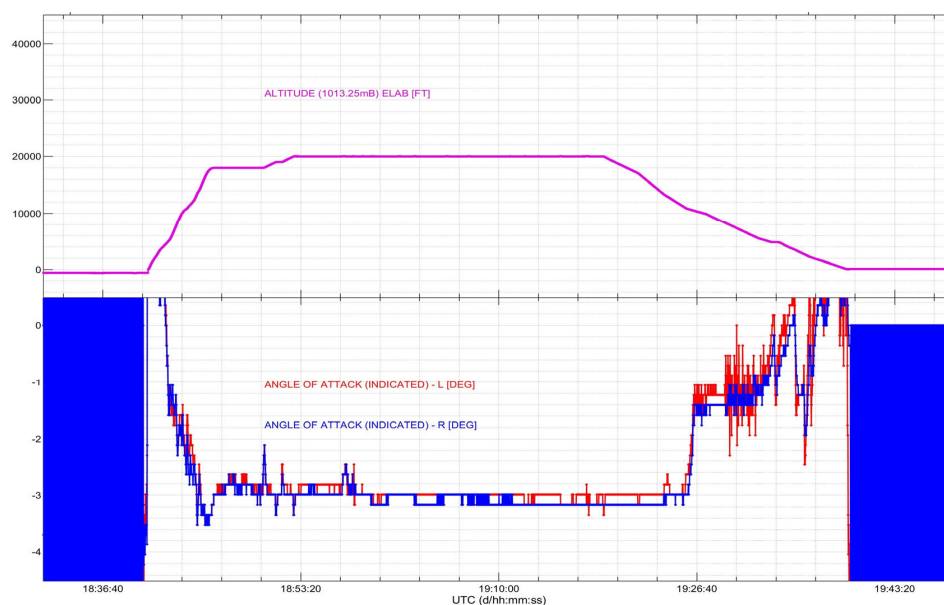
The analysis of this flight data brought to light that the dysfunction of the right AOA sensor gradually evolved over time with the values changing in increasingly longer steps compared to the left AOA sensor where the changes are a lot more dynamic. The following figures show the evolution of the AOA sensor dysfunction between 2015 and 2018 based on the recordings of the values provided by the left and right AOA sensors.

The start of this dysfunction can be detected in the QAR data as early as March 2015, just a few weeks after the aeroplane had been delivered to Transavia. The dysfunction then becomes significantly more marked and is visible up to the last flight before the maintenance work in Norwich (cf. Figure 6). There is then a clear change in the behaviour of the angle of attack values recorded during the flights of 7 and 8 February and the dysfunction is less visible (cf. Figure 7).

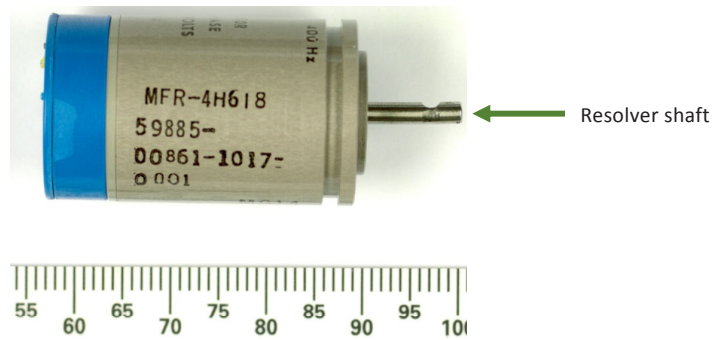
Figure 8: Faulty resolver

The faulty sensor was removed from the aircraft and sent to KLM EM⁽¹⁶⁾ in Amsterdam for tests and disassembly in the presence of the BEA. The examination found damage to several internal components. The gears between the two resolvers were damaged and at ambient temperature, the shaft of resolver 2 was blocked in rotation and was slightly deformed. At operating temperature, reached after the vane heater test, the two resolvers gave indications which differed from each other by around 100°.

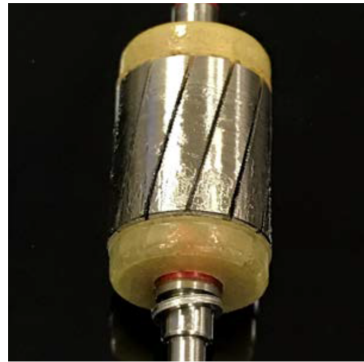
Figure 9: Rotor with presence of a viscous substance

Resolver 2 was sent to the manufacturer of the AOA sensor, Collins Aerospace, who coordinated an examination with its subcontractor, MOOG, the resolver supplier. The examination of the resolver blocked in rotation found the presence of a viscous and tacky substance, between its stator and rotor, which prevented the relative movement of these two parts.

Examinations carried out by Collins Aerospace and MOOG found that this substance was composed primarily of epoxy resin, used in the manufacture of resolvers (winding) but contaminated with one or more other substances.

Regardless of the source of contamination, Collins Aerospace implemented additional material handling procedures and affixed warning notices on all the equipment using THFA to minimize the risks of THFA accidentally coming into contact with one or more resolvers. Collins Aerospace considered that the damage to the gears and the deformation by torsion of the resolver 2 shaft was probably the result of abnormal loads experienced since 2015 due to the blocking caused by the contamination. The difference observed between the values supplied by the two resolvers could be due, according to Collins Aerospace, to a momentary disengagement of the gears linking the resolvers. The handling of the sensor by the maintenance teams after the flights might also have caused additional damage and increased the magnitude of the resolver offset observed during examination.
