## Incident to the CESSNA - 182 - P registered N609PC

on 28 February 2018  
at Yonval (Somme)

### Vibrations and smell of smoke en route, commanded engine shut-down, off-field forced landing

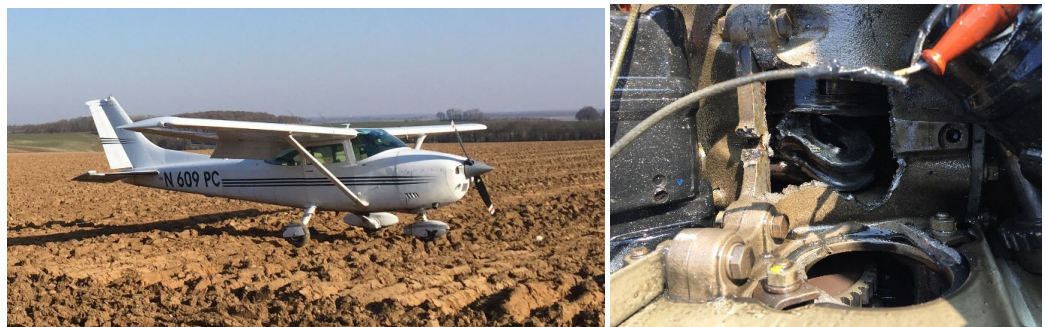
Once on the ground, the two pilots inspected the plane and observed that the crankcase was perforated.

Figure 1: Aircraft on forced landing site (left) and perforation of crankcase (right)

On the landing site, the day of the incident, the aeroplane's cowlings were removed by the members of the company which maintains the aircraft. The perforation of the crankcase in line with cylinder No 1 and the separation of the right magneto were observed. The BEA did not visit the aircraft landing site.

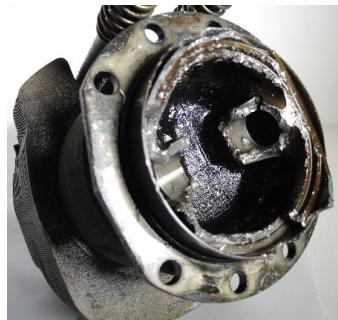
- sudden failure of crankcases;
- rod broken into multiple fragments;
- partial destruction of piston;
- damage to crankpin associated with rod, with signs of intense heating.

Figure 6: Partially destroyed piston blocked in cylinder

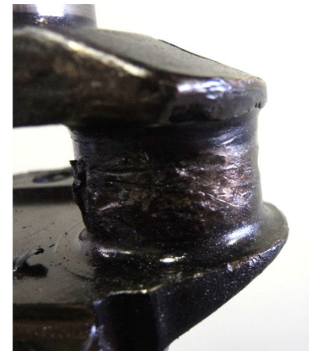
Figure 7: Crankpin

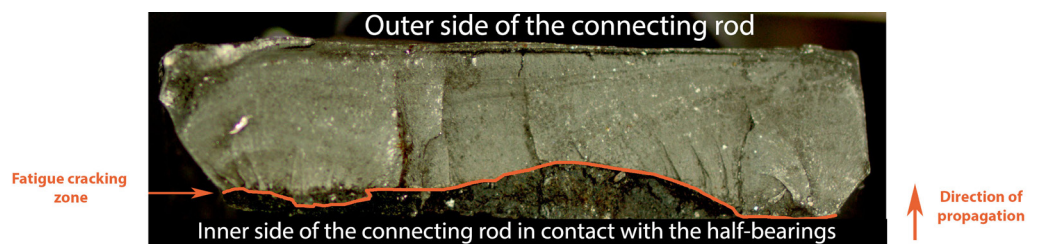
The I-beam had broken at each end. Amongst the analysable debris, signs of fatigue cracking were identified, very locally over a small depth, on the rod cap fragments (see Figure 8), which had initiated on the inner side of the rod (crankshaft end).

Figure 8: Rod No 1 fracture surface

This cracking zone was associated with abnormally high hardness of the material composing the rod. Despite exchanges with the manufacturer, Continental Motors, it was not possible to determine if this high hardness could have contributed to the occurrence or was generated during the failure by local heating.

The BEA's examinations of the engine showed that a fatigue failure of rod No 1 was behind the engine shutdown.

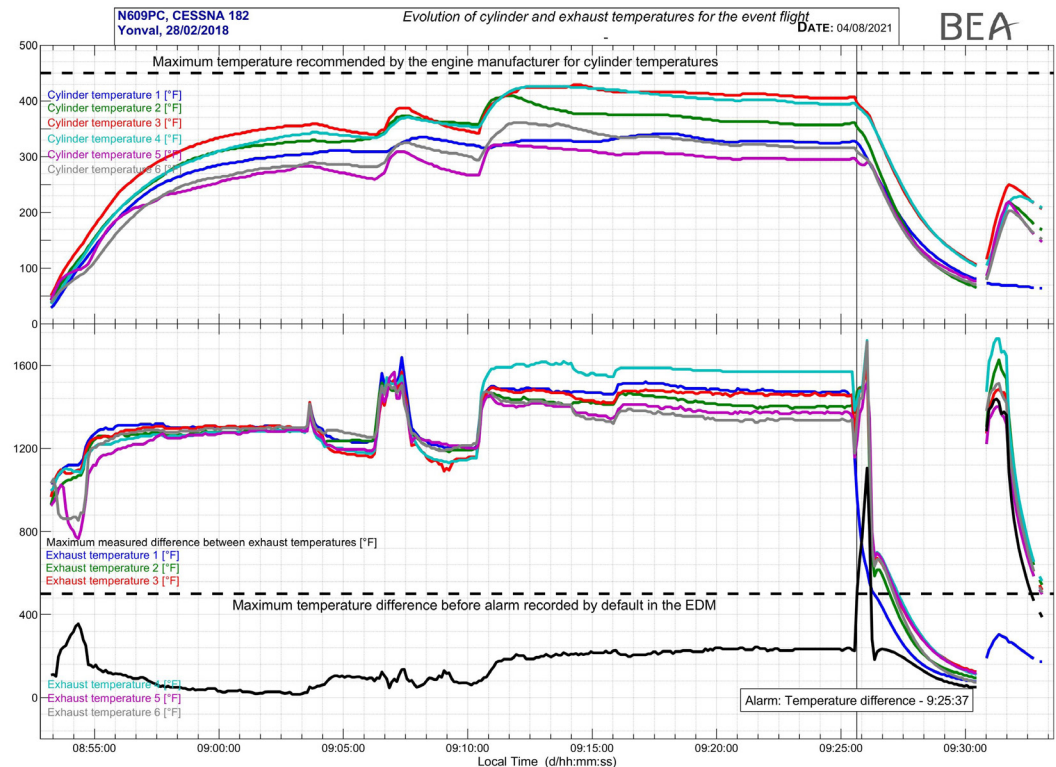
Figure 9: Engine cylinder and exhaust gas temperatures read out from EDM

In particular, it can be observed that during the flight, the temperature of the six cylinders was below the activation threshold of the EDM warning at 450 °F.

The exhaust gas temperatures were in a normal range, between 1,350°F and 1,550°F for all the cylinders, except for cylinder No 4 whose temperature was slightly higher. The EDM does not activate a warning simply based on the value of the exhaust gas temperature, but there is a warning if the measured difference between the various exhaust gas temperatures exceeds 500°F.

Around 09:25, this difference suddenly increased, exceeded the warning activation threshold and reached around 1,100°F. This was due to a substantial drop in the exhaust gas temperature for cylinder No 1 while the temperatures for all the other cylinders showed a high peak before a sudden drop. This is consistent with a perforation of the crankcase in line with cylinder No 1. The attempt to restart the engine shortly after, followed by its definitive shutdown, was also recorded.

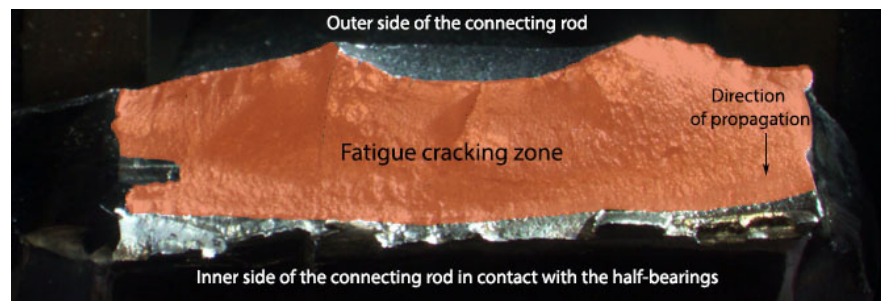
The examinations of the engine had shown that the engine shutdown was due to the failure of rod No 4. The laboratory examination of this rod had shown that the fatigue crack had initially started on the outer surface of the rod cap. The growth of this crack had then resulted in a sudden failure and the rod's separation from the crankshaft.

- ❑ The position of the incipient crack zone; respectively on the inner side of the rod in contact with the rod bearings (see [Figure 8](#)) and on the outer side of the rod (see [Figure 10](#)).
- ❑ The extent of the fatigue cracking zone; very local (a few  $\mu\text{m}$ ) on N609PC (see [Figure 8](#)) and to a much wider extent (a few cm) on F-HNCM (see [Figure 10](#)).
- ❑ The modification of the mechanical characteristics of the material (hardness) in the vicinity of the incipient crack zone on N609PC and without modification on F-HNCM.

Figure 10: Fracture surface on F-HNCM
