## INVESTIGATION REPORT

### Serious incident to the ATR 42-500

Registered F-GPYF

On 25 March 2018

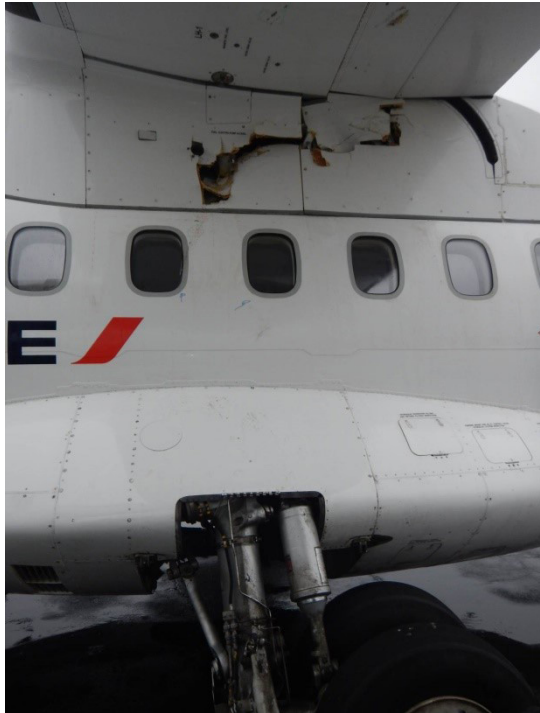
Figure 1: Wing fairing damage and missing L MLG door

- ☐ all the component parts of the left main landing gear door were missing;
- ☐ damage to wing root fairings;
- ☐ scratches to cabin window and surrounding skin;
- ☐ tear on lower surface skin of left flap;
- ☐ scratches on lower surface skin of left wing;
- ☐ small dents on vertical stabilizer.

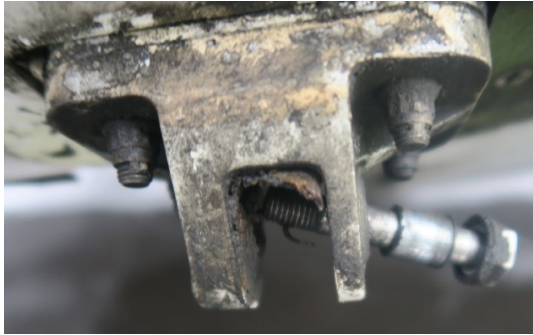
Figure 3: Remaining part of rear hinge assembly

- ❑ At the rear, the screw had come out of its housing and the nut and washer used to hold it in place were missing.
- ❑ At the front, the screw was found in place; a section of the male hinge was broken and locking wire was also present on the screw.

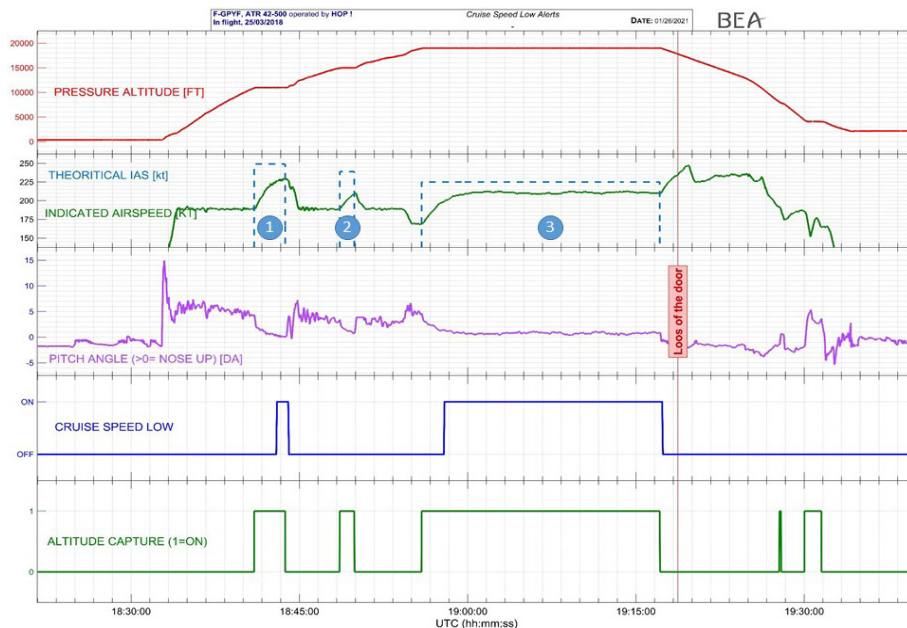
Figure 13: Cruise Speed Low alerts

The second level flight phase (see point ❷ [Figure 13](#)) lasted only 78 seconds, which was not enough time for the alert to be triggered, even if the other conditions had been met.

The Cruise Speed Low alert was triggered a second time 122 seconds after arrival at cruising altitude and remained active throughout the cruise phase (see point ❸ [Figure 13](#)). By design, it stopped when the aircraft began its descent.

The first level flight phase and the cruise (❶ and ❸ on Figure 13) show the same trend: the indicated airspeed increases up to a limit that is lower than the theoretical speed.

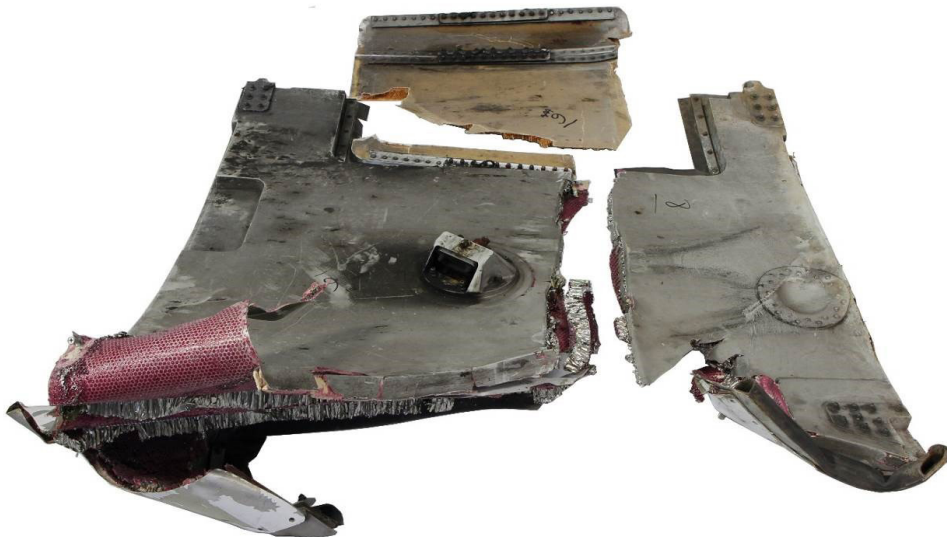
Figure 16: Recovered door components

The door was thus almost completely reconstructed (see Figure 16) and contained both the front and rear male hinge assemblies.

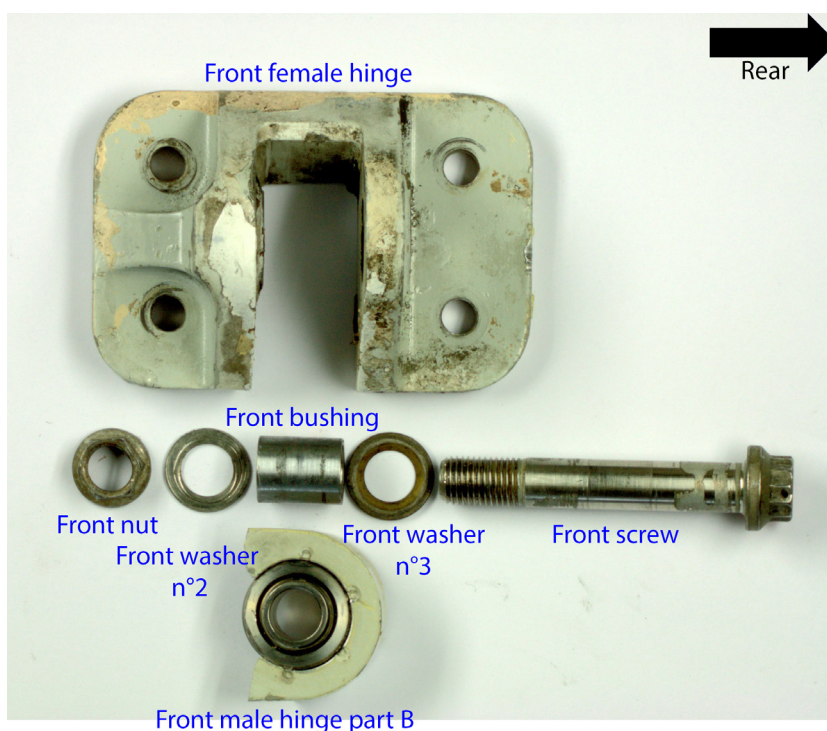
Figure 17: Front hinge assembly components

The front hinge assembly components are shown in Figure 17. The male part of the hinge assembly was broken. A fractographic examination revealed the characteristics of a sudden fracture running from the front to the rear of the aircraft. The screw contained markings that were consistent with the IPC P/N.

An EDS analysis showed that the material and the protection of the nut did not correspond to the nut specified by the IPC (see paragraph 1.6.2.2). Indeed, the protection of the nut analysed was composed mainly of cadmium and the measured content of chromium and the material of the nut did not display the characteristics of a stainless steel nut.

Lastly, the nut is magnetic while the stainless steel that makes up a P/N MS21043-6 nut is non-magnetic. An R marking was observed on both wrenching faces of the nut. This R may correspond to the marking of the nut manufacturer.

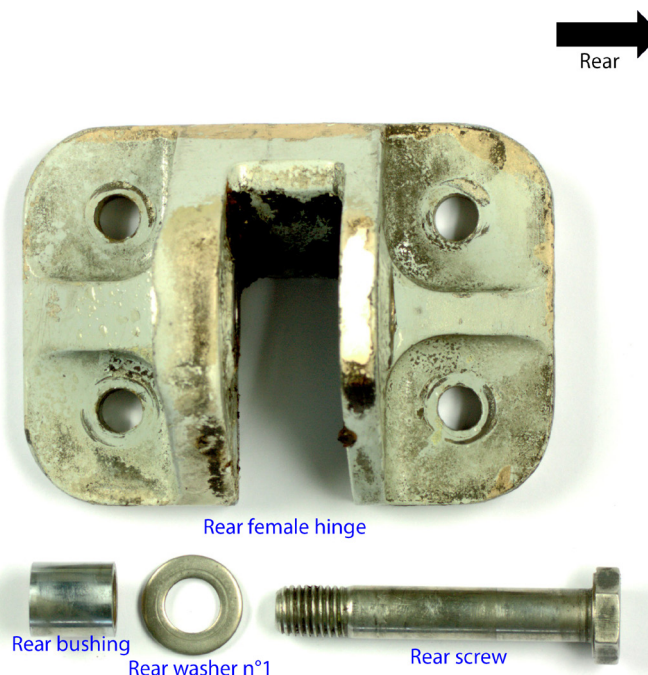
Figure 18: Rear hinge assembly components

As indicated in paragraph 1.3 (see Figure 3), a washer and a nut on the rear assembly were missing. The disassembled parts of the female rear hinge are shown in Figure 18.

The female and male parts of the rear hinge assembly and the screw did not display any significant damage. The screw had a marking that was consistent with the IPC P/N.

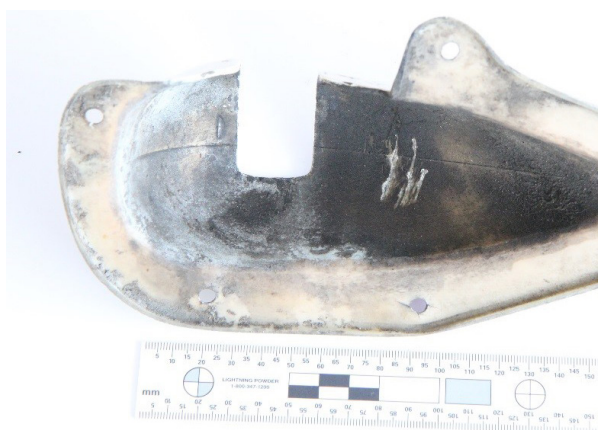
Figure 19: Rear fairing - inside face

The inside face of the rear fairing displayed traces corresponding to markings left by the screw head (see Figure 19). They bear witness to the significant displacement of the screw observed on the aircraft after the incident (see Figure 3) compared to its normal position.

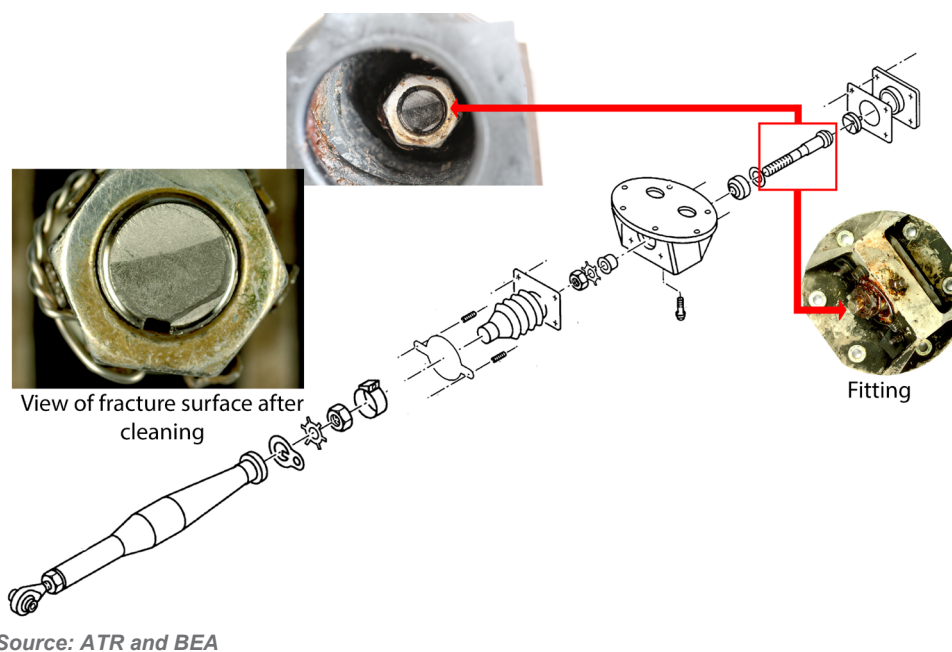
Figure 20: Examination of the link

The link was found detached from its connection to the landing gear door in the place where a screw is fastened to the door fitting (see Figure 20).

A fractographic examination of the screw fracture using an SEM revealed an area of fatigue cracking in the form of fatigue striations with multiple surface initiations and an area displaying dimples, which are characteristic of a ductile sudden fracture.

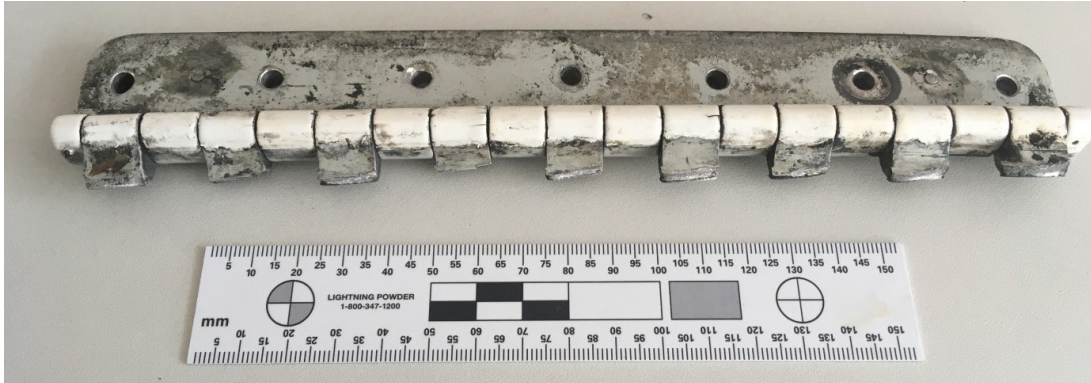
Figure 21: Examination of hinge 1

All the moving parts of the hinges were broken. The fractographic examination revealed the characteristics of a sudden fracture caused by overload. A microscopic examination of the paint on the hinge fracture faces served to determine the direction of fracture propagation through small crack visualisation. It was thus determined that the fracture of the moving parts of the hinges was caused by overload from the front to the rear of the aircraft.
