Accident to the CESSNA 525A "CitationJet CJ2+" registered D-IULI

on 06 June 2018

at La Môle (Var)

Runway overrun during landing run on wet runway, collision with an obstacle

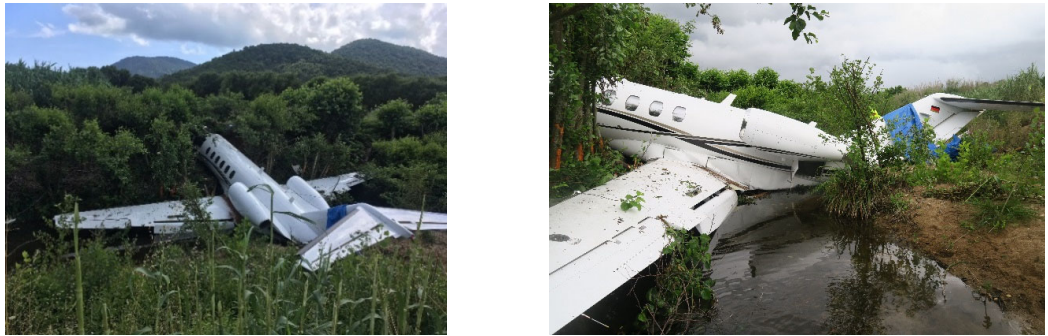
Figure 3: Views of wreckage

The wreckage was positioned in the riverbed at around 100 m from the end of runway 24, on the left side of the runway centreline. The lower central section of the fuselage and the main landing gear were partially submerged in the river. The aft section of the fuselage was lying on the bank on the airport's side and the forward section on the opposite bank. All of the damage observed was the consequence of the aeroplane's runway excursion and collision with the bank. No debris from the aeroplane was found before the wreckage or on the runway.

The main access door situated on the forward left side of the aeroplane was closed and locked. There were deformations in the structure.

There was equipment in the aft hold for a total weight of 140 kg. The equipment was not secured and had severely damaged the aeroplane's structure during the collision.
