Accident to the Serge Pennec GAZ'AILE 2 identified 64AAC

on 26 June 2018

at Gurmençon (Pyrénées-Atlantiques)

Engine in-flight shutdown, forced landing, collision with the ground

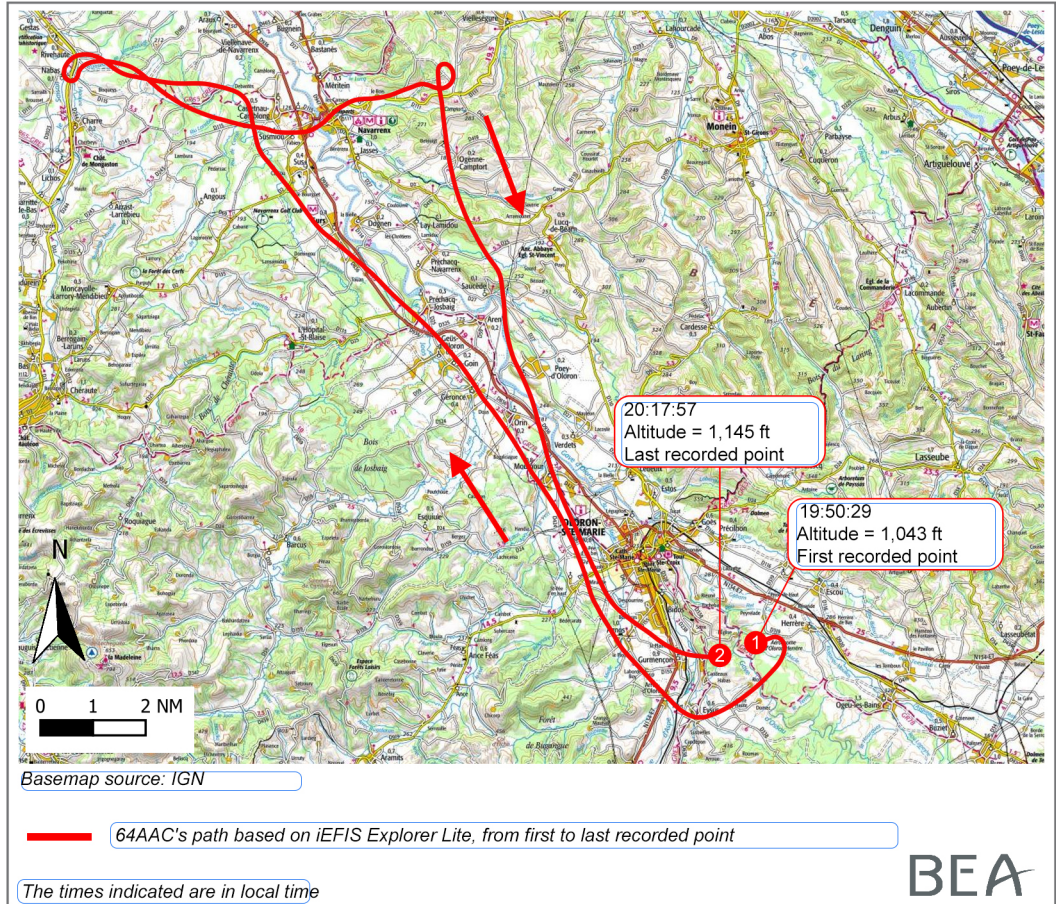
A path, shown below, was produced based on the parameters saved:

- the engine shut down at 20:16:44 when the microlight passed through 1,500 ft in descent;
- the flight continued without the engine for more than one minute before colliding with the ground.
