## Accident to the Cessna F 172 N registered F-GBJQ

on 23 July 2018

at Belvès - Saint-Pardoux (Dordogne)

## Descent at the start of downwind leg after take-off, collision with trees, fire

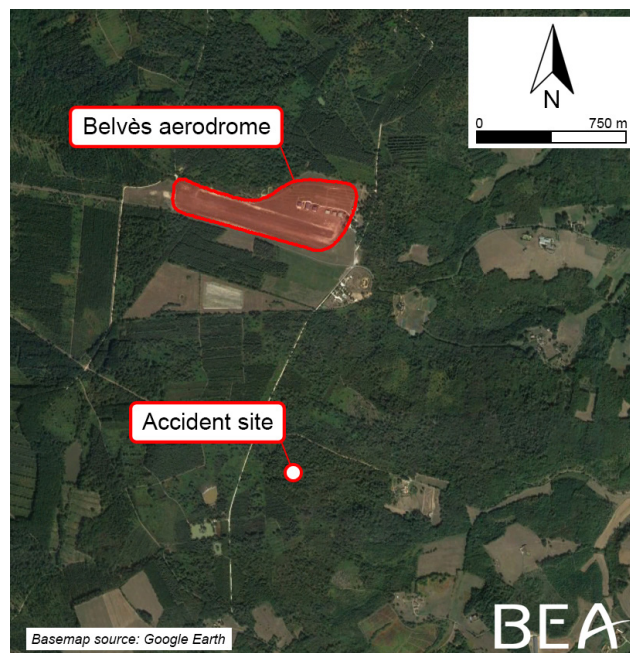
Position of the wreckage

The aircraft collided with the trees, approximately 1,100 m south abeam of the threshold of runway 29, i.e. at the start of the downwind leg (see illustration). The aircraft hit the top of the trees at a height of approximately 20 m. The debris was distributed in a line parallel to the runway, over a distance of around 65 m. The front section of the fuselage was partially destroyed by a fire on the ground.
