Accident to the Arsi AB Esqual VM-1C registered OO-H81

on 21 August 2018
at Rue (Somme)

Loss of control in instruction flight, collision with the ground, fire

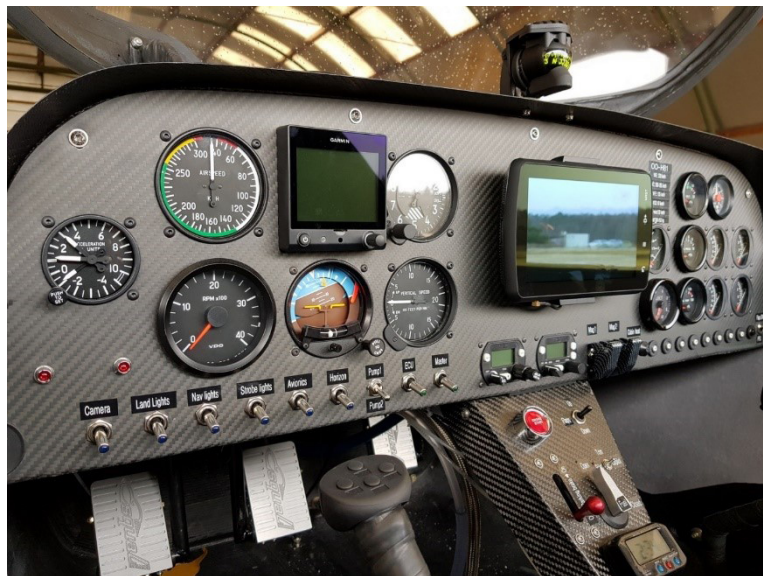
The different items of instrument panel equipment (see picture) that may have had a recording function were extensively damaged by fire and were not downloadable. Only a mechanical accelerometer, initially attached to the left part of the instrument panel, was found in good condition, in the grass, a few metres from the wreckage. It is likely that the extreme values recorded (- 2 g/+ 7 g) resulted from the impact or the ejection of the instrument from the wreckage.

Photo of the OO-H81 instrument panel in the configuration requested by the club
