## Accident to

1. ICP Savannah VG identified 57YM
2. Buse'Air 150 identified 75WQ

on 1 September 2018  
at Valencisse (Loir-et-Cher)

## Collision in cross-country flight with another microlight, loss of control, collision with the ground

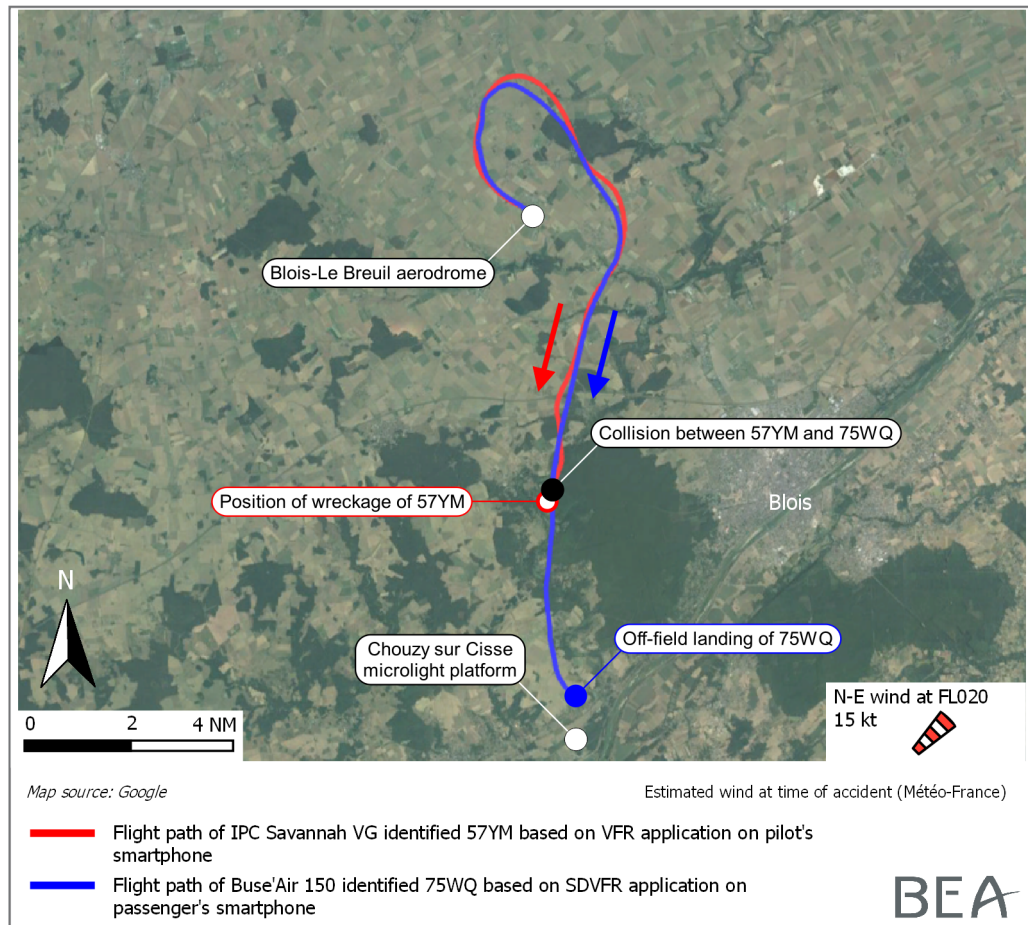
Figure 1: Paths of the two microlights

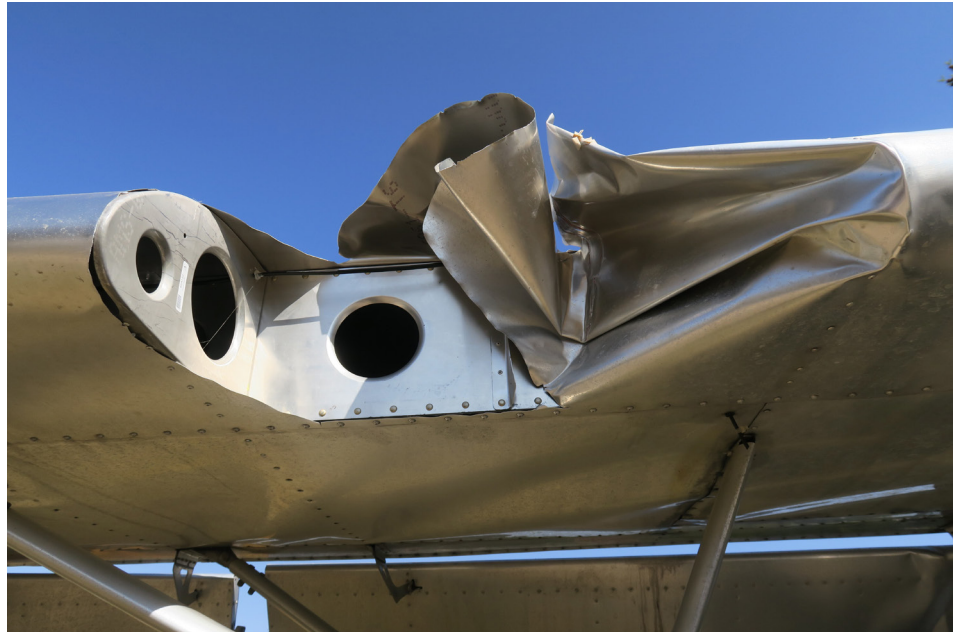
- A depression of the leading edge of the right wing tearing the wing's aluminium coating up to the spar (see [Figure 2](#)). Traces of red paint were observed at this depression (see [Figure 3](#)). This damage corresponds to an interaction with the rudder of 75WQ.
- Damage to the DUC propeller carbon blades from their tips, one of the blades being damaged along almost half of its length (see [Figure 4](#)).

Figure 2: Leading edge of the right wing of 57YM

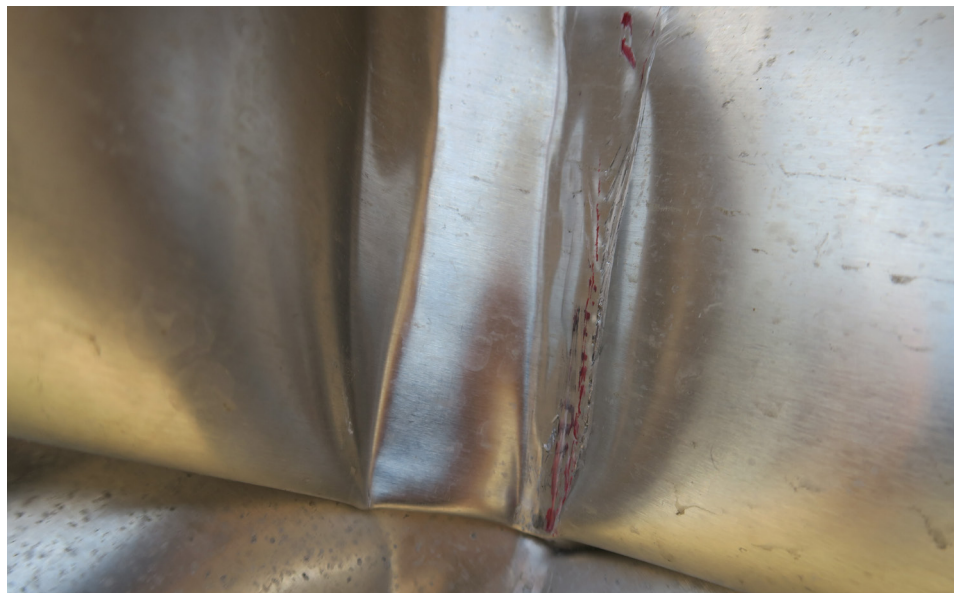
Figure 3: Detail of depression of the leading edge of the right wing of 57YM and traces of red paint

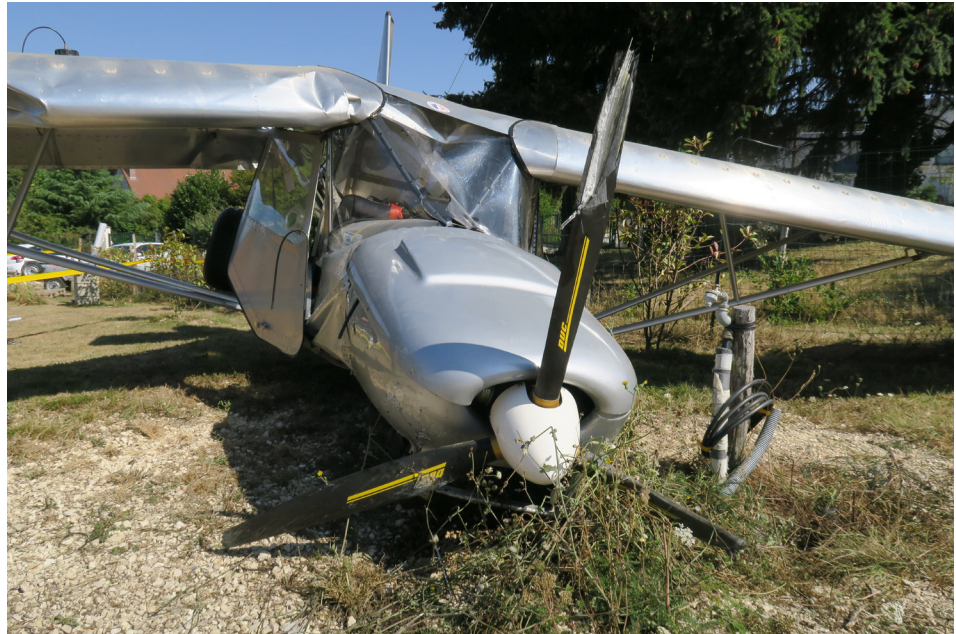
Figure 4: 57YM propeller

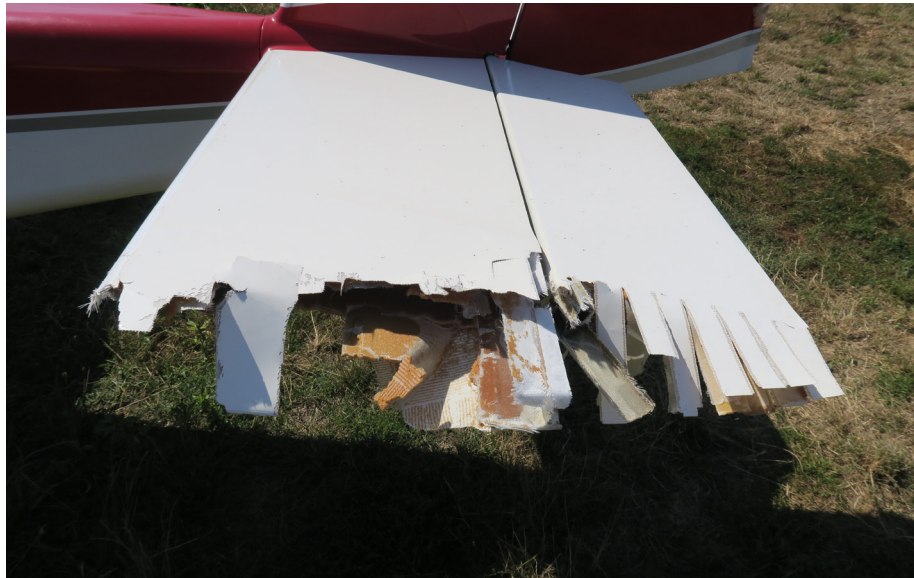
Damage was limited to the left wing tip of the horizontal tailplane and the trailing edge of the rudder. The horizontal plane was damaged by the propeller of 57YM across a width of around 15 centimetres from the wing tip (see [Figure 5](#)) and the lower section of the rudder was struck by the leading edge of the right wing of this same aircraft (see [Figure 6](#)). The flight controls remained effective and unrestricted in travel. It was not possible to check the active or saved radio frequencies.

Figure 5: Left stabilizer plane of 75WQ

The comparison of the contact areas showed that 57YM struck 75WQ whilst roughly on the same heading, slightly to its left and below it.

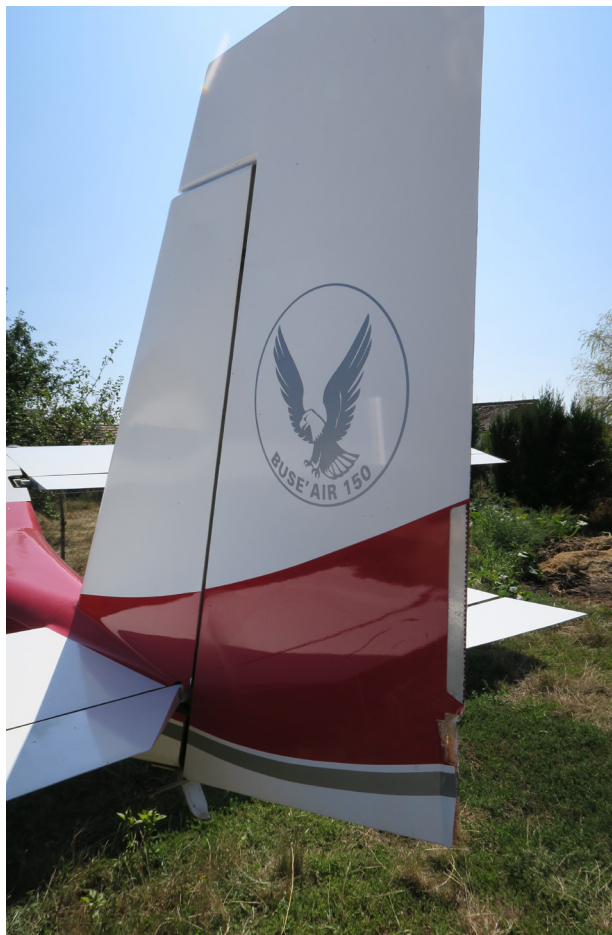
Figure 6: Rudder and failed fixed tab (metal) of 75WQ
