Serious incident between the Bombardier CRJ700 registered F-GRZG and the Boeing 717-200 registered EI-EXB on 12 April 2019 at Strasbourg Entzheim airport (Bas-Rhin)

Immediate departure, low-level missed approach, near collision

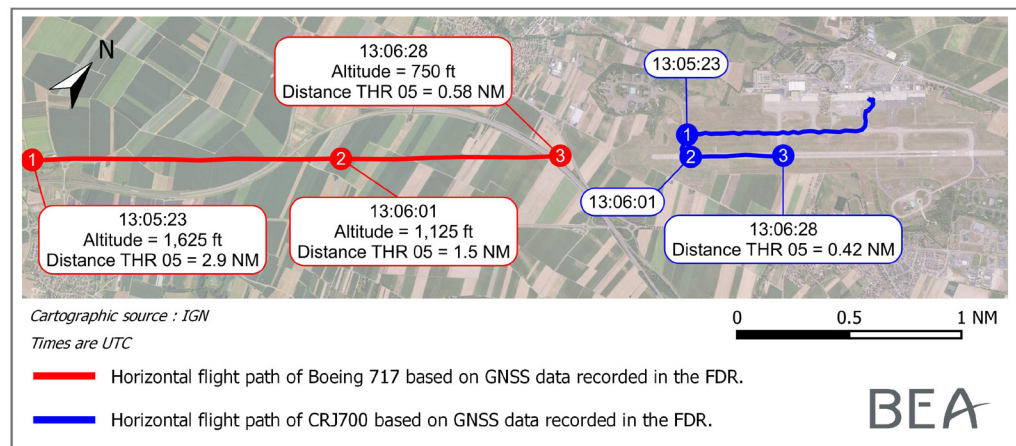
Figure 1: paths of the Boeing 717 (red) and the CRJ700 (blue)

The crew of the Boeing 717, operating the Volotea flight from Montpellier Méditerranée (Hérault), were carrying out an ILS approach to runway 05 (QFU 047) at Strasbourg Entzheim airport. Exchanges between the controller and the crew were in English. At 13:01, the LOC controller asked the crew to continue the approach, indicating that they were number two behind a light aircraft on the downwind leg for runway 05. Four minutes later, the captain of the CRJ700 operating the HOP! flight bound for Marseille Provence (Bouches-du-Rhône), and PM⁽²⁾, contacted the LOC controller, at the GND controller's request, to advise that they were approaching holding point H and that they were ready for departure from runway 05. The exchanges between the controller and the CRJ700 crew were in French. At 13:05:14, the LOC controller asked them if they were ready to take off within the minute and gave them traffic information about an aircraft at 3 NM on final approach without specifying that it was a Boeing 717⁽³⁾. The PM of the CRJ700 accepted and at 13:05:23, the LOC controller cleared them for an immediate take-off from runway 05 (point 1 [Figure 1](#)).

The Boeing 717 was around 3 NM from the runway threshold on final approach at an altitude of 1,650 ft⁽⁴⁾ and an indicated airspeed of 136 kt when the CRJ700 was around 30 m before holding point H. At 13:05:46, the captain of the Boeing 717, PM, announced that they were at 2 NM on final approach. The crew of the CRJ700 lined up on runway 05. The LOC controller informed the crew of the Boeing 717 of the departure of the CRJ700 and asked them to continue the approach. The PM of the Boeing 717 said "unbelievable" on the frequency. Five seconds later, the crew of the CRJ700 started the take-off run (point ② Figure 1).

At 0.90 NM from the threshold of runway 05, at an altitude of 890 ft and an indicated airspeed of 138 kt, the PM of the Boeing 717 informed the LOC controller that they may interrupt the approach. The LOC controller told the crew to continue the approach. Nine seconds later, at 13:06:28, at 0.58 NM from the threshold of runway 05 at a height of 240 ft (40 ft below the decision height (DH)), the crew of the Boeing 717 initiated a missed approach and announced this on the frequency. The CRJ700 was still on the runway at 0.42 NM (780 m) from the threshold of runway 05 at a speed of around 115 kt (point ③ Figure 1).

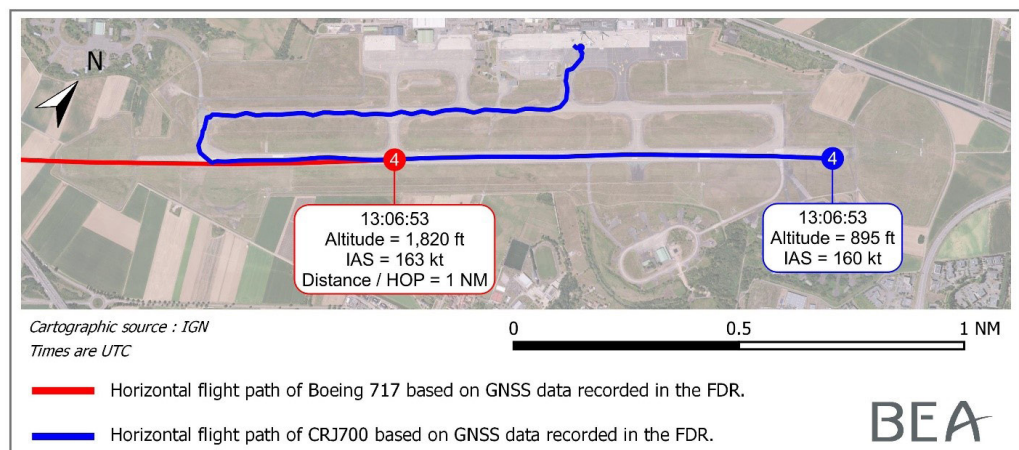
Figure 2: paths of the Boeing 717 (red) and the CRJ700 (blue)

The LOC controller asked the PM of the Boeing 717, who read this back, to keep straight ahead during the missed approach. The PF selected heading 042° and the Boeing 717 started to deviate to the left of the runway centreline. When the HOP! CRJ700 flew over threshold 23 at an altitude of 900 ft and a speed of 160 kt, the separation with the Boeing 717, whose speed was 163 kt and accelerating, was around 1 NM horizontally and 920 ft vertically (point ④ Figure 2).

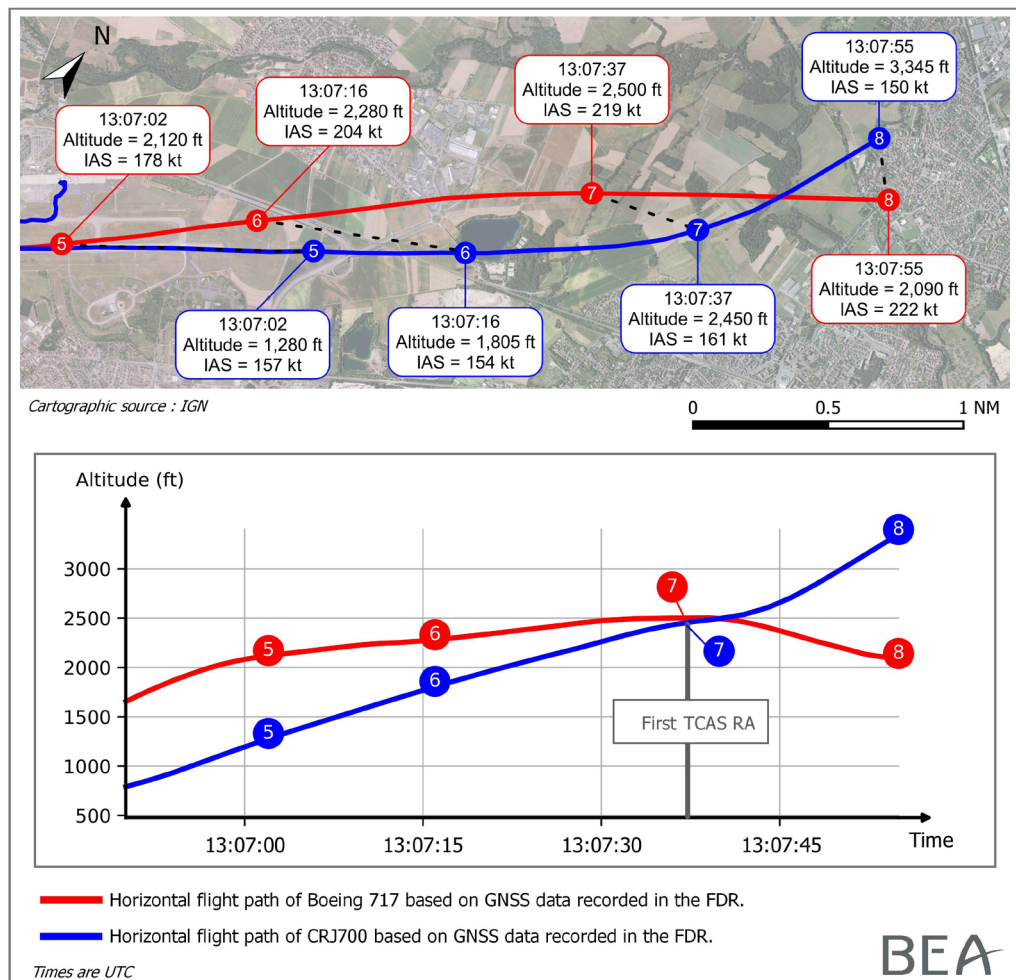
Figure 3: paths of the Boeing 717 (red) and the CRJ700 (blue)

The LOC controller asked (point ⑤ Figure 3) the crew of CRJ700, at an altitude of 1,300 ft and climbing to 6,000 ft to directly turn left towards MIRGU, the last standard instrument departure point (SID)⁽⁵⁾, and the crew of the Boeing 717, at an altitude of 2,300 ft and climbing to 2,500 ft, to immediately turn right to heading 050° (point ⑥ Figure 3). The CRJ700 started turning at 2,100 ft. The horizontal and vertical separations between the aeroplanes were respectively 0.6 NM and 300 ft. The speed of the Boeing 717 was 60 kt higher than that of the CRJ700. The LOC controller asked the crew of the CRJ700 to stop climbing at 2,000 ft. The PM of the CRJ700 asked him to repeat the instruction. The CRJ700 flew through 2,400 ft and was climbing with a vertical speed of around 1,300 ft/min and the Boeing 717 was stable at 2,500 ft. At the same time, the TCAS of the two aeroplanes transmitted traffic advisories (TA). The LOC controller replied to the PM of the CRJ700 by telling him to immediately stop climbing at 2,000 ft. A second later, resolution advisories (RA) were generated on board each plane: MAINTAIN CLIMB for the CRJ700 and DESCENT for the Boeing 717 (points ⑦ and ⑧ Figure 3). The horizontal and vertical separations between the two aeroplanes were respectively 0.40 NM and 50 ft. The resolution advisory (RA) of the CRJ700 was reinforced to INCREASE CLIMB and the PF increased the rate of climb. Five seconds later, the separations were 0.28 NM and 95 ft. The minimum horizontal distance between the two aeroplanes of 0.17 NM was reached five seconds later with a vertical separation of 500 ft.

At 13:07:55, the path conflict had ended and the two crews continued their flights (points ⑧ and ⑧ Figure 3).
