## Accident to the BRM AERO - BRISTELL NG5 registered G-CLDO

on 12 May 2019  
at Montmorillon (Vienne)

### Aborted landing, loss of control and collision with ground

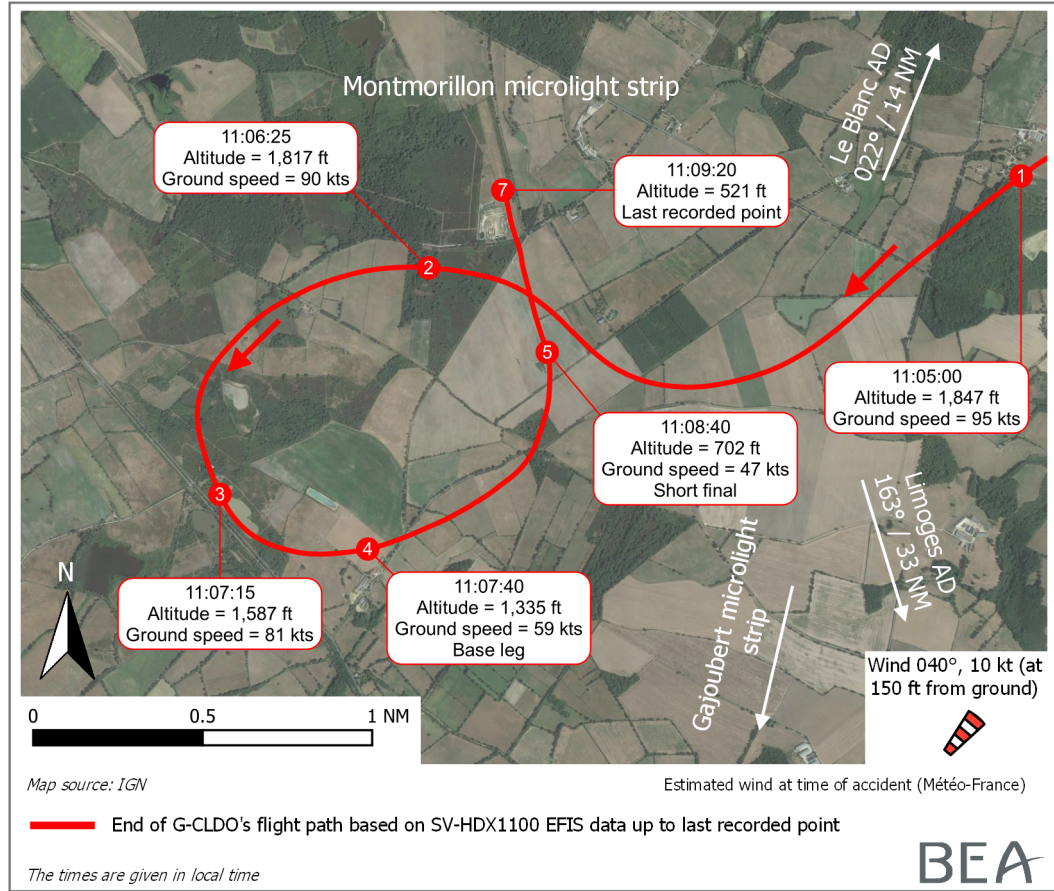
After flying over the airfield, the pilot joined the left-hand circuit for runway 35 on a circular descending flight path. On coming out of the last turn, the pilot intercepted the runway centreline at 0.5 NM from the threshold of runway 35, at a height of 170 ft.

Figure 1: path of G-CLDO based on GPS data

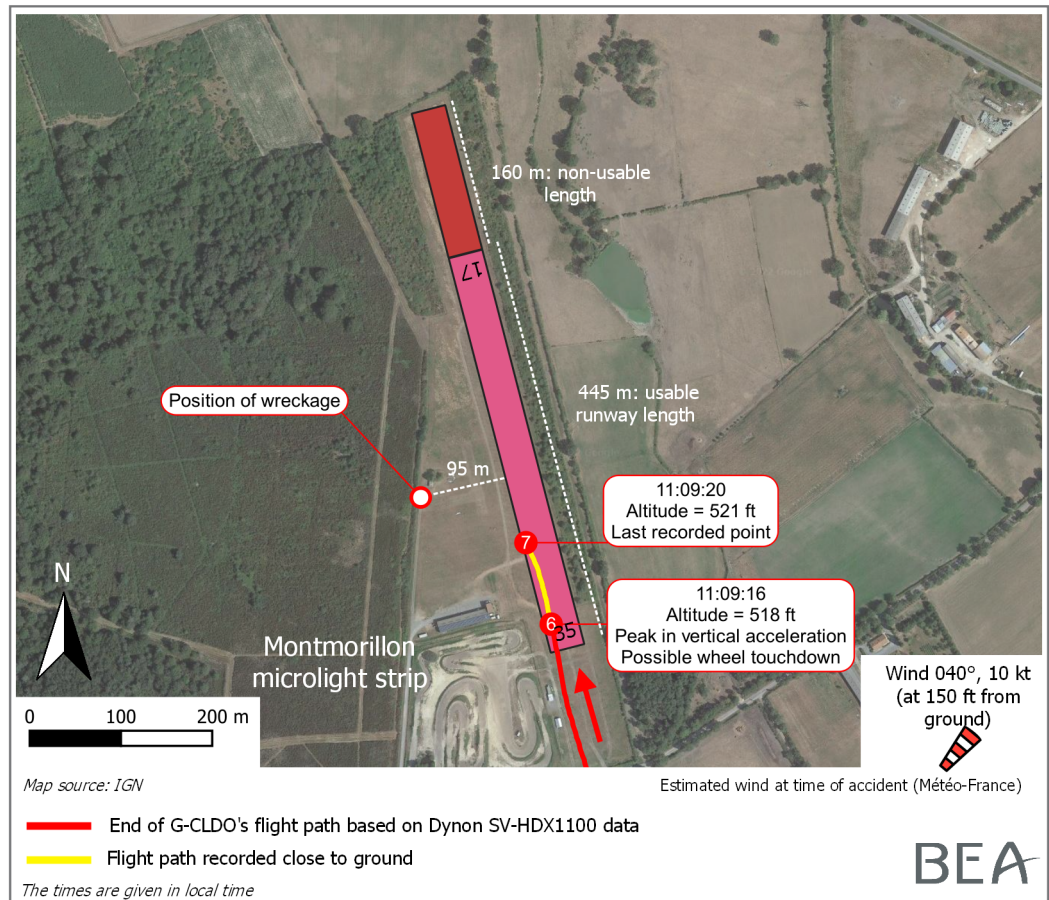
At the end of the final approach, while flying over the runway, the pilot aborted the landing by applying full power. During this manoeuvre, he lost control of the aeroplane which collided with the ground on the left side of the runway, at the edge of the microlight platform grounds. Unable to exit the aeroplane unaided, the pilot contacted the emergency services using his mobile phone.

Figure 2: end of G-CLDO's flight path

The wreckage was found to the left of the runway at a distance of 95 m from its lateral edge and about one third along its length. The flaps were found in the landing position and the pitch trims and ailerons equipping the aircraft were in neutral. The two engine control levers (power and mixture) were found in the maximum forward position. However, it cannot be excluded that their positions were modified on impact.
