Accident to the DG Flugzeugbau DG-1000T⁽¹⁾ registered D-KIST

on 16 July 2019

at Valernes (Alpes-de-Haute-Provence)

Loss of control in turn, collision with the terrain

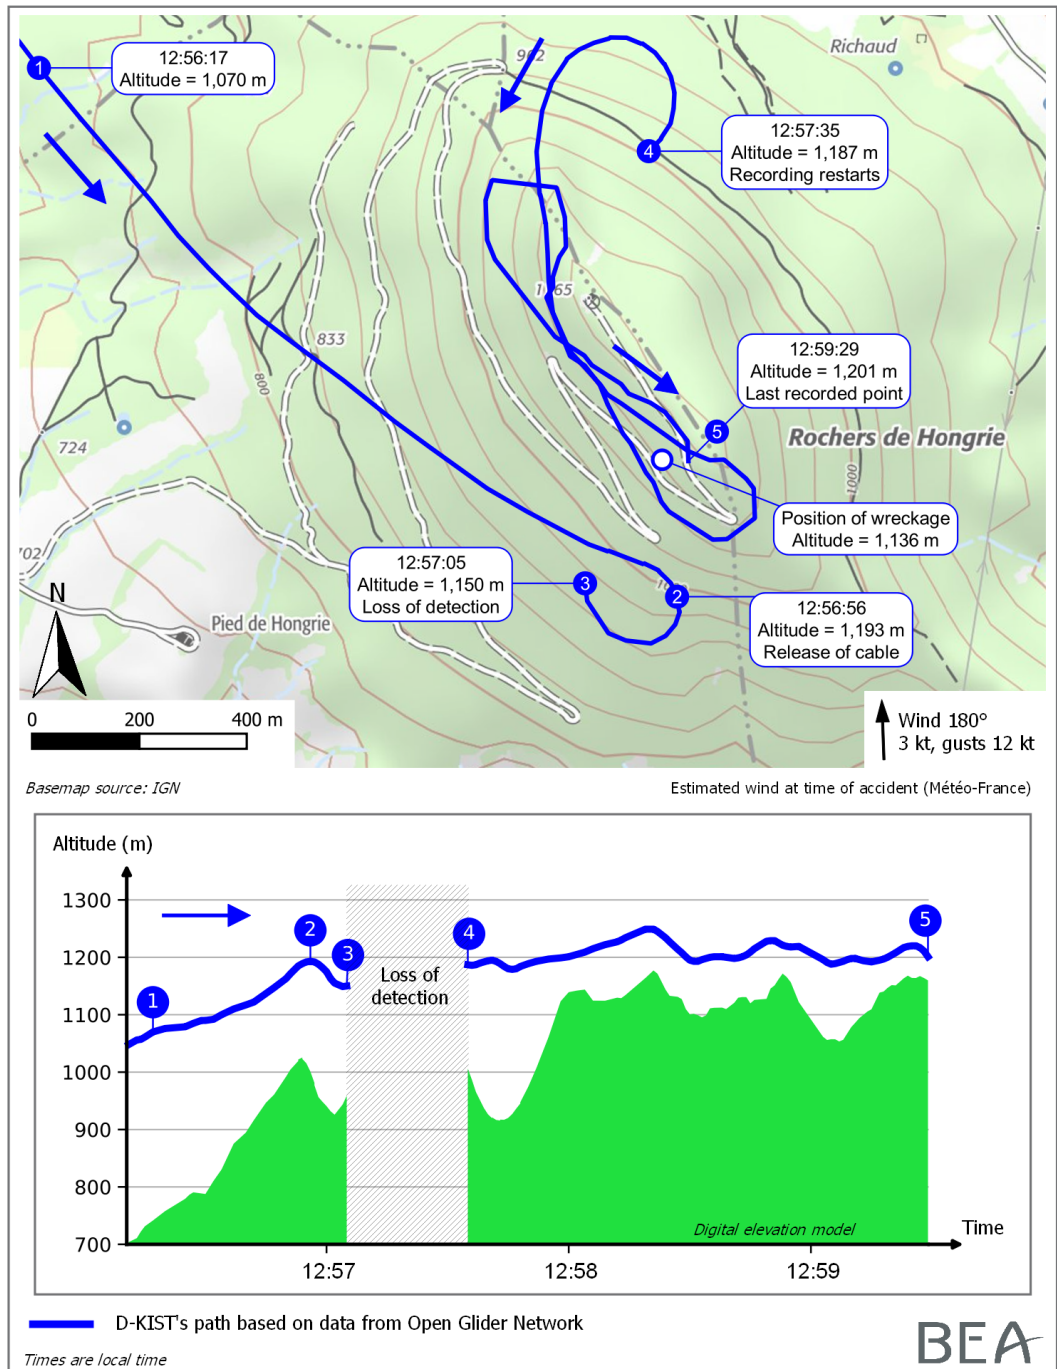
Glider's path

The data recorded by the OGN, which collects the FLARM messages emitted by the gliders by means of a network of receiving antennas on the ground, made it possible to map the path (see [illustration](#)).

On the last straight leg of the path leading to [point 5](#), the average ground speed was between 100 and 110 km/h. The ground speed⁽⁵⁾ calculated using the points recorded in the last five seconds, was around 80 km/h.

The pilot was slope soaring, making figures of eight with a bank angle of more than 30° along the Rochers de Hongrie. The analysis of the parameters found that the speed of the glider had progressively decreased in the last seconds of the flight, approaching the stall speed. Then, in a right turn, the pilot lost control of the glider.
