Accident to the SCHEMPP HIRTH - JANUS B registered F-CFAJ

on 2 August 2019

at Val-des-Prés (Hautes-Alpes)

Collision with trees during an off-field landing, fall into a river

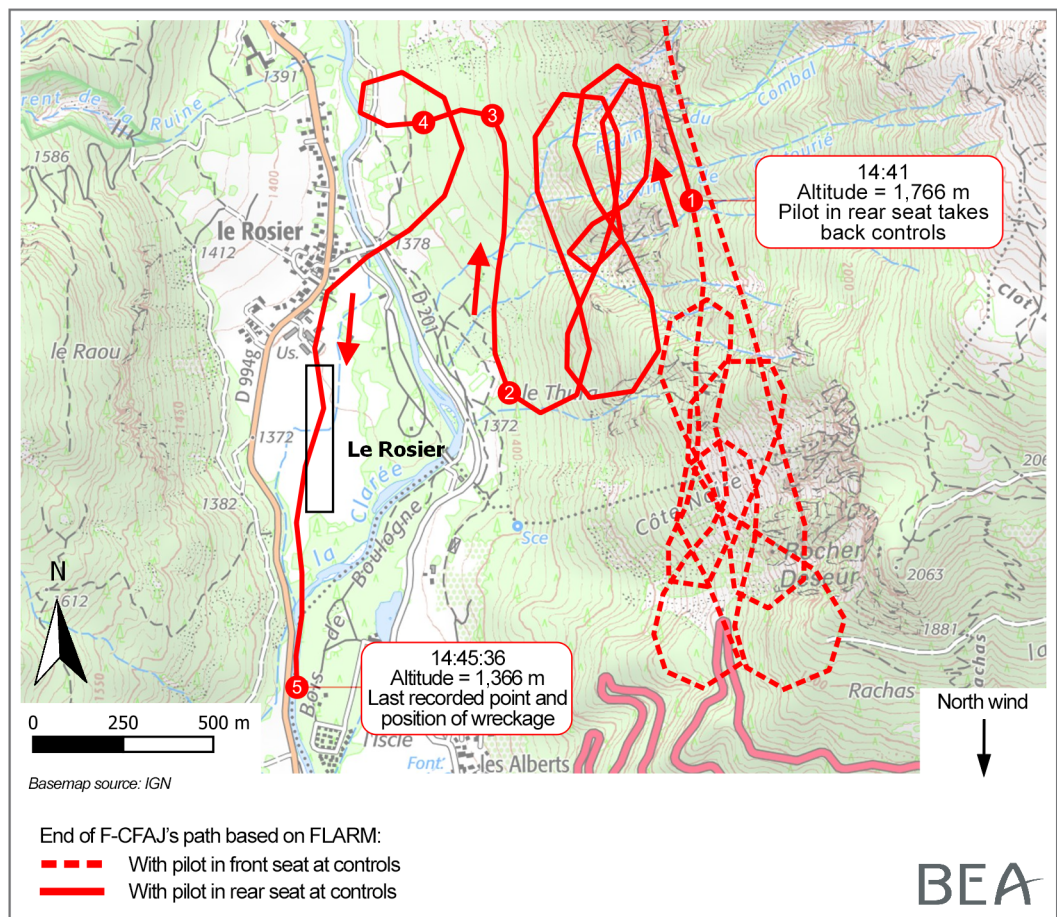
Figure 1: End of F-CFAJ's path based on FLARM data

The pilot in the rear seat then took over the controls and made a few alternating turns in a figure-of-eight in an attempt to find lift **1**, to no avail. He decided to abort the flight and to make an off-field landing on Le Rosier safe landing area. He went on to the left-hand downwind leg **2** and then to the base leg **3** to land facing south. In the middle of the base leg, because the glider was too high on the path, and he turned away **4** to lose altitude to the northeast of the field. On final, seeing that the glider was still not descending sufficiently, he extended the speedbrakes fully, set the flaps to the landing position, and asked the pilot in the front seat to deploy the drag chute. The pilot in the front seat jettisoned it by mistake.

The glider flew over the whole field. Both pilots retracted the speedbrakes and pulled the elevator control to clear the trees at the edge of the field and attempt to land in another field further on. The glider struck the trees, fell into a river, and rolled over **5**. The pilot in the front seat evacuated the glider unaided. The pilot in the rear seat managed to free himself and evacuated the glider with the help of witnesses who had come to help.

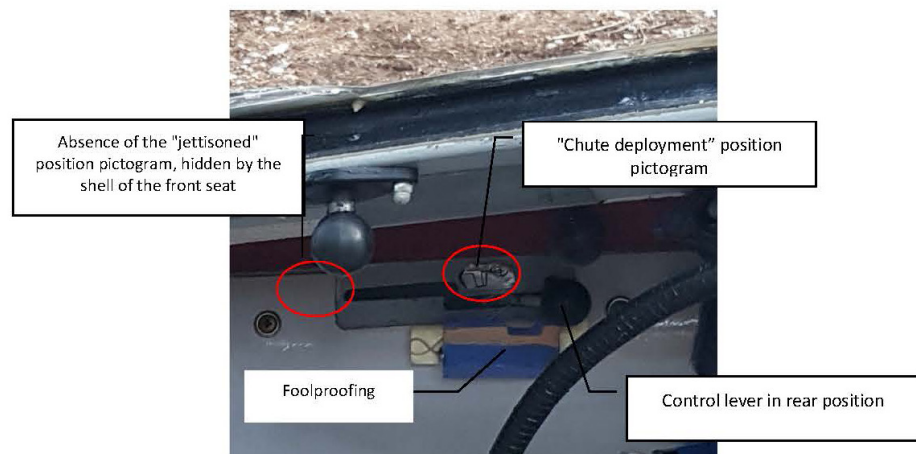
Figure 2: Post-accident photograph showing the drag chute control device

The glider's drag chute was not found. The chute opening control lever was in the rear position. This position is probably due to the return spring on the lever. The pictogram corresponding to the "jettisoned" position was not visible because it was hidden by the shell of the front seat (Figure 2).

- The non-visibility of the pictogram indicating the “jettisoned” position of the drag chute, which meant that the pilot in the front seat did not realise he would jettison the drag chute by putting the control in the front stop position.

Following the accident, the *Aéroclub de Saint-Rémy Les Alpilles* decided to implement mandatory training for pilots released on the Janus B in the use of the drag chute.
