Accident to the Beechcraft Bonanza A36 registered OO-JBM

on 9 August 2019

in the Golf of Girolata (Corse-du-Sud)

Engine shutdown in flight, stall during flare to ditch

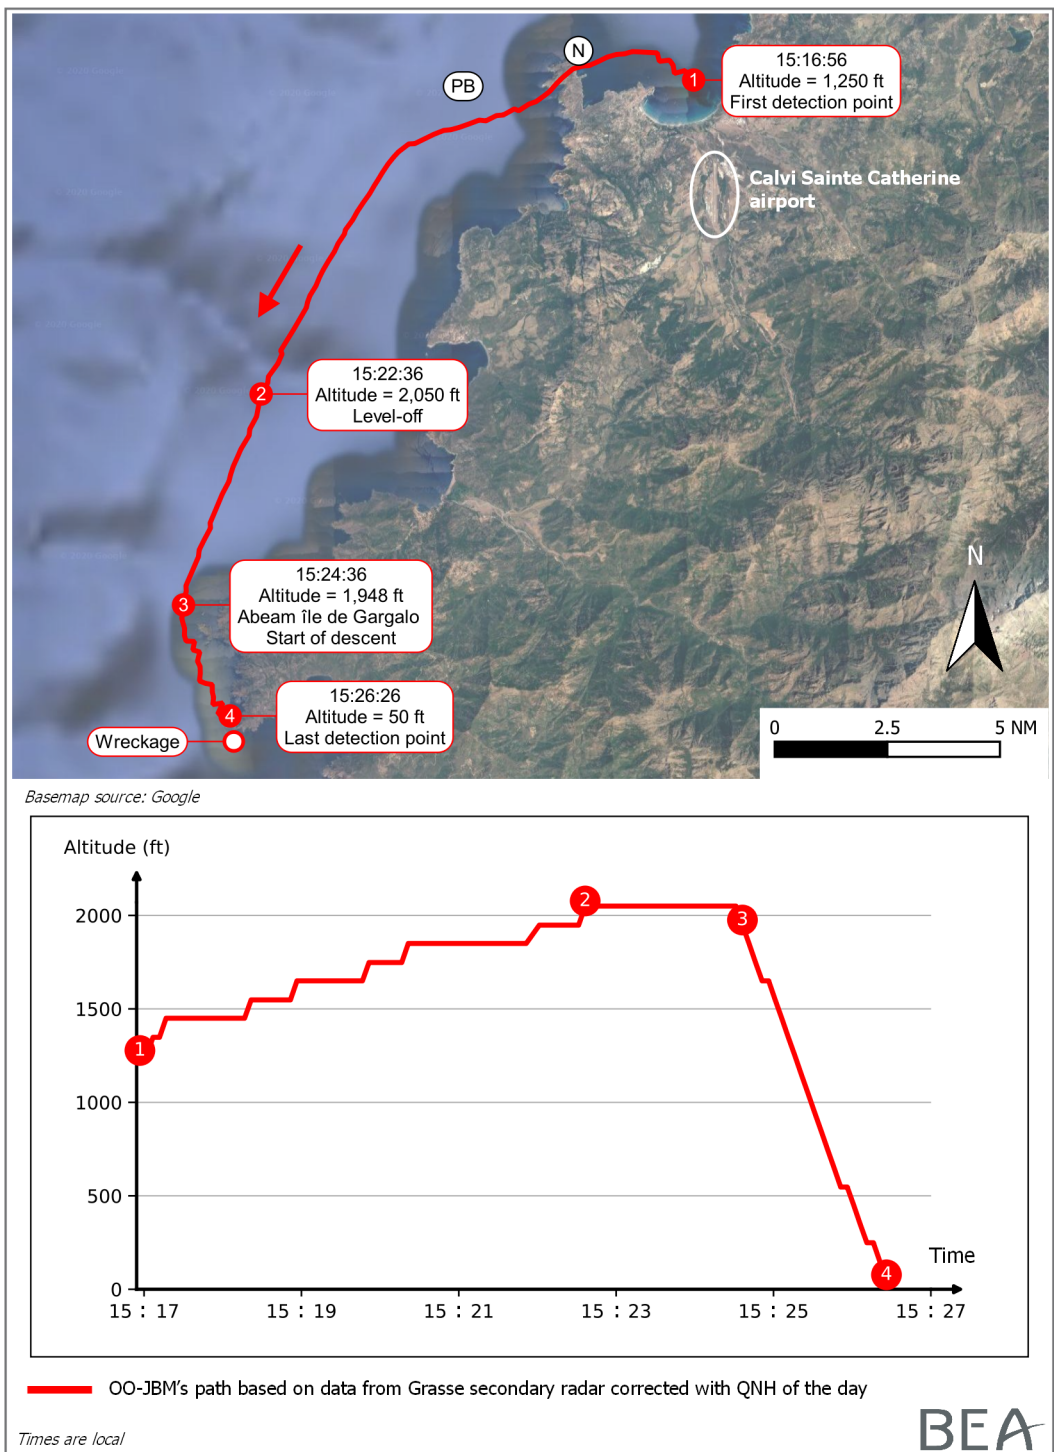
Reconstructed flight path

At 15:24, two "bangs" were heard at an interval of around 15 seconds. The aeroplane's manifold pressure and speed decreased. Around 30 seconds later, when the aeroplane was around 2 km off the île de Cargalo (Corse-du-Sud), the engine shut down (Point ③ - [see illustration](#)). The pilot tried to restart the engine but to no avail (selection of right fuel tank, power lever to full power, check of position of mixture control, electric pump on and action on starter). He adopted the best glide speed of 110 kt while the passenger made two distress calls on the Ajaccio information frequency, which went without response. At an altitude of 1,200 ft, as the engine had still not started, the pilot decided to ditch with the landing gear and flaps retracted. He headed towards the coast with the intention of ditching as close as possible to pleasure boats.

He turned to ditch parallel to the coast. While he was getting ready to start the flare with the flaps and landing gear retracted, the aeroplane stalled around ten metres above the water. The aeroplane's right wing and then its nose collided with the surface of the sea. The aeroplane then came to a stop for a few seconds with a nose-down attitude of around 45°, the forward section of the fuselage half submerged in the water. Under the weight of the engine, the aeroplane then rapidly sunk as several pleasure boats arrived to assist the occupants. The latter, who were not wearing life jackets, released their seat belts as water started to fill the cockpit. The passenger succeeded in opening the door when the cockpit was sufficiently full of water. The two occupants successfully evacuated the aeroplane and rose to the surface. They then swam to the boats where they were immediately taken care of by the amateur sailors.
