## Accident to the Pioneer 200 registered 87FR

on 30 October 2019

at Saint-Junien (Haute-Vienne)

## Loss of control on approach, collision with trees and then with the ground

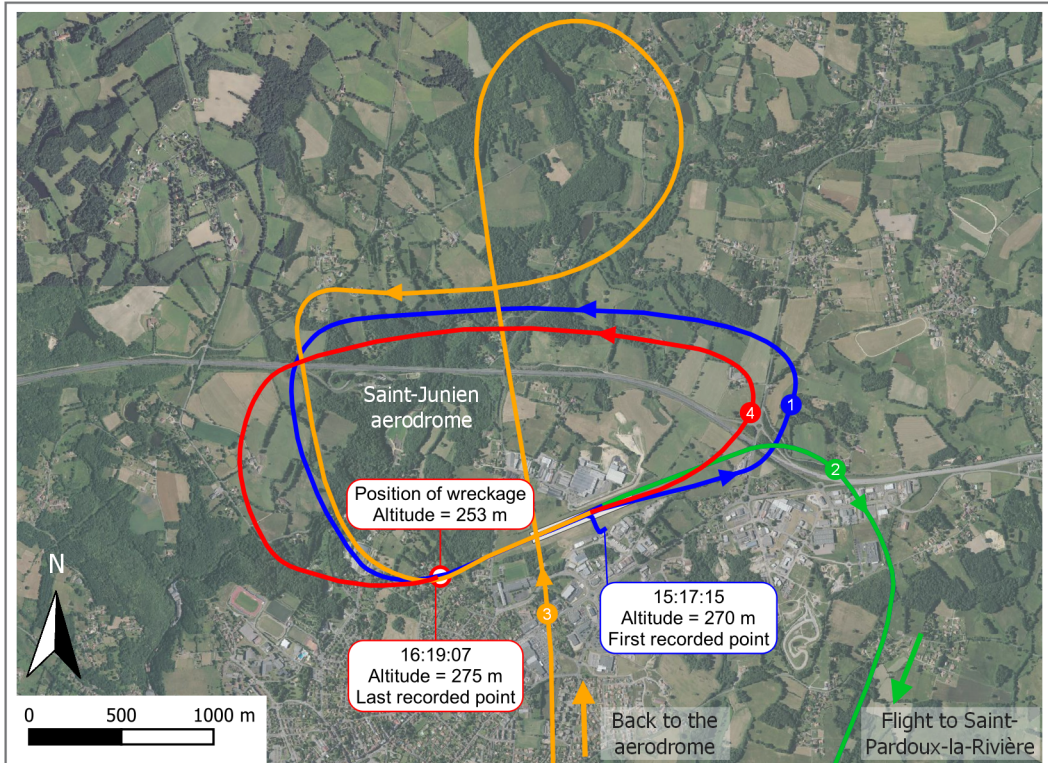
Partial path of 87FR recorded in the SDVFR application:

- Take-off, first runway circuit and touch-and-go
- Return to the aerodrome, joining the traffic pattern and touch-and-go
- Accident runway circuit

*The variable sampling of the path points does not allow the reconstruction of the descent profiles to the threshold for the first two approaches. Times are given in local time.*

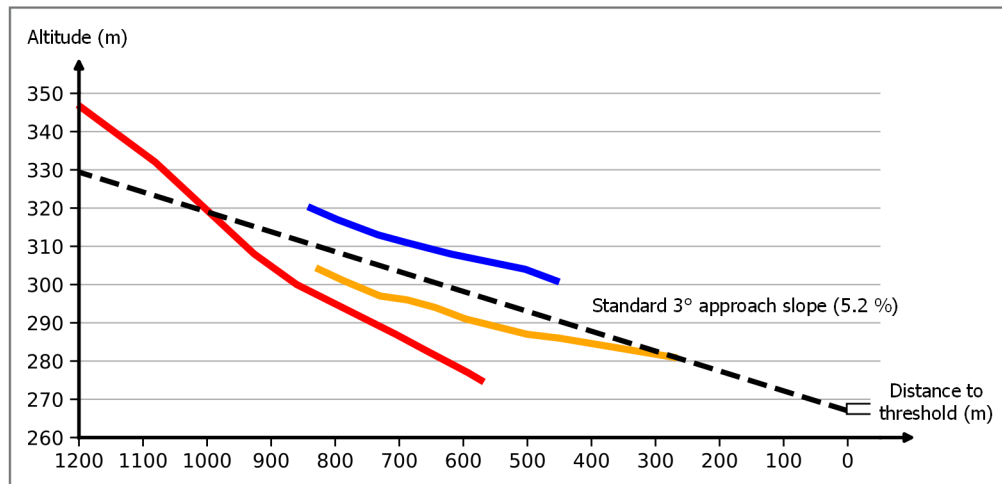
Detailed view of the three approaches, at the beginning and the end of the flight

The GNSS data of the flight was extracted and shows, among other things, that:

- ❑ The base leg of the last approach (in red, [see illustration](#)) was at a distance of about 500 m from the microlight traffic pattern.
- ❑ The ground speed was between 85 and 90 km/h on final during the runway circuit performed at the beginning of the flight and during the touch-and-go on the return flight (in blue and yellow), [see illustration](#)).
- ❑ The last approach was conducted with a steeper slope than the theoretical standard slope and dropped below it about 1 km from the runway threshold. The ground speed was between 80 and 85 km/h on final. The increase in slope without a significant increase in ground speed can be explained by an attempt to return to the approach slope by deliberately making asymmetric rudder inputs (sideslip<sup>(5)</sup>).
