INVESTIGATION REPORT

Serious incident

on 14 November 2019

to the BOEING - 737 - 800

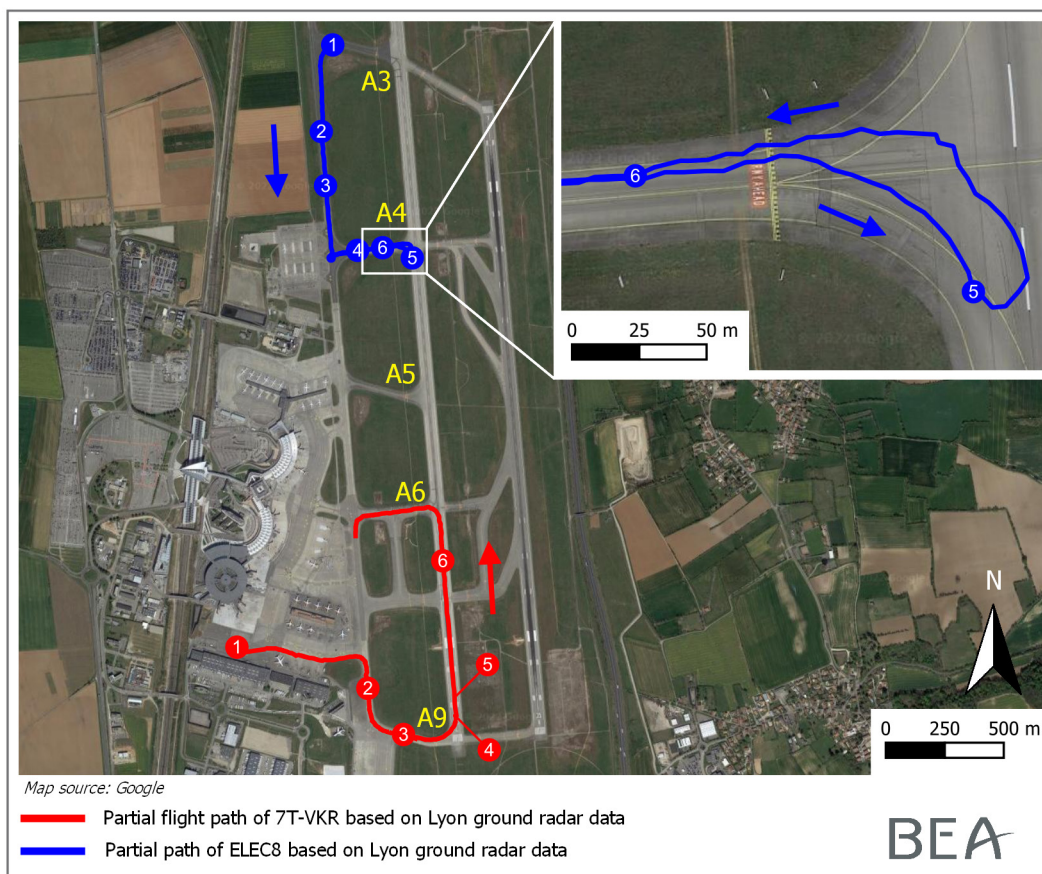
Figure 1: Partial paths of Boeing 737-800 registered 7T-VKR and of lead vehicle of snowploughs

At 22:35:22, lead vehicle ELEC8 told the GND controller that the runway was vacated (point 6).

At 22:42, the crew of flight AH1157 coming from A9, lined up again on runway 35L and took off; wheel lift-off occurred at taxiway A5.

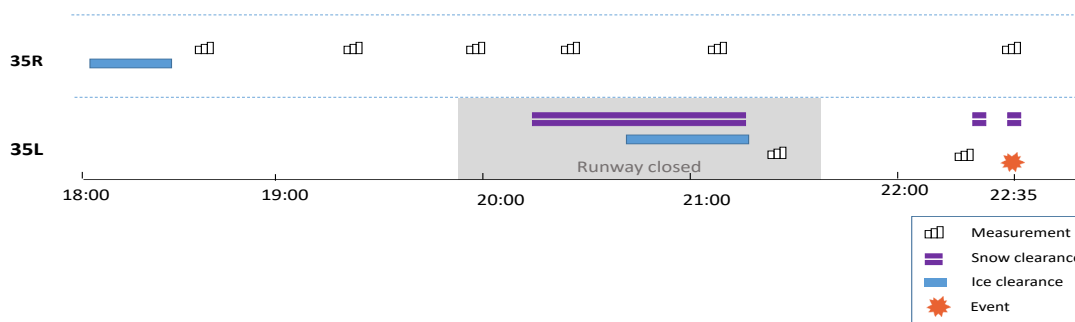
Figure 12: Snow clearance operations between 18:00 and 22:35

The snow clearance was difficult, requiring several passes, the runway quickly turned white again, the snow being heavy and wet. The snowploughs continued to clear snow from the edges while the fire fighting services started clearing the ice. The runway was freed after the runway surface condition measurements at 21:25. All that remained was for the runway to be joined to the taxiways which implied the vehicles entering the runway again to remove the remaining mounds of snow. The lead vehicle and the snowploughs resumed the snow clearance operations, after a 30 minute, wait on taxiway T, followed by A3 and then A4.

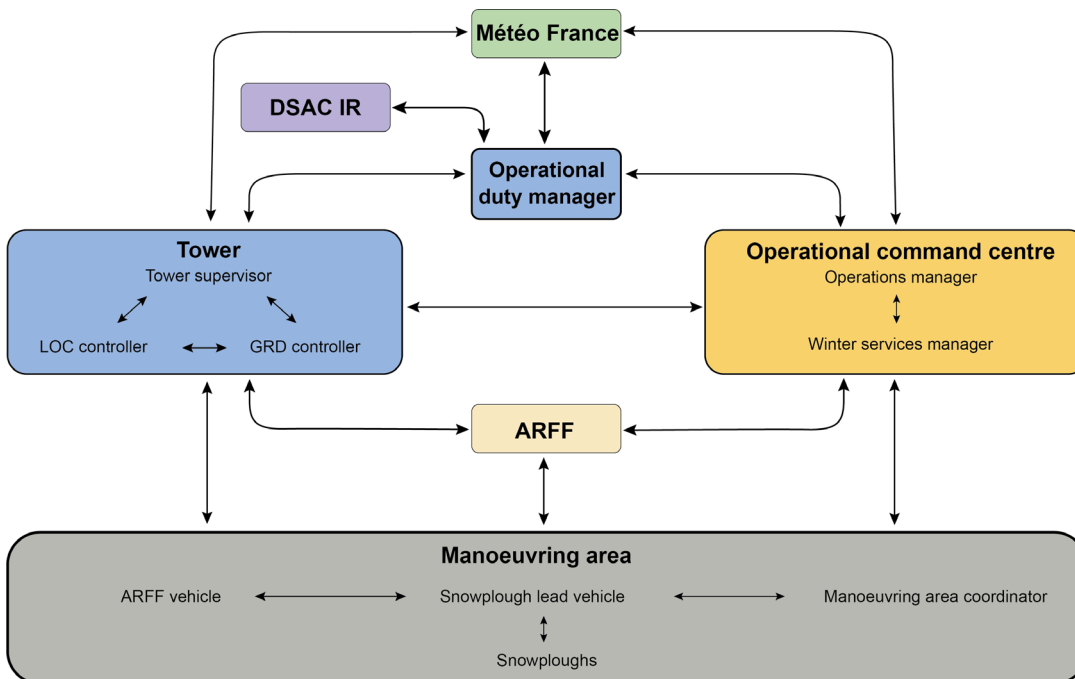
Figure 14: Main contacts and interactions with respect to the snow clearance strategy and the implementation of zero capacity

The operational duty manager called the DSAC duty manager when zero capacity was implemented. The DSAC IR personnel encountered in the scope of the investigation indicated that the DSAC duty manager did not monitor the evolution of the runways' surface condition as he did not have the expertise to decide on their closure based on the runway surface condition measurements.
