Accident to the MOONEY - M20F registered F-HOSJ

on 29 January 2020

at Biscarrosse-Parentis (Landes)

Loss of electrical power, partial extension of landing gear, collapse of landing gear on landing

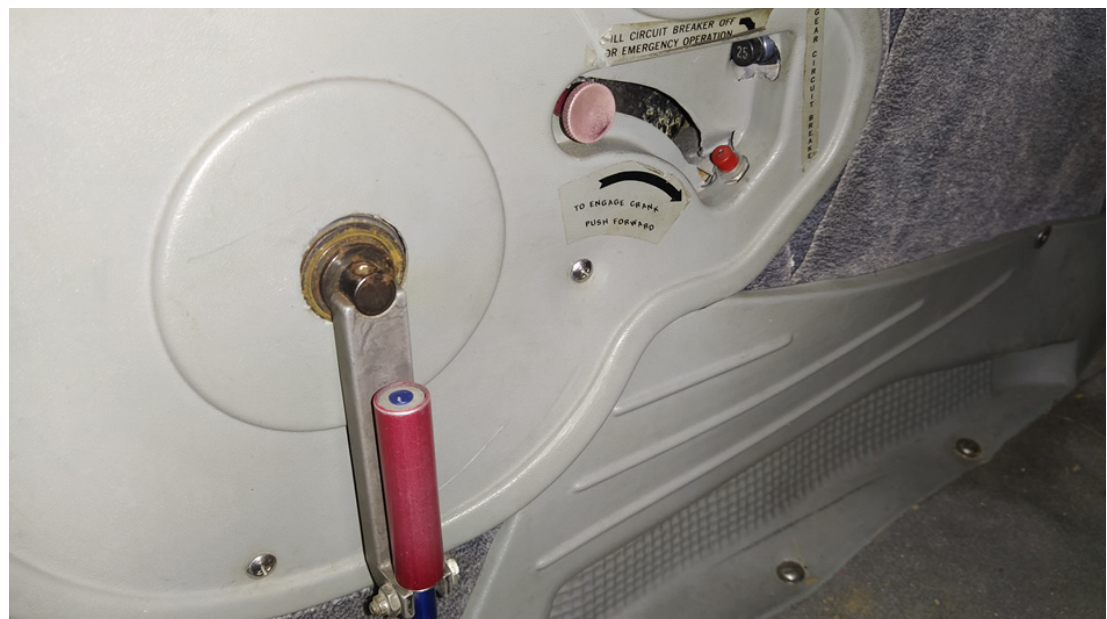
Figure 1: emergency landing gear extension handcrank (view from bottom of pilot's seat)

It was possible to extend and lock the landing gear after around 60 turns of the handcrank. It is possible that the compression deformation of the rods may have affected the number of turns of the handcrank. It was possible to retract the landing gear by turning this handle in the counterclockwise direction.

As his action had not completely extended and locked the gear, he then wanted to turn the handcrank in the opposite direction, i.e. clockwise. As the force to be applied was too high, he was unable to turn the handcrank and stopped his action as he did not want to break it.

He next started turning the handcrank in the counterclockwise direction again. After around one minute, i.e. about ten turns, the mobile black line of the visual gear extension indicator was still stuck in the same spot. The pilot indicated that he then thought that he had broken the emergency extension control. In retrospect, he had a doubt as to whether he had correctly engaged the drive mechanism for the emergency landing gear extension (refer to point 3 of the procedure described in paragraph [2.1.3](#)).

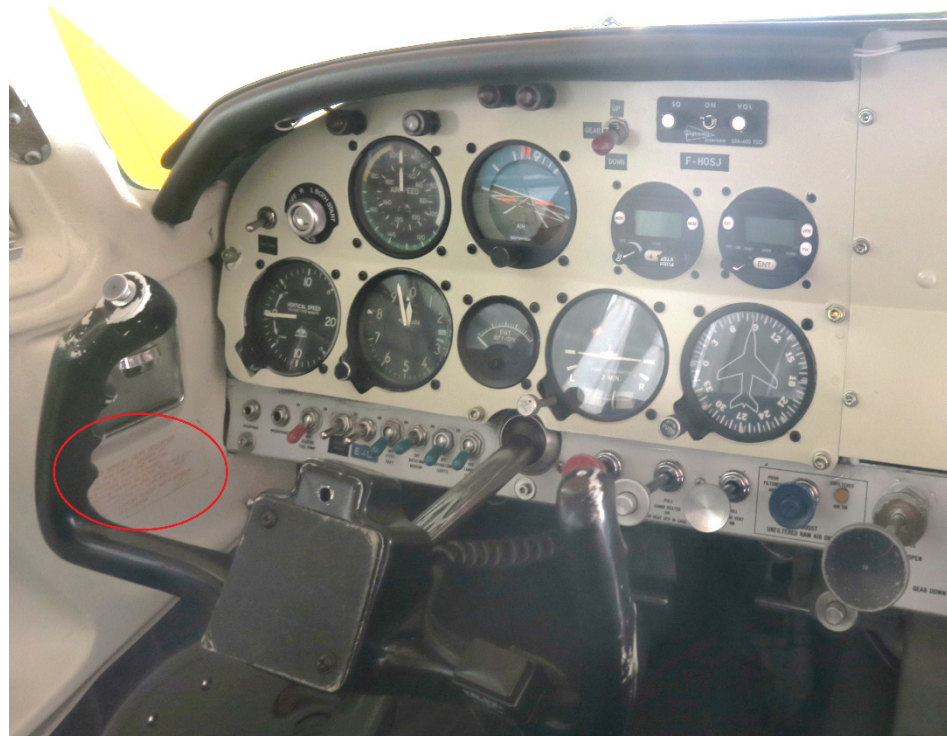
Figure 2: view of label from pilot's seat

A label giving the procedure in full (in English) was situated above the emergency landing gear extension handcrank.

He had neither the checklist nor the normal and emergency procedures on board the plane. The pilot specified that he did not think to consult the onboard flight manual.

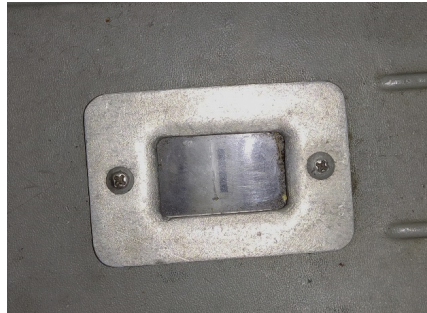
Figure 3: visual landing gear extension indicator

After trying to extend the landing gear in the usual way, he started flying 360° turns again, this time overhead the lake, south abeam the control tower. He pushed his seat back to access the emergency landing gear extension handcrank. He added that he turned it in the counterclockwise direction for three to four minutes, i.e. just over twenty turns. The handcrank turned easily. On checking the visual gear extension indicator between the two front seats, he had confirmation that the landing gear was extending. Nevertheless, the mobile black line stopped well before the centre⁽⁶⁾ of the visual gear extension indicator.

In this example, the mobile black line is centred which indicates that the landing gear is extended and locked.
