## Serious incident between the CENTRAIR SNC34C Alliance and the Sportine Aviacija LAK19 registered F-CJBH and F-CHNP

on 27 May 2020  
at Parentignat (Puy de Dôme)

## Midair collision between two gliders using uplift

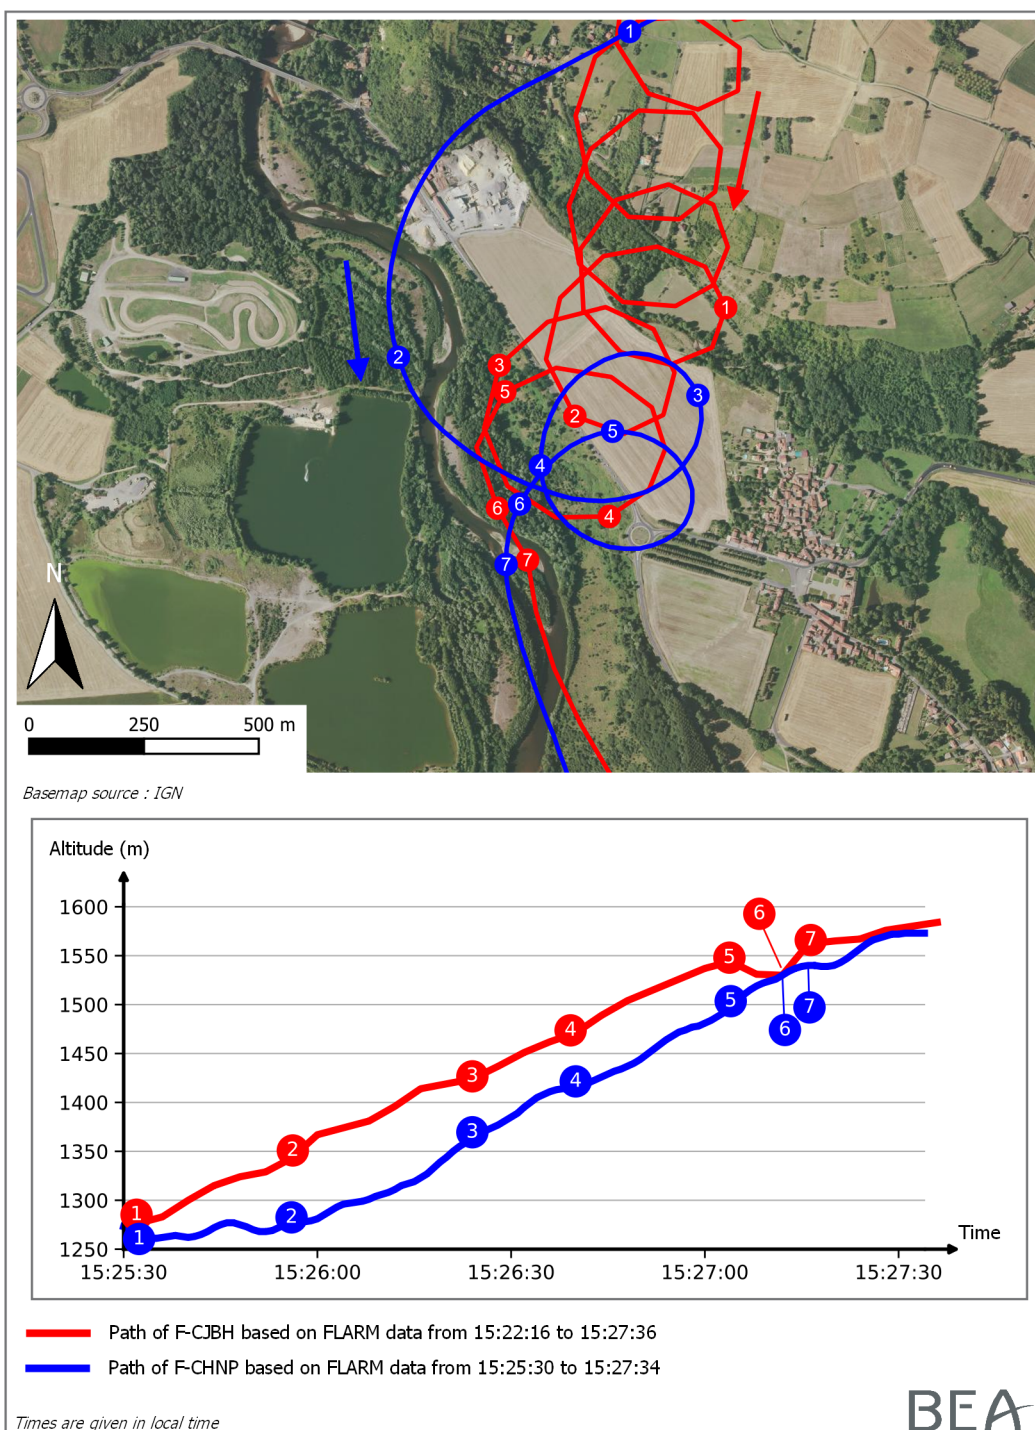
Part of the paths based on the FLARMs of both gliders
