Accident to the REIMS CESSNA F 150 M registered F-BXNO

on 20 June 2020

at Montbéliard Courcelles (Doubs)

Fuel exhaustion during approach, collision with vegetation on short final, collision with the ground

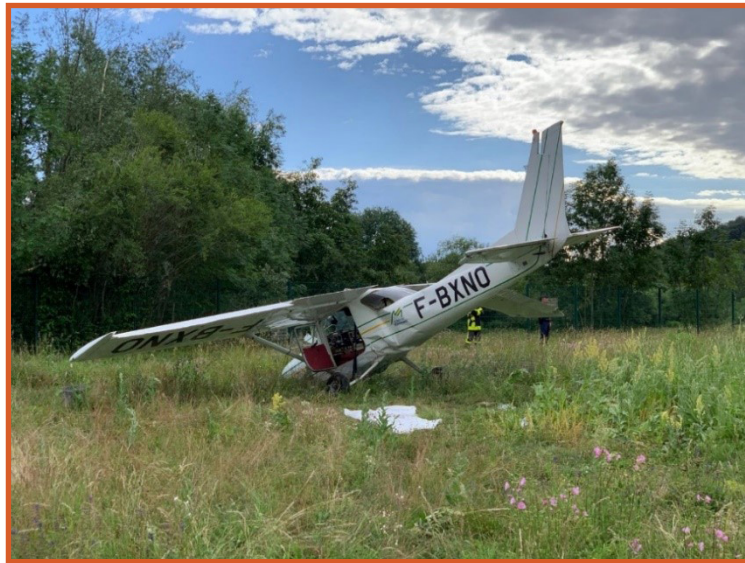
Aeroplane shortly after the accident

Damage to the fuselage, wings and landing gear resulted from the impact with the vegetation and subsequent collision with the ground.
