Accident to the CESSNA - U206 SUPER SKYWAGON registered F-HIDZ

on 2 June 2020

at Gap-Tallard (Hautes-Alpes)

Incorrect rigging of roll control cables during a maintenance operation, loss of roll control during the take-off rotation, during post-maintenance check flight

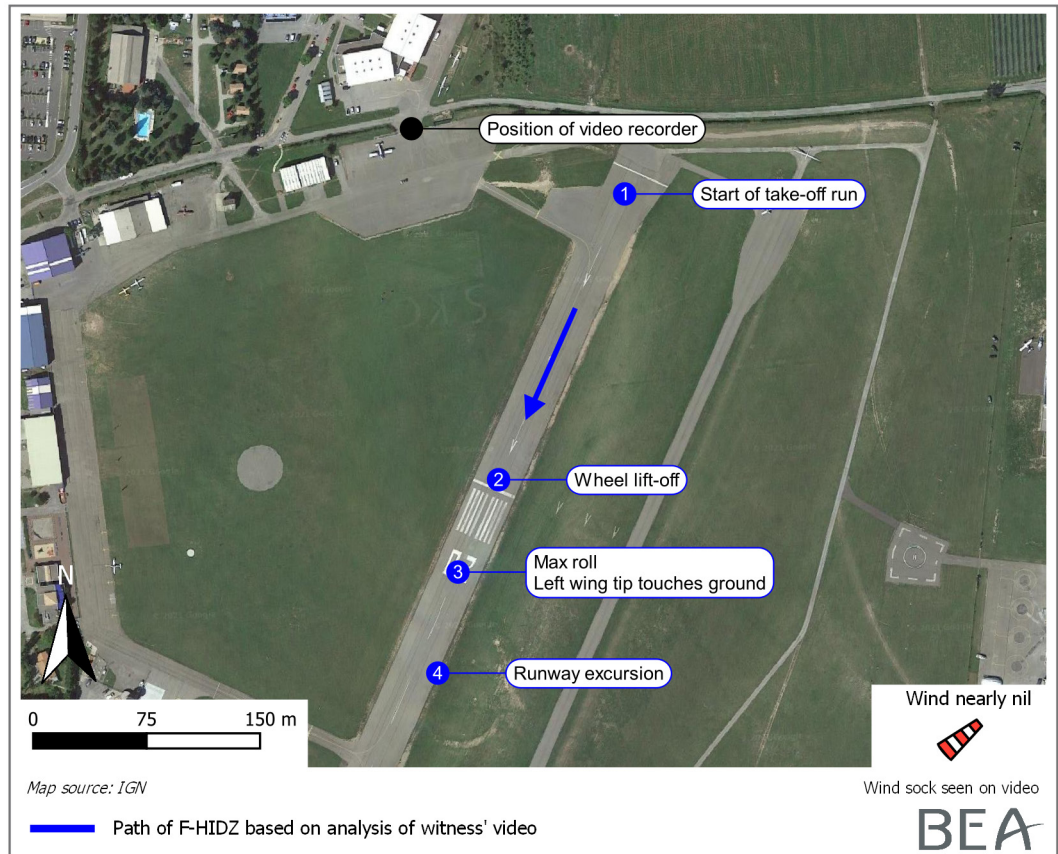
Figure 1: Aeroplane's take-off path

After a run of around 200 m, at roughly 100 km/h with the control wheel slightly turned to the right⁽³⁾, the aeroplane started banking to the left a little during the rotation. The pilot countered this by turning the control wheel fully to the right. The aeroplane continued to bank (up to around 30° to 40°) and the tip of the left wing touched the runway.

The plane veered to the left of the runway centreline at around one metre from the ground still with a high bank angle and still with the wing tip in contact with the ground. The pilot made a full right rudder input and reduced power by setting the propeller to "Beta"⁽⁴⁾ mode. The aeroplane came to a halt on the left side of runway 20R and the pilot evacuated the aircraft after shutting down all the systems.

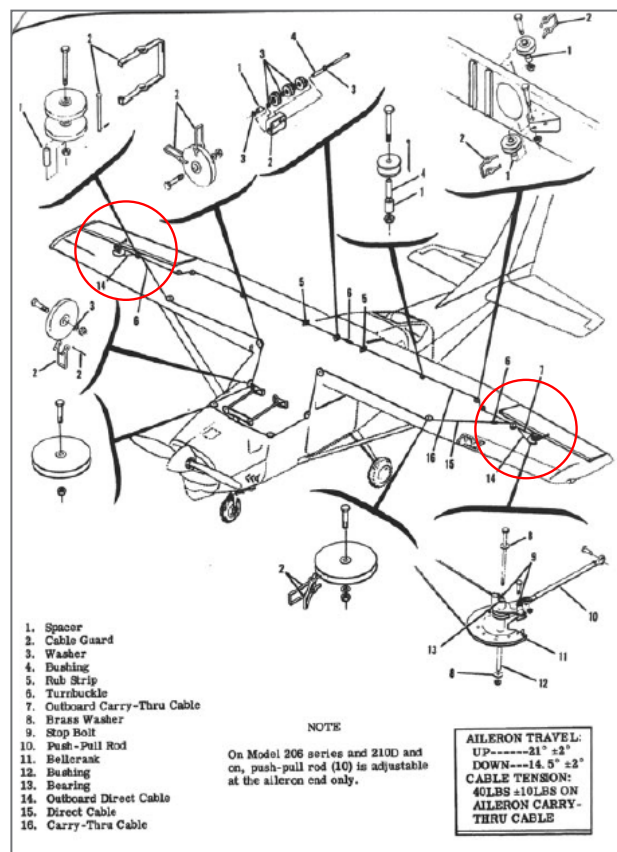
Figure 2: Excerpt from section 6 of MODEL 200 SERIES (1960- 1965) DEPT. HEADS MANUAL

According to the pilot, the cables had been removed before the purchase of the aeroplane and the wires were not present. Consequently, this easy reinstatement method was no longer possible. He explained that he had been uncertain about the correct routing when rigging the new cables.

He had checked this point in the Service Manual but according to him, the diagram was not clear and he had difficulties in interpreting it (see Figure 2). He finally routed the cables mistakenly reversing the outboard carry-thru cable and the outboard direct cable at the bellcrank situated in the wings.

Following the accident, ICARIUS AEROTECHNICS raised the awareness of its personnel with respect to the risk of confusion when re-rigging flight controls. A list of critical tasks was drawn up for each type of aeroplane in order to clarify the tasks requiring an independent inspection. The sheet recording the movement of each flight control system was modified with the addition of the instruction to check the direction of movement. The company also modified the aeroplane's check-list with the addition of the check for the correct direction of movement of the flight controls during the pre-take-off checks.
