Accident to the Pilatus – PC-12 - 47E registered LX-JFD

on 30 March 2020

on approach to Nice-Côte-d'Azur airport (Alpes-Maritimes)

In-flight lightning strike, structural damage observed on ground

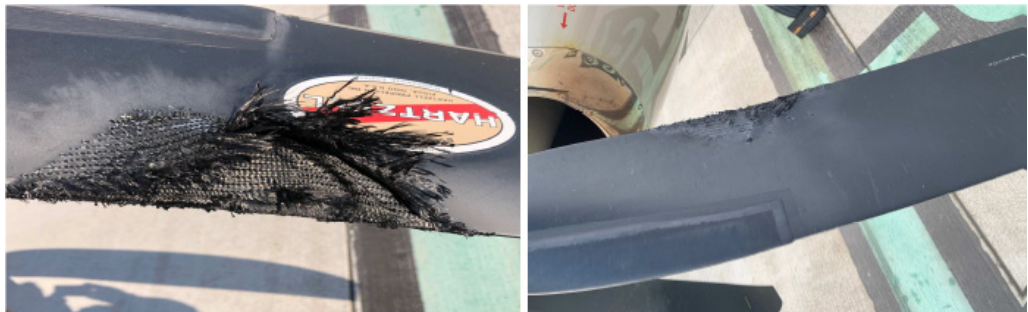
One of the propeller blades was damaged by the lightning (see Figure 2).

The main damage was located in the trailing edge area of the blade. This area is composed of foam and approximately 1 mm-thick carbon fabric ply. This area is not considered as structural. The blade was not repairable.

Figure 2: Damage observed on a propeller blade

The propeller manufacturer had never previously observed this type of damage in operation due to an in-flight lightning strike. In its experience, the damage occurs near the blade tips and several blades are generally affected. The particular nature of this damage could correspond to an exit point rather than an entry point, i.e. the lightning travelling through the aircraft airframe towards the blade and not from the air towards the blade. The severity of this lightning strike is similar to what can be observed in the laboratory during the propeller certification and corresponds to relatively high energy. The propeller manufacturer considered that the damaged blade was still structurally solid in the spar area and that the propeller could continue to operate without failure or rupture.

After replacing the blade, the propeller was overhauled and then reinstalled on the aircraft.

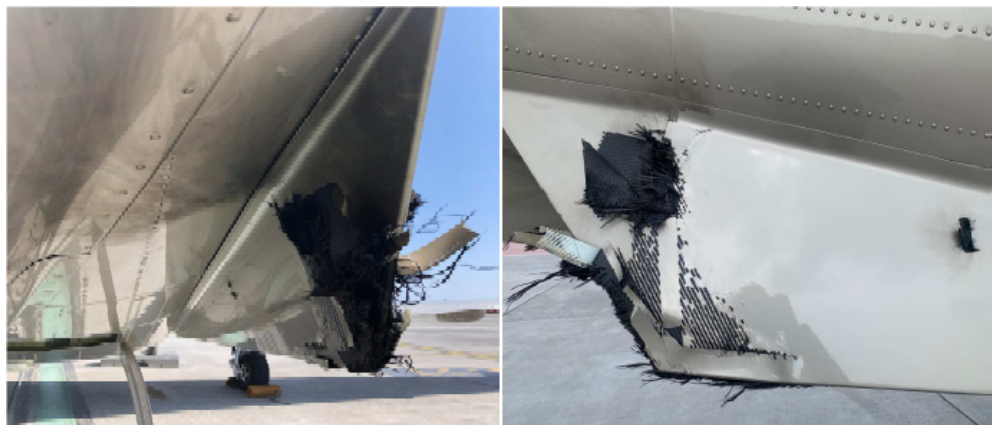
The right ventral fin was damaged by the lightning (see Figure 3).

Figure 3: Damage observed on right ventral fin

After repair, the ventral fin was reinstalled on the aircraft.

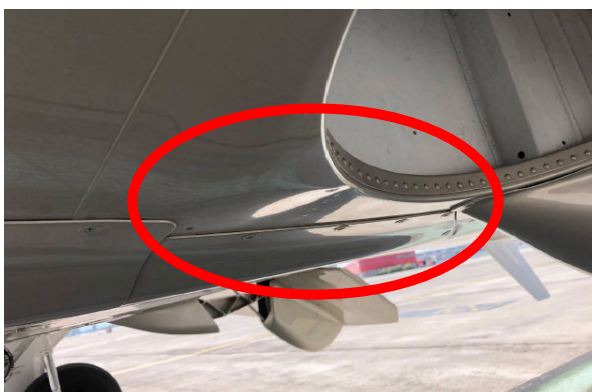
The damage observed by the maintenance personnel consisted of deformations of the left wing skin, at the leading edge and under the wing (see [Figures 5](#) and [6](#)).

Figure 6: Deformations observed on lower surface of left wing

Signs of major structural damage were observed on the skin of the left wing in the form of diagonal folds/creases in several places. The arm of the outboard flap mechanism was permanently deformed.

The observations made on the aircraft seem to support the hypothesis of high loads in flight rather than a hard landing.

The left wing and certain parts of the trailing edge flap had to be replaced to return the aircraft to service.
