Accident to the AIR CREATION GTE 503S / MILD 16 identified 17KB

on 17 July 2020

at Expiremont microlight strip

Loss of control during runway circuit, collision with the ground

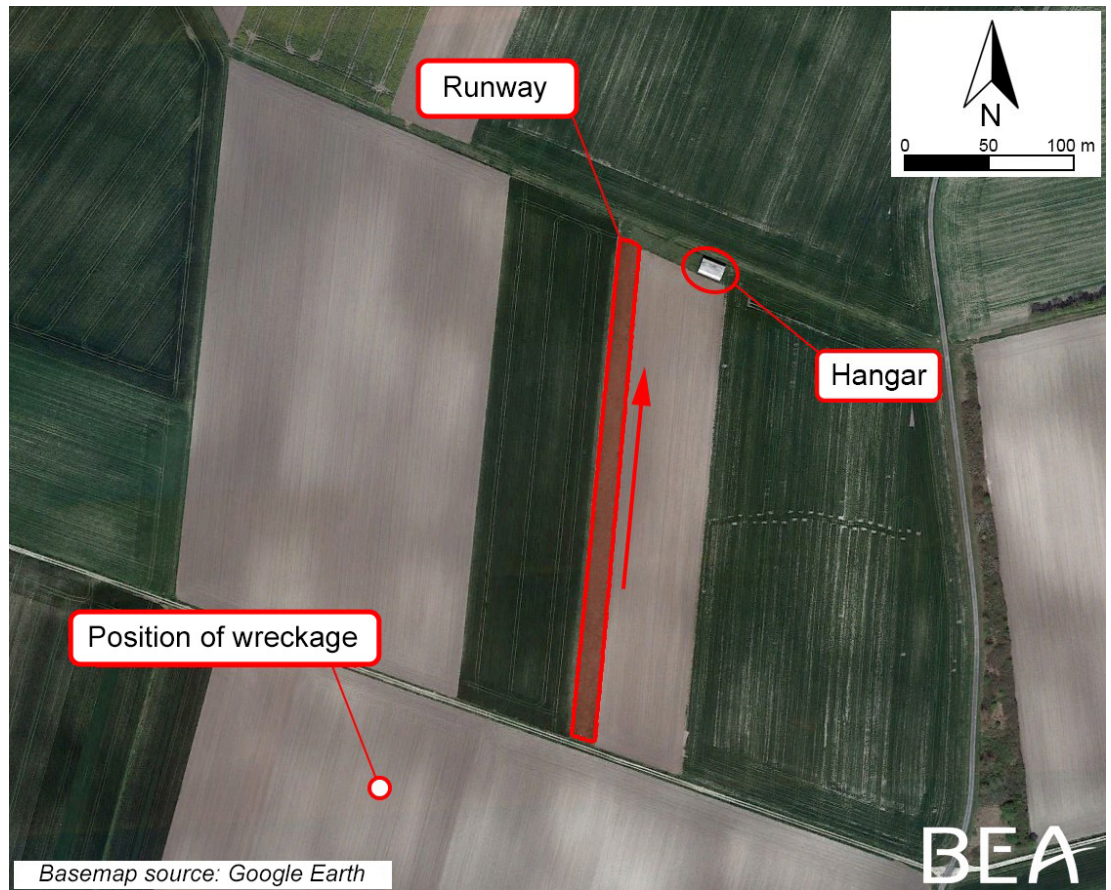
Figure 1 : Position of the wreckage

The wreckage was located about 115 m from the runway threshold, in a field of sunflowers. The marks in the field were not dispersed: only one impact was identified on the ground.

The observations made on the pendulum ultralight seem to testify to contact with the ground with a high nose-down attitude.

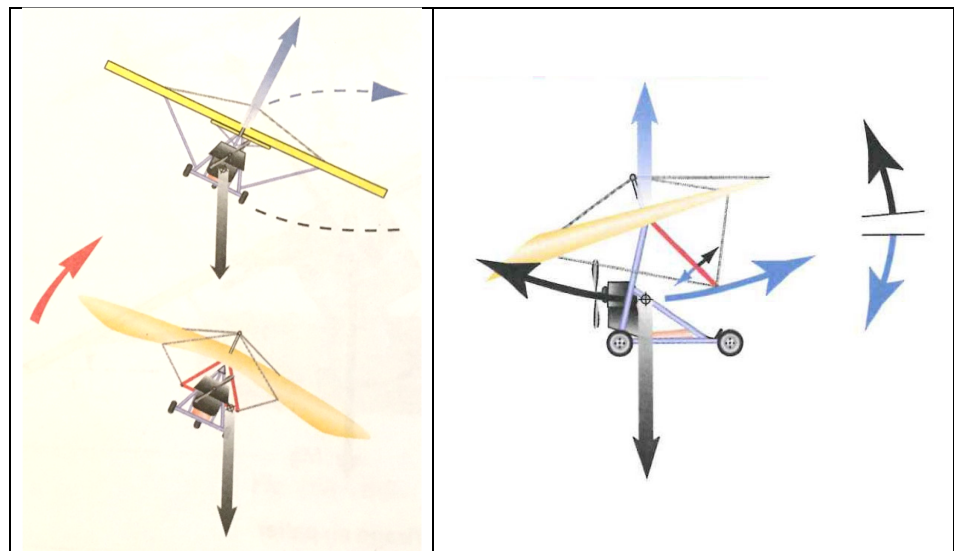
Figure 2: Change of path on pendulum ultralight

A pendulum ultralight is controlled by the lateral and/or longitudinal shift in the centre of gravity causing an aerodynamic response on the wing. To bank the pendulum ultralight right, the pilot moves the control bar laterally to the left. To climb, the pilot pushes the control bar forwards and to descend, the pilot pulls the control bar backwards. (Figure 2 below).

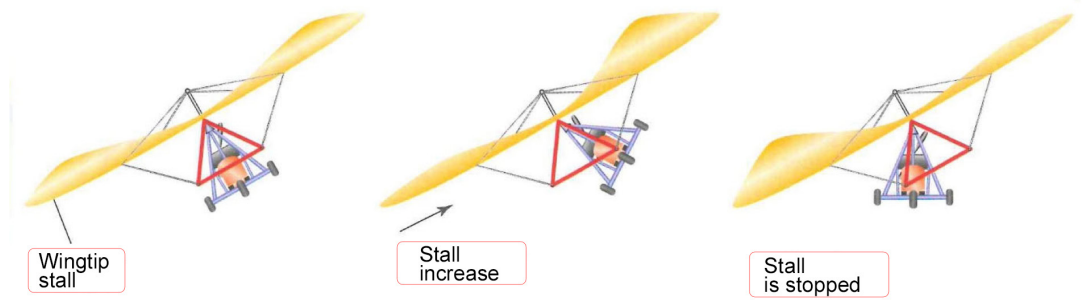
Figure 3: Image of stall in right turn, front view (BEA annotations)

During the stall in right turn (as shown in Figure 3), the inside wing stalls first. If the pilot tries to counter the wing drop by moving the control bar to the right, the lobe⁽³⁾ on the left side will further increase the angle of attack of the inside wing. If the pilot moves the control bar to the left, the movement of the lobe to the right wing will decrease the angle of attack of the inside wing and can eliminate the stall.
