## Accident to the AEROSPATIALE - AS350 - B1 registered F-GNLM

on 26 July 2020

at Clermont-Ferrand (Puy-de-Dôme)

### Loss of yaw control on entering hover, before take-off

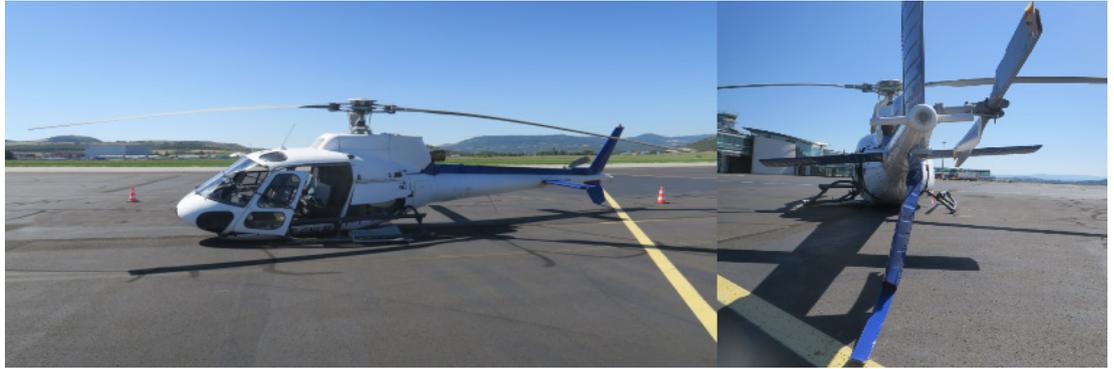
Several examinations were performed (on site then in the workshop). The continuity of the flight control linkages and the operation of the servocontrols and the yaw trim were checked. The mechanical connection between the engine and the tail rotor was checked; the engine was supplying power to the tail rotor at the time of the accident. No anomaly likely to explain the loss of yaw control was detected.

Damage to the helicopter
