Serious incident to the Airbus AS350-B3 registered F-HJSC

on 22 July 2020

5 NM north-east of Nîmes Garons (Gard)

Bird strike on approach

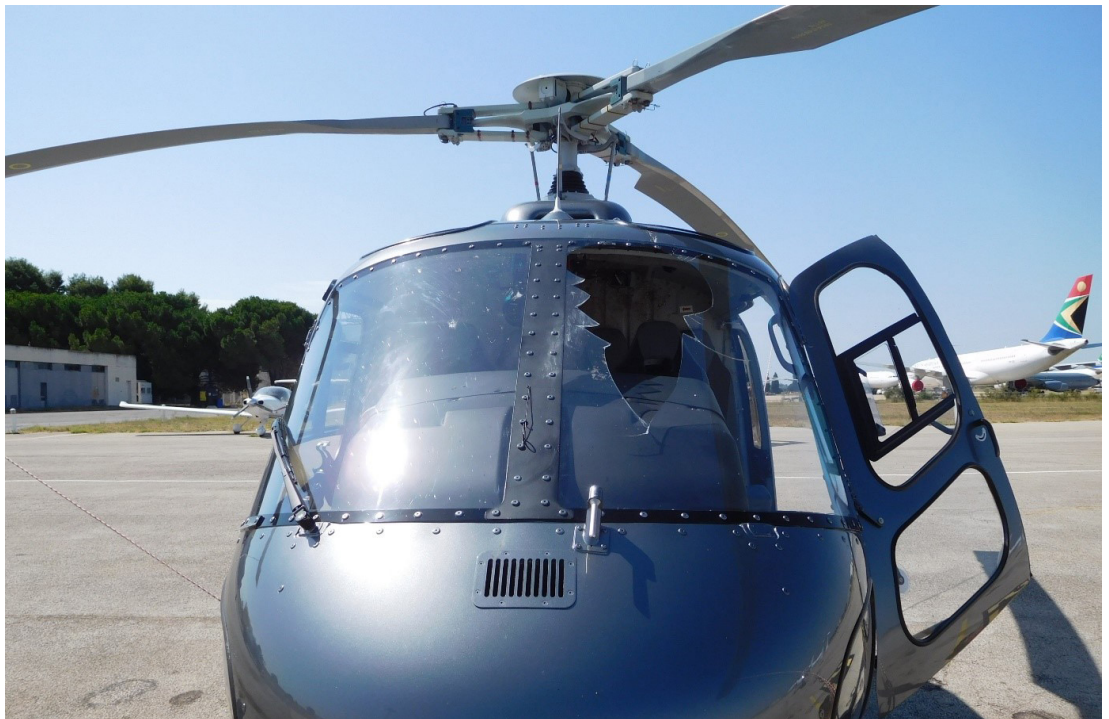
Front view of F-HJSC

The canopy was penetrated on the passenger side, in the immediate vicinity of the windscreen centre post, over a height of 78 cm and a width of 40 cm approximately. The upper metal section of the windscreen post had an impact mark of a few centimetres, located 20 cm to the left of the centre post (aft looking forward). No impact mark or remains of the bird of prey were visible at the air intake, on the rotor mast or on the blades. On the pilot's side, the canopy was intact.

The protection of the engine fuel shut-off handle was no longer in its safety position. The pilot stated that he had not touched it. The fuel shut-off handle had not moved. Biological traces were found on the aft bulkhead of the cabin and the backs of the rear seats. The biggest pieces of the canopy debris found measured around 25 cm.
