Accident to the CIRRUS - SR22 registered PH-SJN

on 28 July 2020

at Nancy-Essey (Meurthe-et-Moselle)

Abnormal contact with the runway, loss of control, re-application of power, runway veer-off

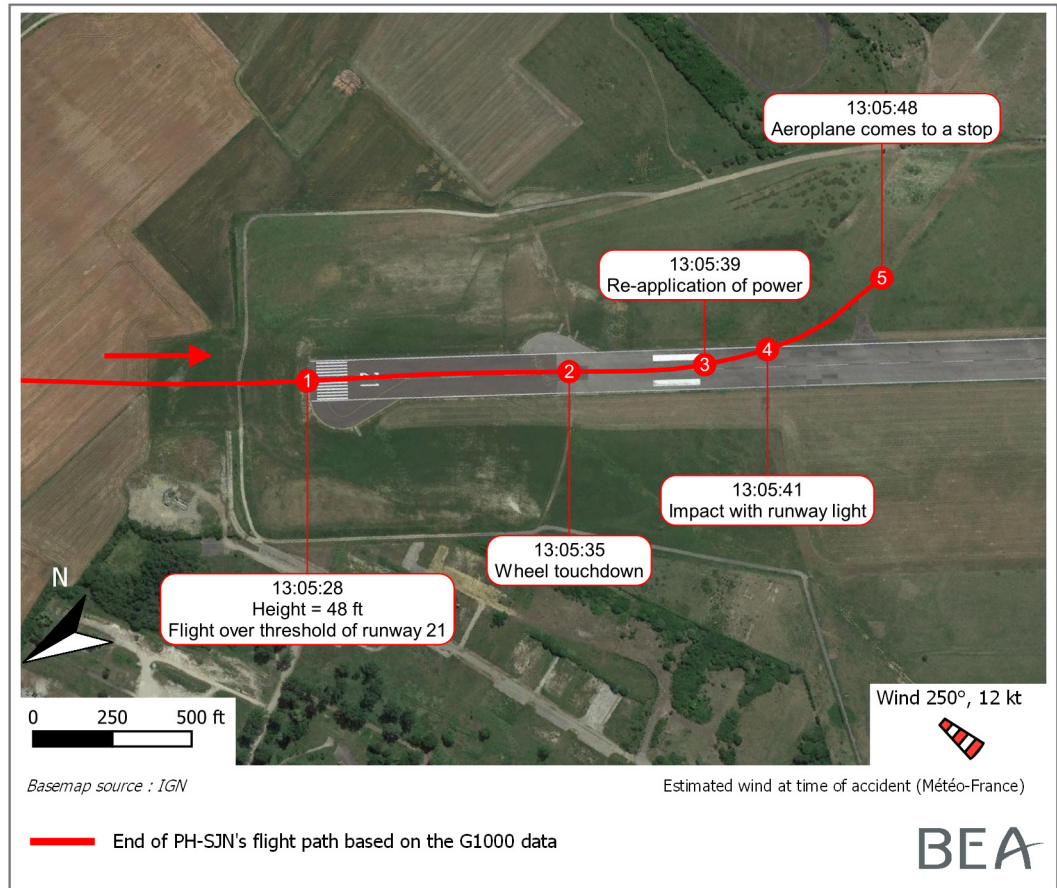
Figure 1: Path of PH-SJN

After the wheels touched down on the runway, the pilot lost control of the aeroplane, which bounced and banked left. The pilot re-applied power, the left wing tip hit a runway light. The aeroplane veered off the runway to the left, its nose wheel made contact with the ground and the plane bounced again. The pilot reduced the power. The aeroplane came to a stop on its belly after spinning 180° to the right.

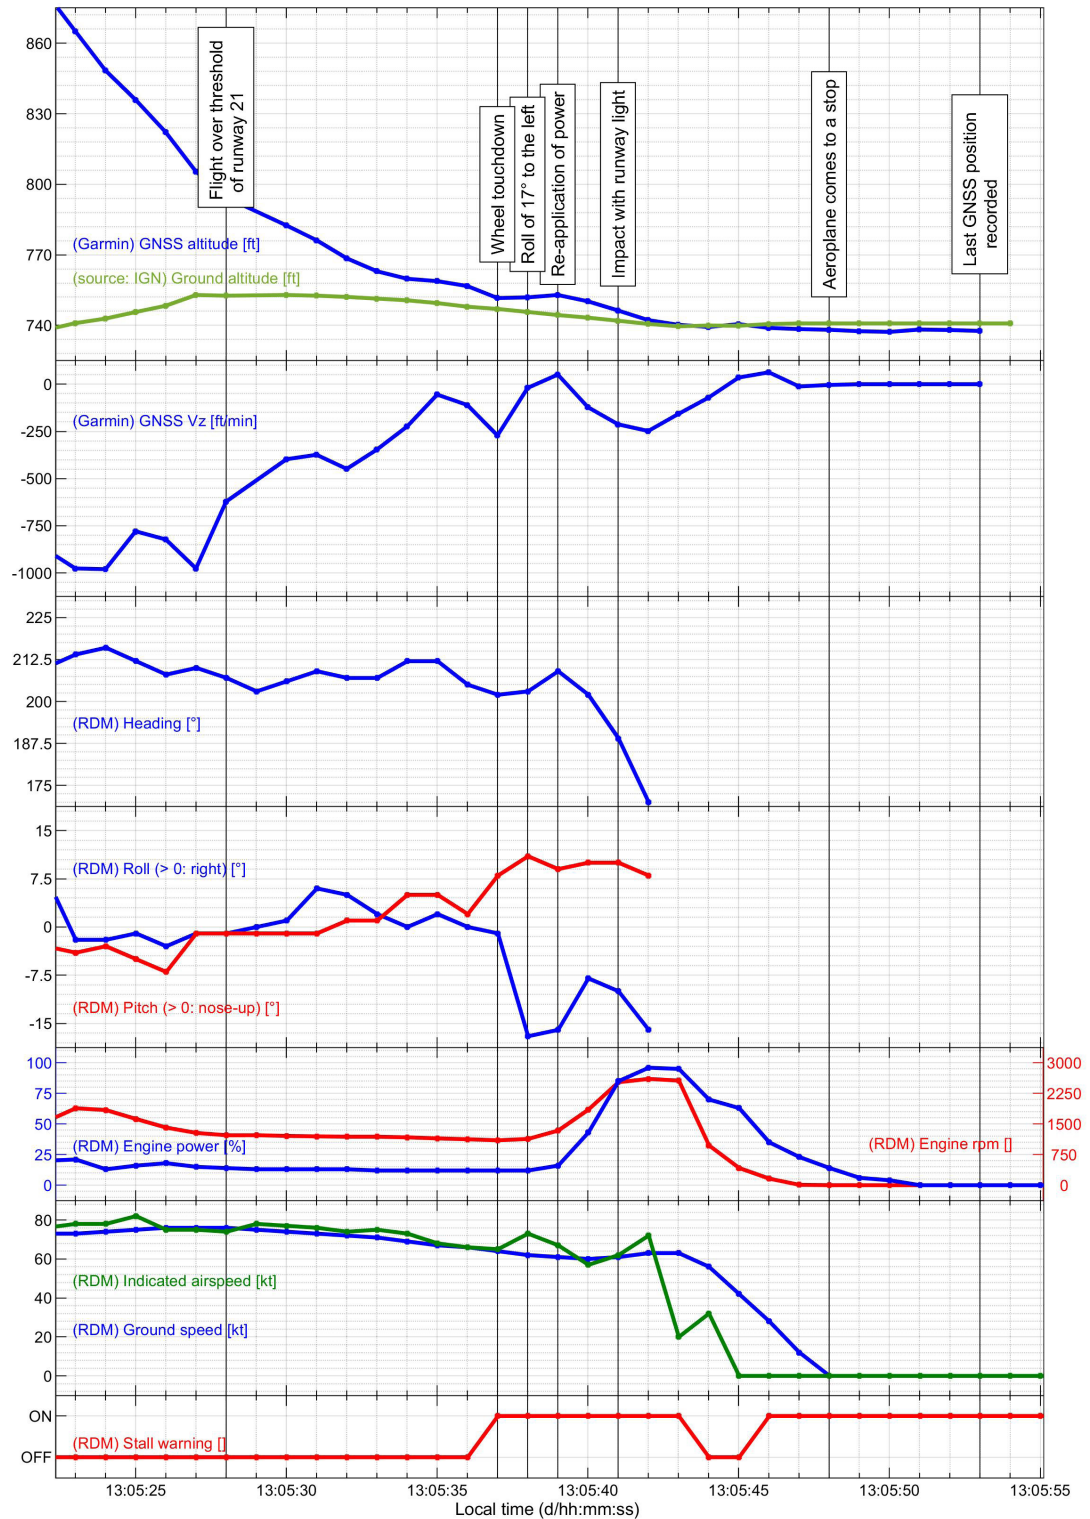
Figure 2: Parameters recorded from the threshold of runway 21

When flying over the runway threshold at 13:05:28, the aeroplane was at a height compliant with standard procedures, on the runway centreline, in the "100% flap" configuration, and the indicated airspeed was consistent with that recommended in the flight manual.

Throughout the final approach and at the moment the wheels touched down, the wind calculated by the G1000 avionics system was consistent with the Météo-France forecasts, i.e. an average wind of 12 kt from 250°.

When the wheels touched down at 13:05:37, the aeroplane had a nose-up attitude of 8° and the stall warning sounded.

At 13:05:38, a roll of 17° to the left and a nose-up attitude of 11° were recorded. One or two seconds later, the pilot re-applied power. The yaw of the aeroplane increased to the left. The stall warning remained active.

At 13:05:41, the left wing tip of the aeroplane hit a runway light.

At 13:05:48, the aeroplane came to a stop.
