Accident to the FLIGHT DESIGN - CTSW identified 83AGL

on 6 August 2020
at Cruis (Alpes-de-Haute-Provence)

Go-around during landing, loss of control, collision with the ground, fire

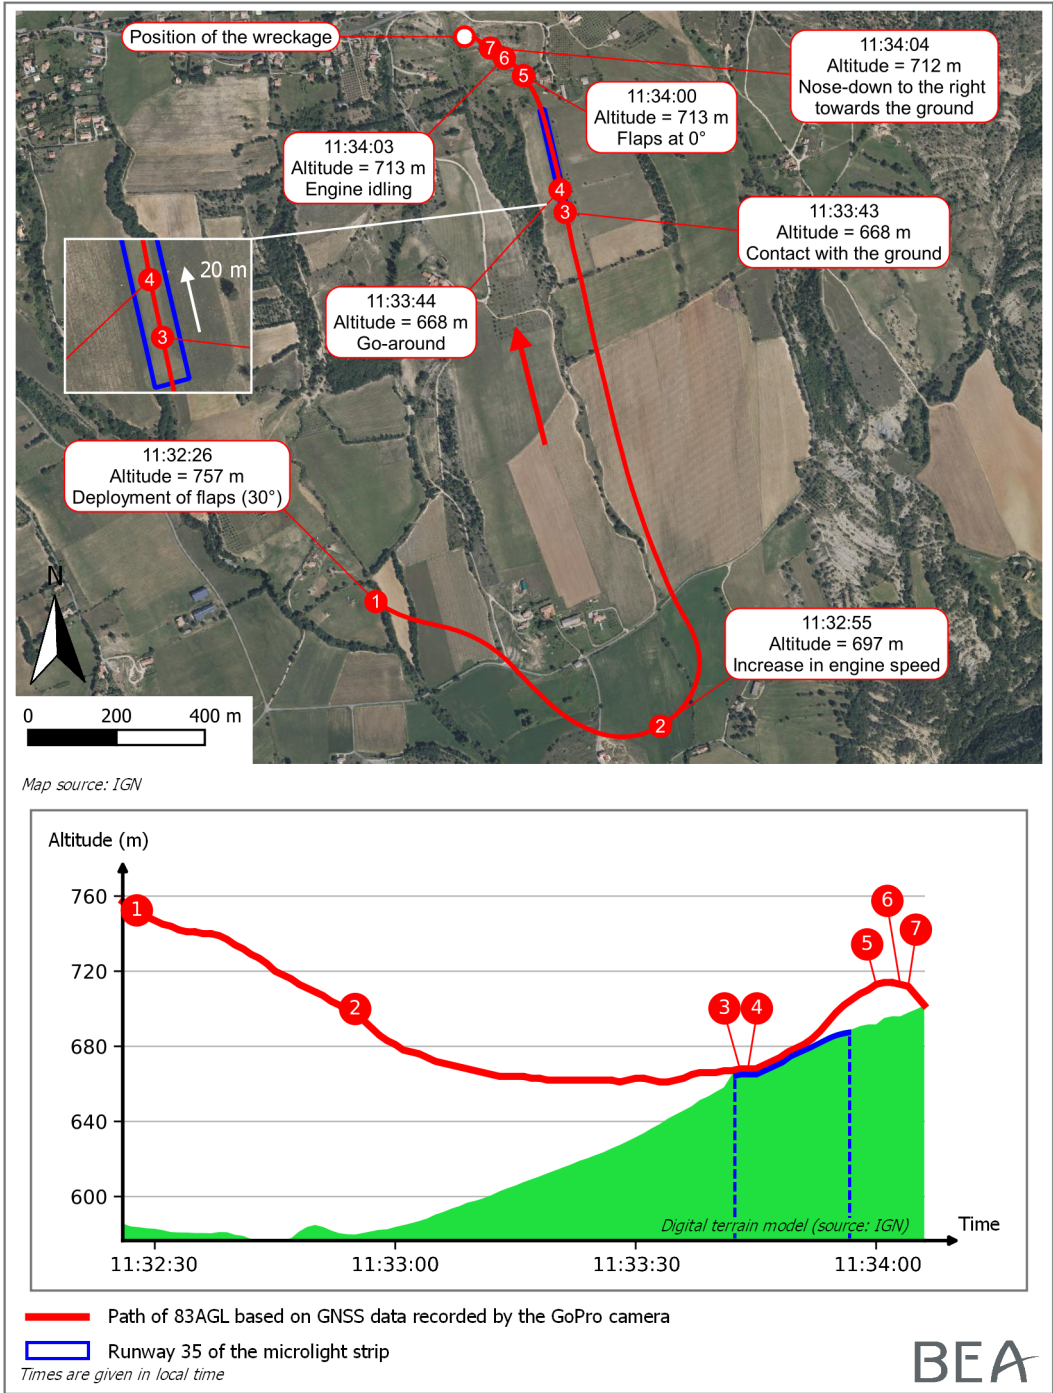
Figure 1: Path of end of flight

The camera recorded the associated GNSS data for each image. This data was used to reconstruct the flight path of the microlight before it collided with the ground (see [Figure 1](#)).

This path shows that, during final, the approach path was not stabilised. In addition, significant variations in engine speed were recorded during the final approach up to the moment the wheels touched down.

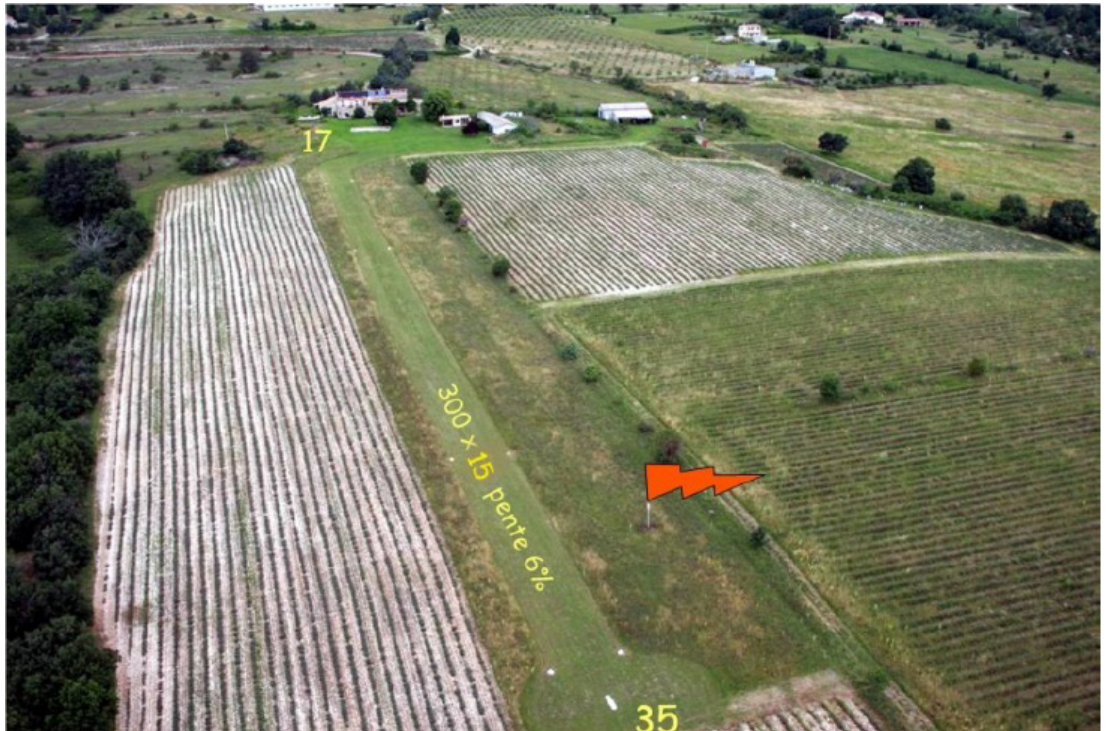
Figure 2: Annotated view of strip

Cruis Mas des Grailles strip is a private microlight base comparable to a mountain airstrip⁽³⁾. It is located at an altitude of 690 m and has a 300 m-long grass runway oriented on 17/35. Landing must take place on runway 35, which has a +6 % slope.

The main building at Mas des Grailles is located approximately 25 m from threshold 17, close to a group of trees approximately five metres in height and in the direct extension of the runway.

The microlight strip chart was updated and now includes wording prohibiting the practice of a go-around beyond a certain ground marker.
