Accident to the AVIAKIT Vega 912 T identified 84FK

on 15 August 2020

at Saint-Martin-de-Londres (Hérault)

Collision with vegetation during a low pass, loss of control, collision with the ground

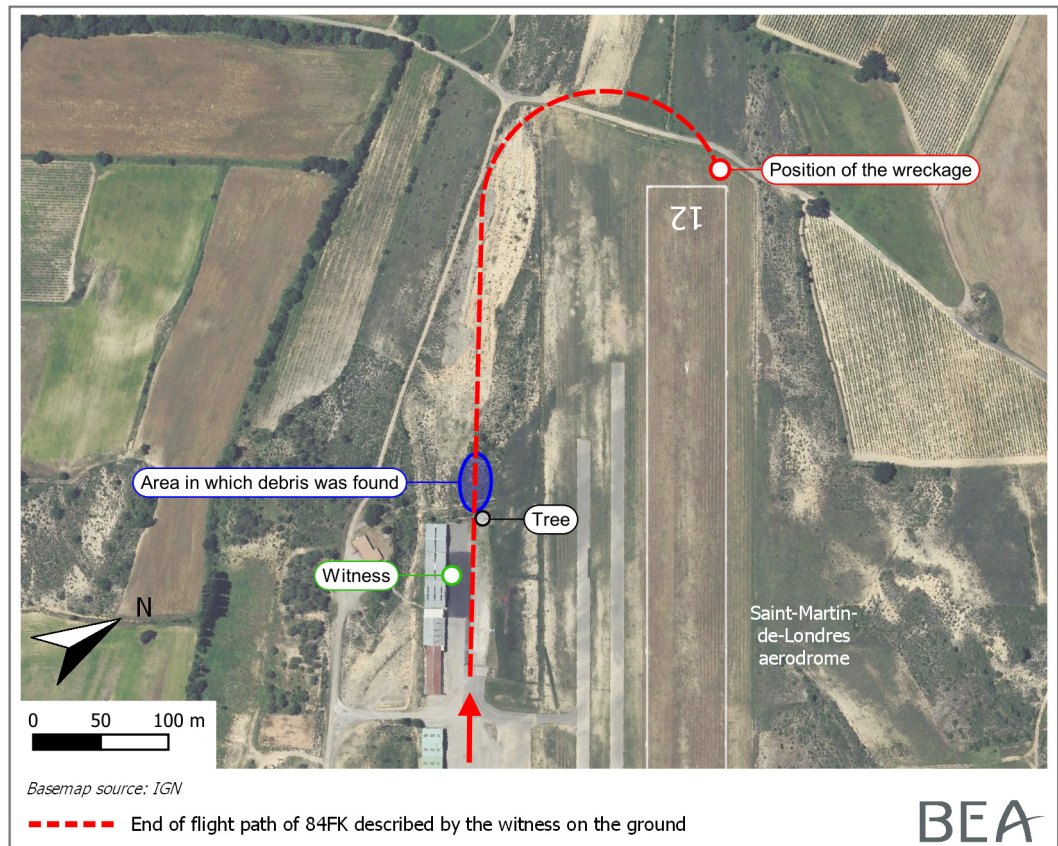
A witness on the ground, who had been opening the doors on the runway side of a hangar at the aerodrome, saw 84FK fly over at a height that he estimated to be between 5 and 15 m, coming from the east, on a path parallel to the runway and over the paved apron in front of the hangars (see [illustration](#)).

As it was flying between the hangars and a tree, the microlight hit the tree with its right wing. A section of the wing broke off. After the collision with the tree, the witness saw the microlight adopt a nose-up attitude and gain altitude before turning right after reaching a height of around 50 m. During the right turn, when the microlight's path was in the direction of the centreline of runway 12, the witness saw the microlight tilt onto its right side and fall with a path that he estimated to be, from where he was standing, in a spin and practically vertical.

The microlight collided with the ground near the threshold of runway 12 and caught fire.

End of the path

Parts corresponding to a section of the microlight wing were found in the axis of the flight path described by the witness on the ground, approximately 15 m from the tree (see [illustration](#)). The debris found included a section of fabric from the lower surface marked with the microlight's identification number.

A branch on the tree was found to be broken off at a height of around 10 m.

The distance between the tree and the hangar was estimated to be 22 m. The tree was 120 m from the edge of the runway.
