Accident to the SCHEMPP HIRTH - VENTUS 2B registered F-CIJT

on 19 August 2020

at Saint-André-les-Alpes (Alpes-de-Haute-Provence)

Loss of control in slope soaring flight, collision with the terrain

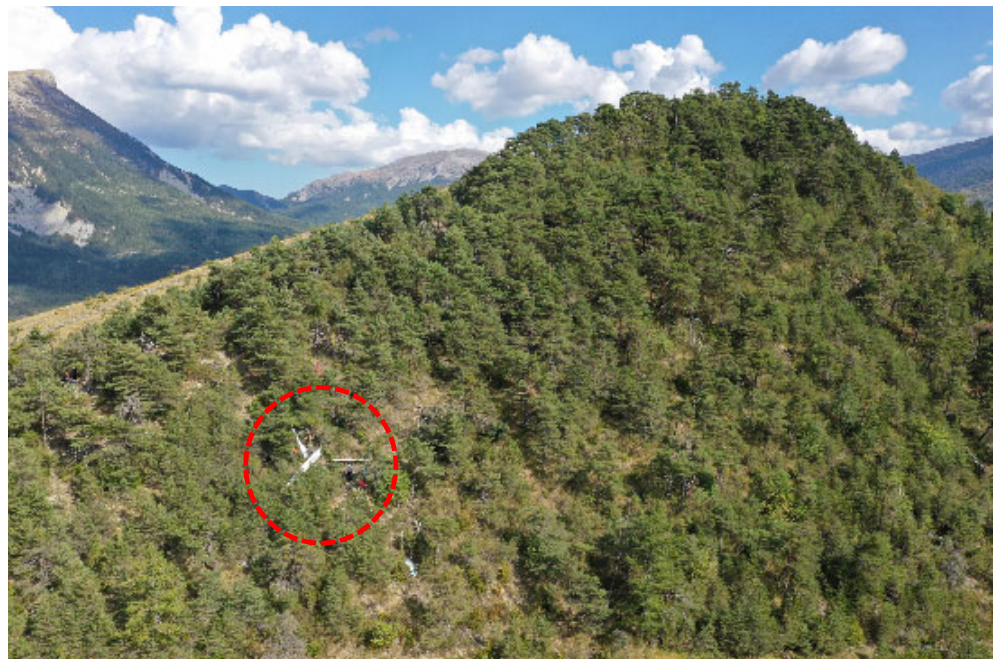
Figure 1: Aerial view of the site and the position of the wreckage from a drone

The wreckage was located at an altitude of 1,089 m in an area of forest on the western slope of the terrain, 40 m below the Grau ridge (see Figure 1). The glider struck the vegetation with a low horizontal speed, on a nose-down path, before the nose of the glider collided with the ground. The examination of the wreckage indicated that the glider was complete before the impact. The front part of the fuselage was destroyed (longitudinally compressed); the instrument panel was destroyed, and the instruments could not be examined. The high level of energy upon impact meant the pilot's chances of survival were slim.

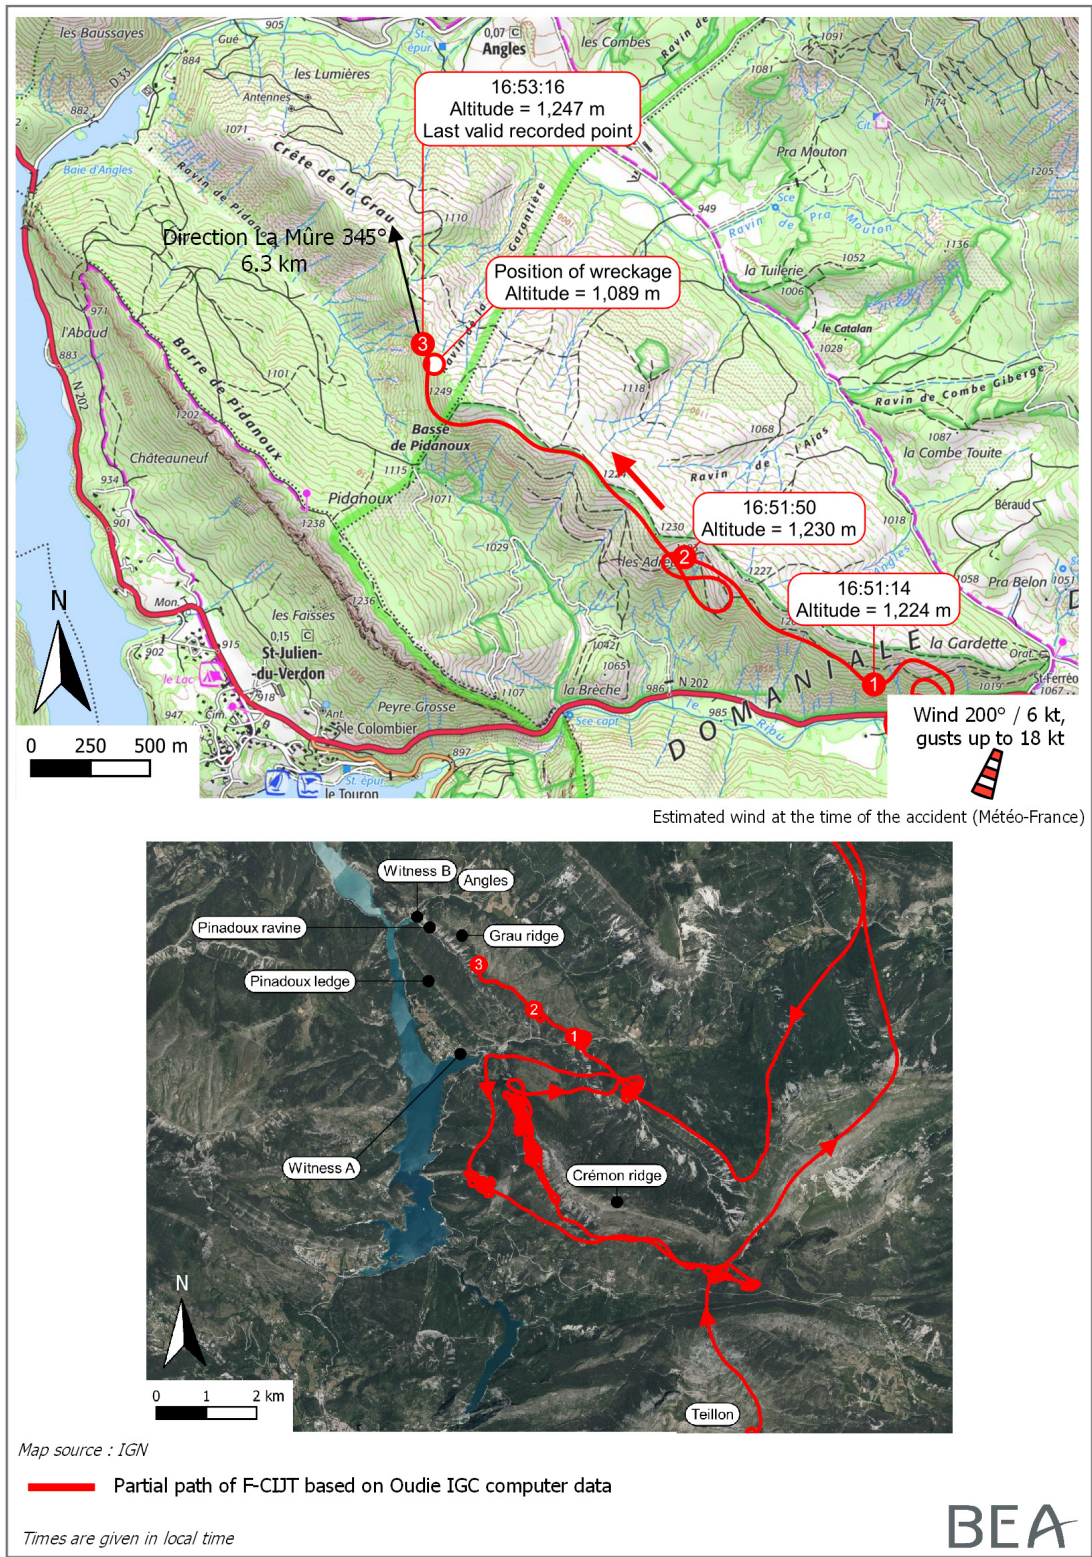
Figure 2: F-CIJT's flight path

On the return leg to the departure aerodrome, the pilot followed more or less the same route as on the outbound leg, and flew at an altitude of 2,800 m in the Allos Valley. According to the chief-pilot of the Association Aéronautique Provence Côte d'Azur (AAPCA), this altitude is not sufficient to reach the aerodrome directly from this position. As he was unable to cross the Teillon located south of his path, it seems that the pilot tried, unsuccessfully, to bypass it to the west. He turned around and came back to use the uplifts on the western slope of the Crémon, then above terrain located east of the Crémon. At about 16:50, he entered the valley located between the Pidanou ledge and the Grau ridge at an altitude of 1,200 m (see Point ❶ in [Figure 2](#)). From this moment on, the pilot was no longer in the vicinity⁽⁴⁾ of the La Mûre safe landing area⁽⁵⁾, even with a lift-to-drag ratio of 35. The area overflown by the glider was wooded, and from the altitude at which it was flying, it could not reach any area suitable for an off-airfield landing.

During the last two minutes of flight which were recorded, the glider was slope soaring in a north-westerly direction, at an altitude of between 1,235 m and 1,250 m, and it used uplifts, making a figure-of-eight on the western slope of the Grau ridge (see Point ❷ in [Figure 2](#)). At the end of the path recording, the glider was overhead a ravine located at the edge of a forest (see Point ❸ in [Figure 2](#)). It was then in the vicinity of the La Mûre safe landing area again.

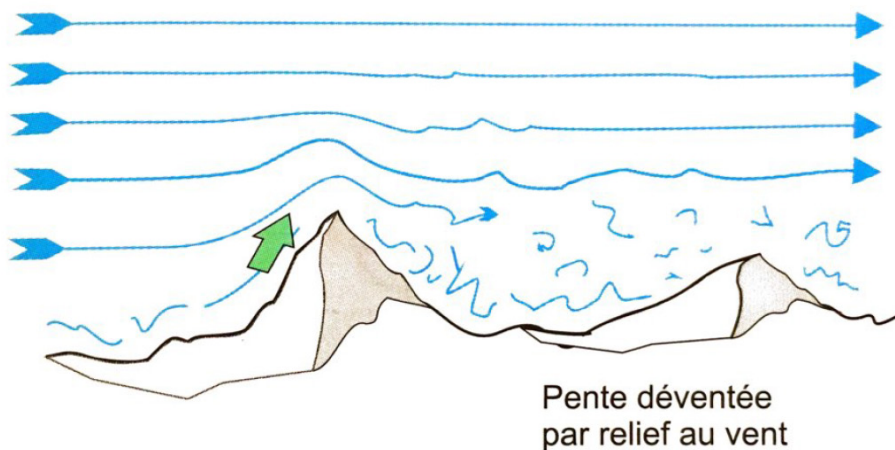
Figure 3: Slope shielded from the wind by a windward terrain

The *Manuel du pilote vol à voile* states that a slope, theoretically conducive to a slope effect, may be downwind of another fairly close terrain. In this case, the slope can be “masked” from an aerological point of view. The uplifts are weak and irregular, or even non-existent⁽¹⁰⁾. In the same way, the mountain wave induced by a windward terrain can destroy the slope effect on the leeward terrain. Therefore, the pilot should not hesitate to cancel the purpose of the flight. Good anticipation of the decision to turn around is essential.

The Grau ridge was located downwind to the east of the Pidanoix ledge, another terrain reaching 1,238 m at its highest point. At the time of the accident, the Grau ridge was probably “masked” from an aerological point of view (shielded from the wind) and the uplifts were probably weak and irregular.

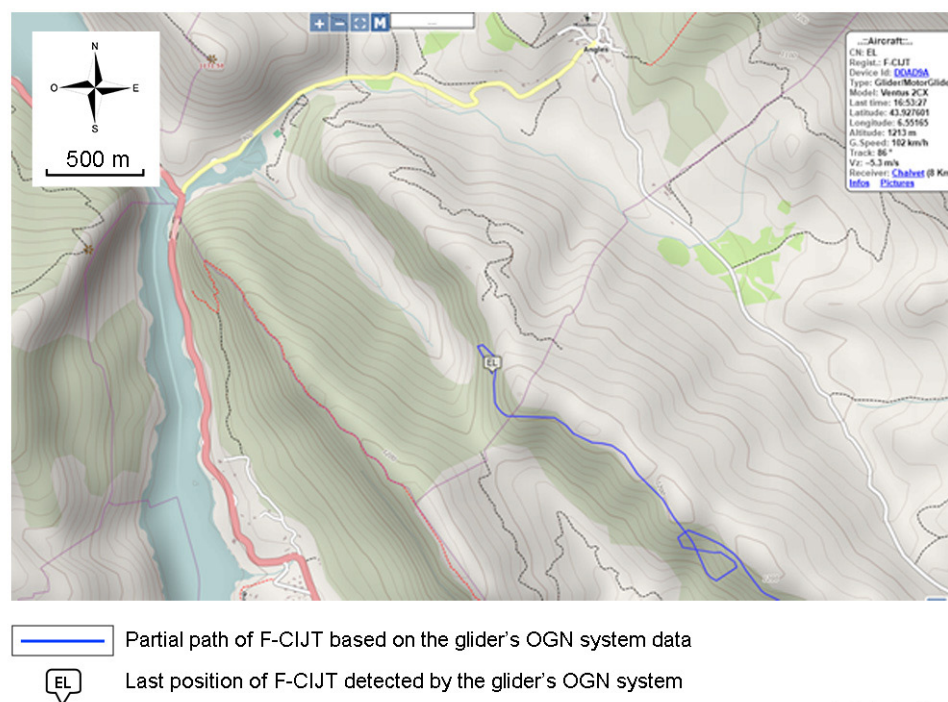
Figure 4: Path and last position transmitted by the OGN operator to the ARCC Lyon

At the same time, and separately from the above, the AAPCA chief-pilot, who had not seen the pilot return, telephoned the ARCC Lyon at around 20:10, using the gliding centre's to-do instructions. The glider was equipped with a FLARM, so the ARCC Lyon retrieved the last known position of the glider from the OGN GLIDERNET system operator at around 20:15. The latter indicated that the system's detection was good in this valley and that the position of the wreckage was almost certain (see [Figure 4](#)), since the glider's signal was still being received and was stationary.

The head of the department's Fire and Rescue Service (SDIS 04) stated that the CODIS and fire station staff did not have good knowledge of the ARCC Lyon resources to locate an aircraft. The fact that the ARCC Lyon was not informed by the CODIS 04 of the possible occurrence of an accident did not enable the CODIS to benefit from the specific tools at the disposal of the ARCC Lyon that could be used to quickly determine the probable accident area. This was only done once the chief-pilot transmitted the alert to the ARCC Lyon, nearly 2 hours and 30 minutes after the accident, and the glider was found less than 70 m from the last known position sent to the ARCC Lyon by the OGN system operator (see Figure 4, above).

The fact that the CODIS 04 implemented only local equipment and human resources initially, due to not having good knowledge of the specific resources available to the ARCC Lyon, caused delays in locating the wreckage. The resources available to the ARCC Lyon would have made it possible to remove any doubt about the actual occurrence of the accident and to determine its position more quickly. The ARCC Lyon can be contacted, in particular by the emergency services, even in the event of a simple doubt about the occurrence of an accident.

Following this accident, the Alpes-de-Haute-Provence prefecture decided to amend the specific SATER provisions for its department. It is planned to produce to-do instructions based on the new document in order to update the operational documentation of the services involved in search and rescue missions, so that these services systematically alert the ARCC Lyon.
