## Accident to the TeST TST-3 ALPIN TM<sup>(1)</sup> identified 32DH

on 31 August 2020

at Condom Valence-sur-Baise (Gers)

### Loss of control in initial climb, collision with the ground

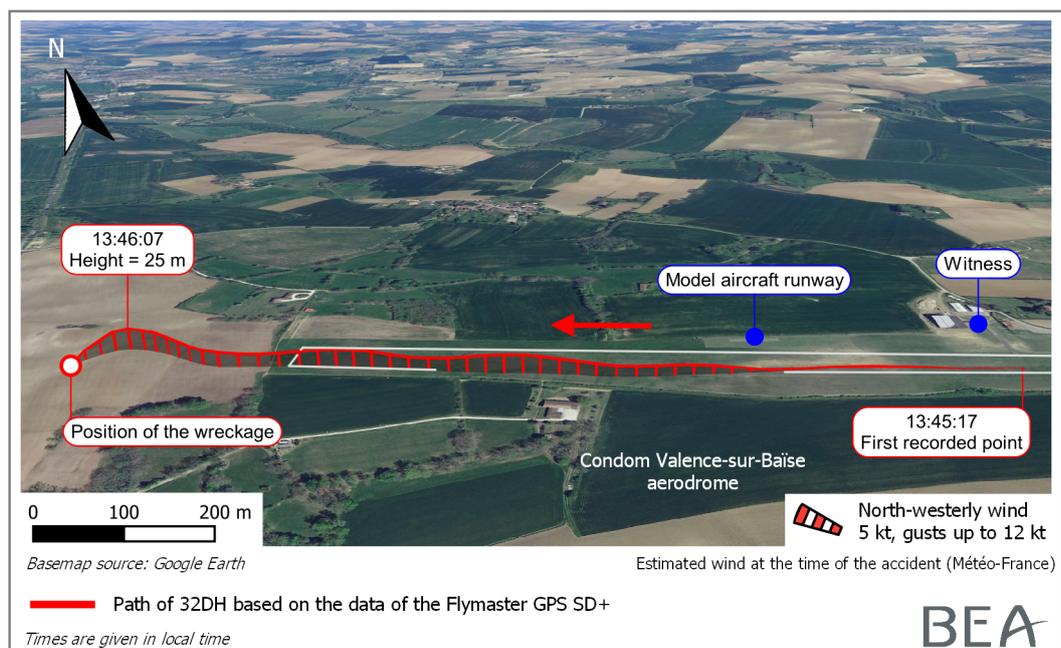
Path

The read-out of this data shows that the pilot performed a short level flight acceleration (lasting two to three seconds) after take-off and that the ground speed of the microlight, after take-off, averaged 70 km/h.
