Accident to the MAGNI M24 PLUS identified 49ABZ

on 31 August 2020

at Saumur - Saint-Florent (Maine-et-Loire)

Loss of control in initial climb, collision with the ground, fire

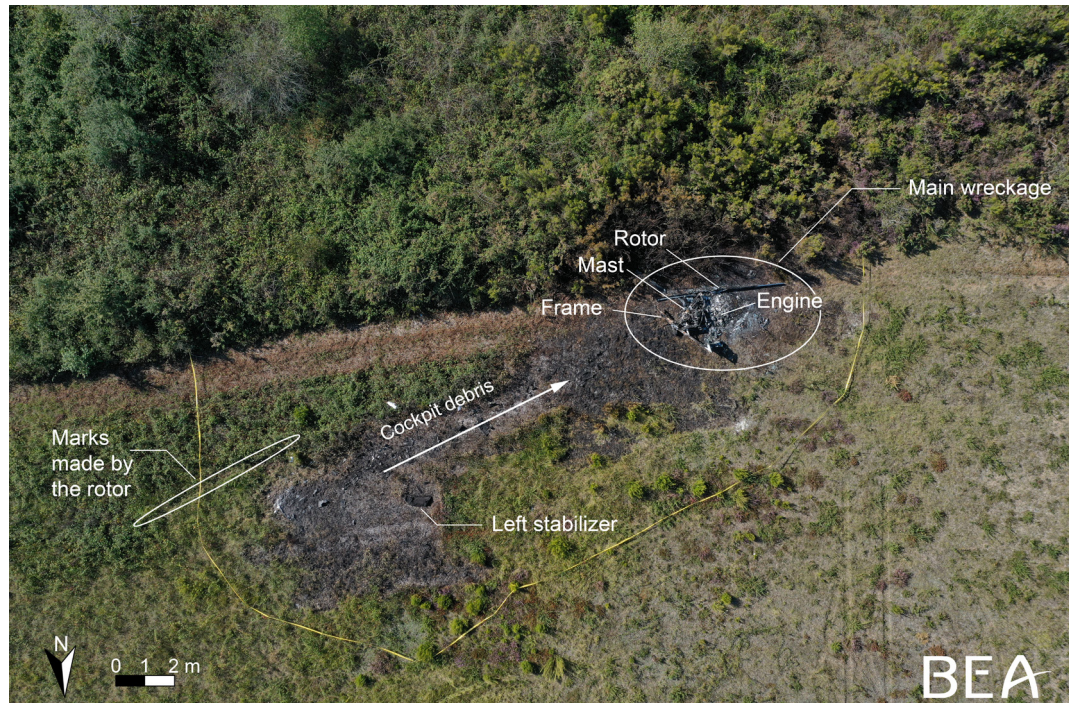
Figure 1: Aerial view of the accident site

Marks left by the main rotor and the airframe in the vegetation at the edge of the aerodrome are consistent with a microlight steeply banked to the left and with a nose-down attitude just before the collision with the ground.

Damage caused by the fire restricted the observations of the wreckage. The position of the elevator trim in particular could not be checked. However, it was possible to determine that:

- the microlight's flight control linkages were continuous;
- the engine was producing power at the time of the collision.

No anomaly that could explain the accident was identified.

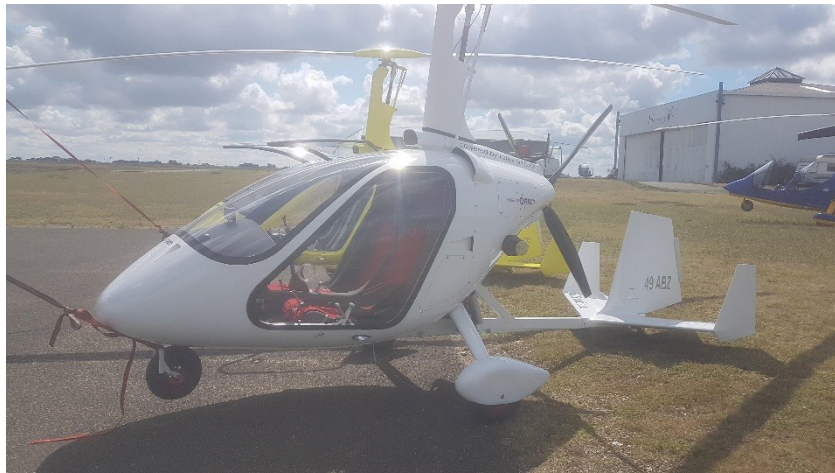
Figure 2: Gyroplane identified 49ABZ

The microlight identified 49ABZ was a Magni M24 Plus gyroplane, equipped with a Rotax 915 IS engine delivering a maximum power of around 140 hp and with a composite four-bladed propeller. The Magni M24 Plus has two seats in side-by-side configuration.
