## Accident to the ROBIN - DR400 – 120 registered F-GIKZ

on 12 September 2020

at Arcachon - La Teste-de-Buch (Gironde)

### Take-off outside weight and balance envelope, flying on backside of power curve during initial climb, loss of control in flight, collision with the ground, fire

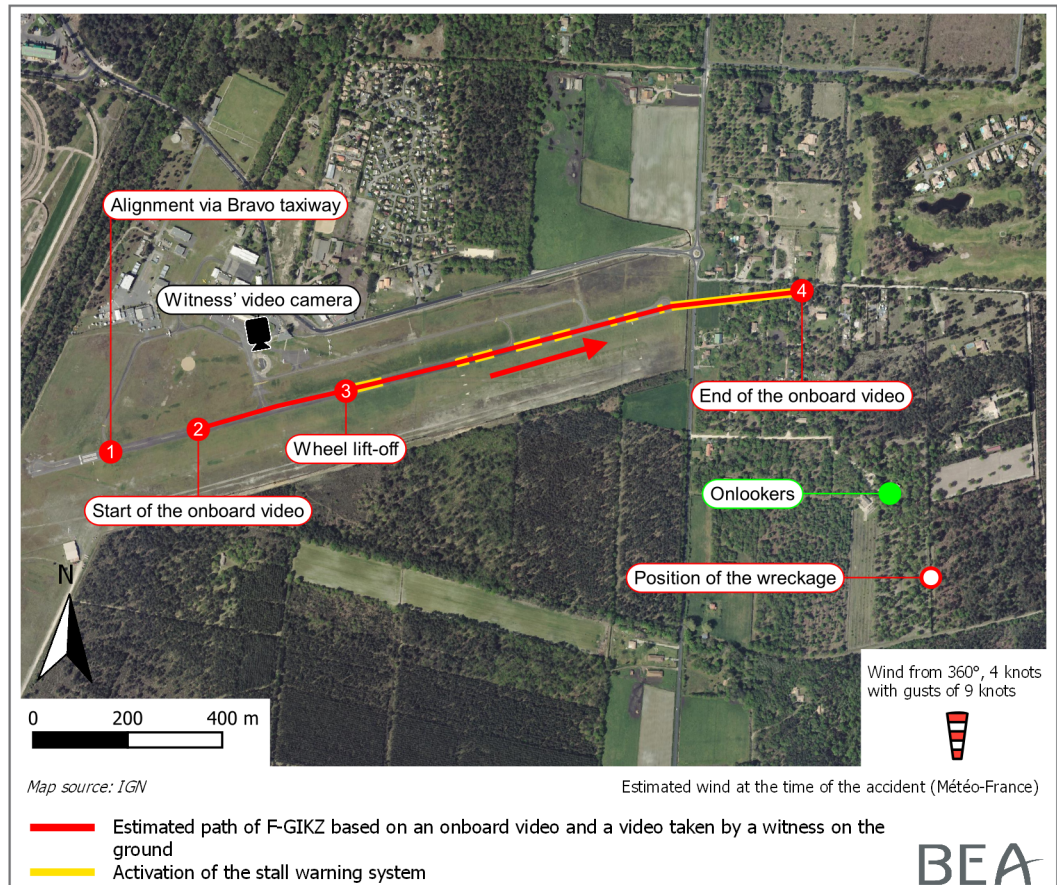
Wheel lift-off occurred around 500 m after the alignment (point [3](#) [Figure 1](#)), at an indicated airspeed of 110 km/h and with a significant variation in nose-up attitude. During the rotation, the pilot turned around to speak to the passenger seated to his right and his attention was not on the flight parameters.

Figure 1: Estimated path of the aeroplane based on video footage

The wreckage was found in a wooded area, near the airport (see Figure 1). The aeroplane struck the top of a 12 m-tall tree and came to a stop approximately 20 m from the tree in a ditch approximately 2 m deep. The wreckage was complete and not dispersed. The examination of the wreckage indicated that the aeroplane had probably hit the ground with a nose-down attitude on a downward slope.

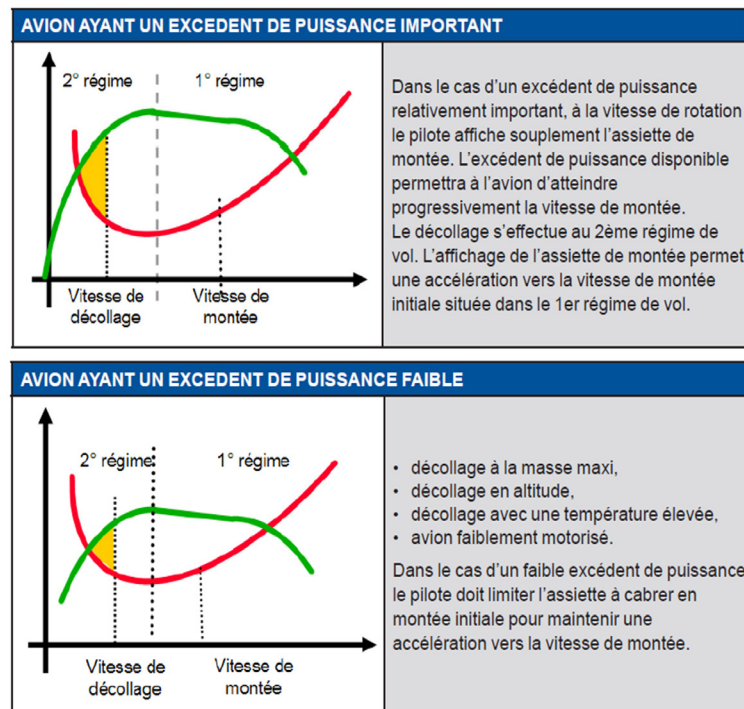
Figure 2: VFR instructors' guide  
Green curves: power output  
Red curves: power required

A pilot who maintains a low climb speed with a steep attitude can therefore find themselves in a situation in which the aeroplane does not have enough power to accelerate to the power required curve and continue the climb. In the presence of an obstacle in the path, the pilot's instinctive reaction may be to increase the attitude to attempt to fly over the obstacle. This action, which increases the angle of attack, exacerbates the phenomenon (watch the IASA's video: <https://vimeo.com/210931589#t=6m30s>).

In a dynamic situation, this phenomenon may be perceived by the pilot as a partial loss of engine power.
