Accident to the ROBIN - DR400 - 140B registered F-GSBS

on 12 September 2020

at Col du Pas de la Coche, Belledonne Massif (Isère)

Transition to the backside of the power curve, collision with the terrain, post-impact fire, during a mountain BIA flight

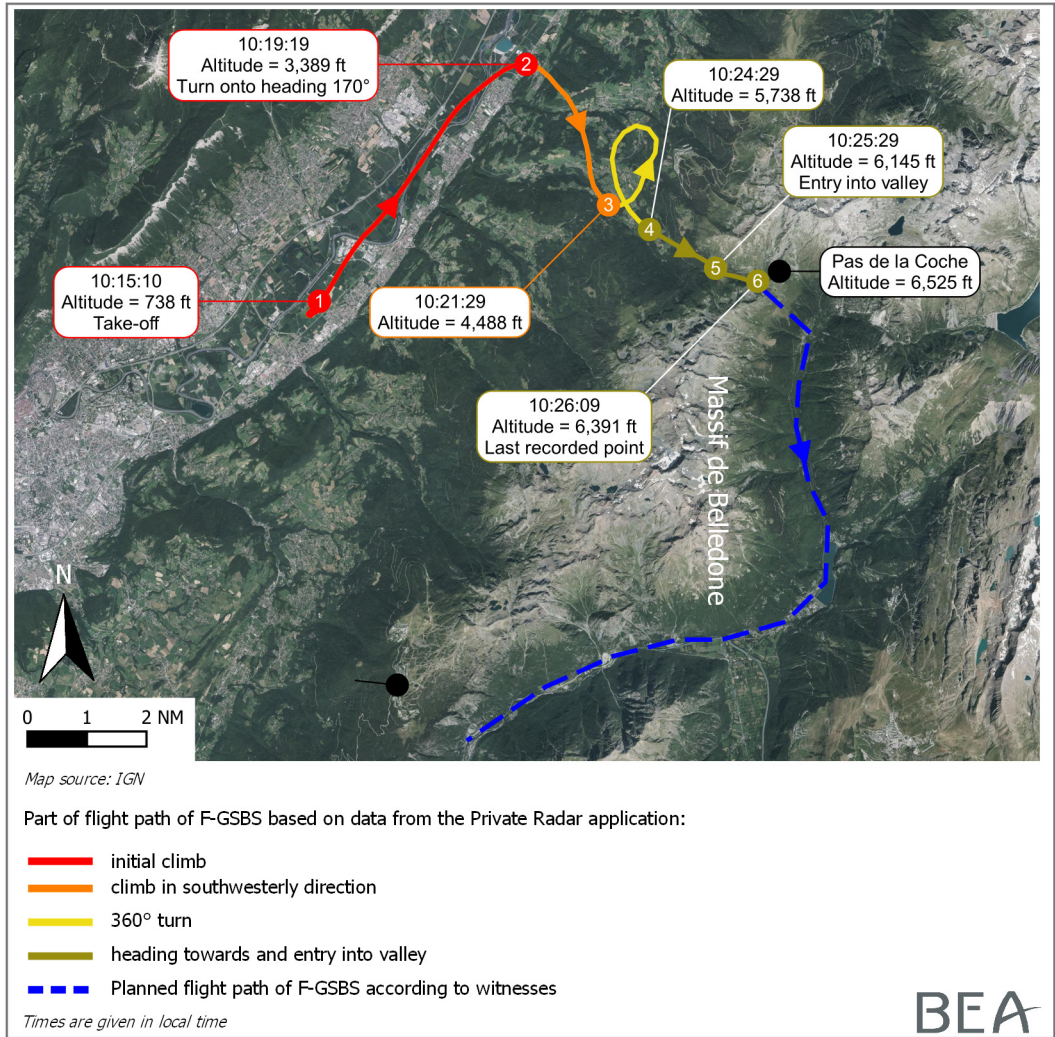
Figure 1: Path of the accident flight

At the end of the initial climb (see [Figure 1](#), point ②), the pilot turned right towards the south-east flying through an altitude of 4,500 ft (see [Figure 1](#), point ③), and made a 360° turn, at the end of which she had reached an altitude of 5,750 ft (see [Figure 1](#), point ④). She continued her route towards the south-east climbing for about three kilometres and entered the valley leading to the Pas de la Coche pass at an altitude of 6,150 ft (see [Figure 1](#), point ⑤). She flew through the centre of the valley below the ridge. She reached the bottom of the valley about thirty seconds later at an altitude of 6,400 ft. This altitude is lower than that of the pass. The aeroplane collided with the terrain about 100 metres below the pass (see [Figure 1](#), point ⑥), then caught fire.

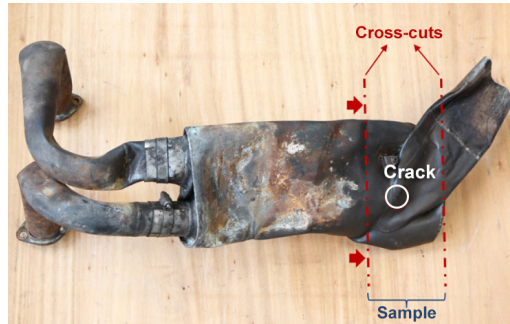
Figure 2: General view of the F-GSBS exhaust system

A detailed examination of the aeroplane's exhaust system revealed a crack in the exhaust outlet pipe, in line with its connection with the exhaust muffler (see Figures 2 and 3).

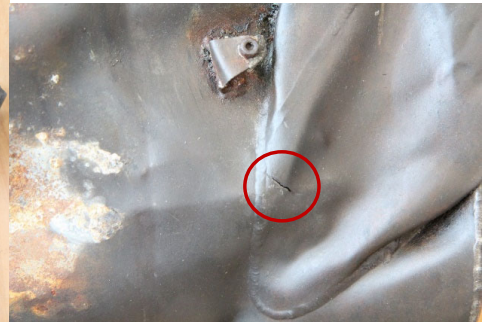
Figure 3: View of the crack

The metallographic examinations and chemical analysis of the area around the crack showed the initiation of a corrosion phenomenon which had then progressively developed during use of the exhaust pipe. This phenomenon most likely led to an incipient crack which then grew. It was not possible to determine when this crack appeared or its dimensions prior to the impact.

The opening resulting from this crack may have caused exhaust gases to leak into the aeroplane's engine compartment during the flight, possibly leading to a higher-than-normal carbon monoxide (CO) level.

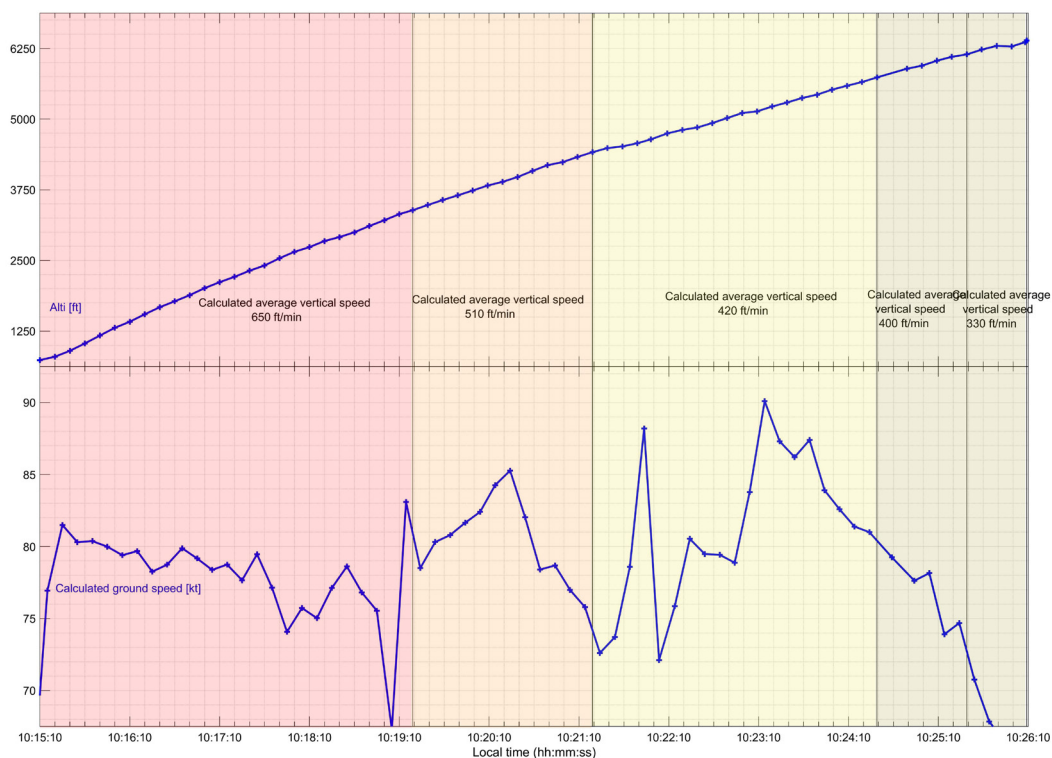
Figure 5: Parameters of the accident flight

At the end of the 360° turn (see [Figure 5](#), point ④), the pilot headed in a straight line towards Pas de la Coche. During the last two minutes of flight, the ground speed of the aeroplane decreased gradually from about 80 kt (see [Figure 5](#), point ④) to 65 kt (see [Figure 6](#), point ⑥). Assuming there was no wind influence and taking an altitude of 6,000 ft, the indicated airspeed of the aeroplane therefore decreased from 70 kt to about 55 kt⁽⁵⁾.

In addition, the average vertical speed, which was 420 ft/min during the 360° turn, dropped to 330 ft/min in the last 30 seconds⁽⁶⁾ to reach a value close to zero in the last seconds of the flight.

The decrease in speed combined with the low vertical speed value is characteristic of a transition to the backside of the power curve.
