Accident to the ROBIN - DR400-160 registered F-GMRV

on 13 September 2020
at Caussou (Ariège)

Management of the fuel selector, unpriming of the fuel system, reduction in engine power, forced landing on the side of a hill, during an introductory flight

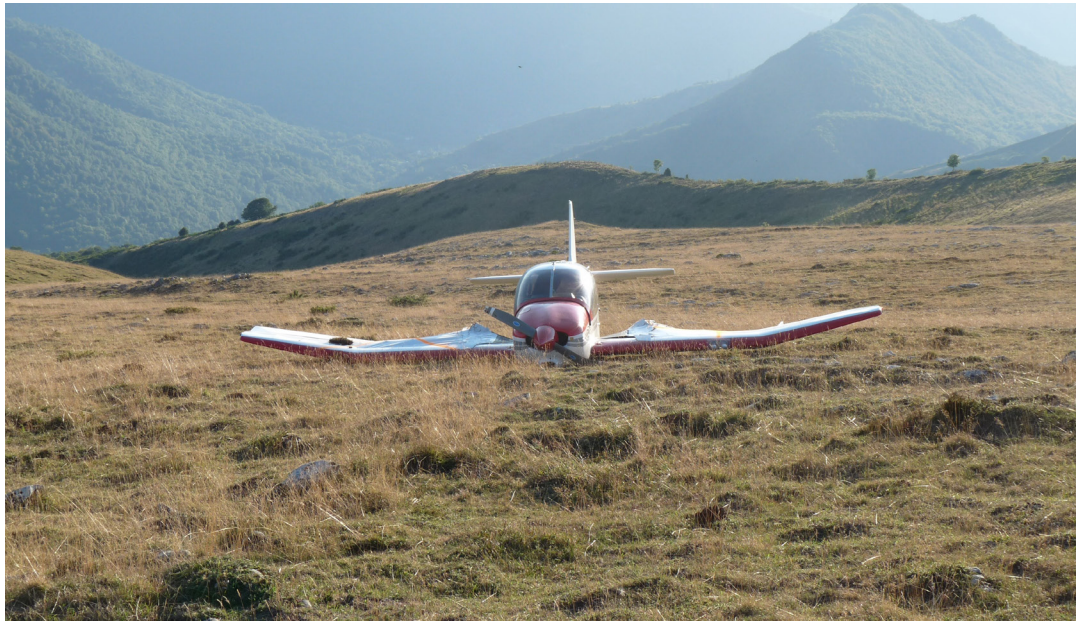
Figure 1: Accident site

The plane touched down, bounced then rolled around 20 metres before coming to a stop. The three landing gears were broken.

The accident site is a low mountain area, on a slope. The distance between the first impact and the wreckage was around 20 metres.

The damage observed on the propeller is compatible with the lack of power at landing.

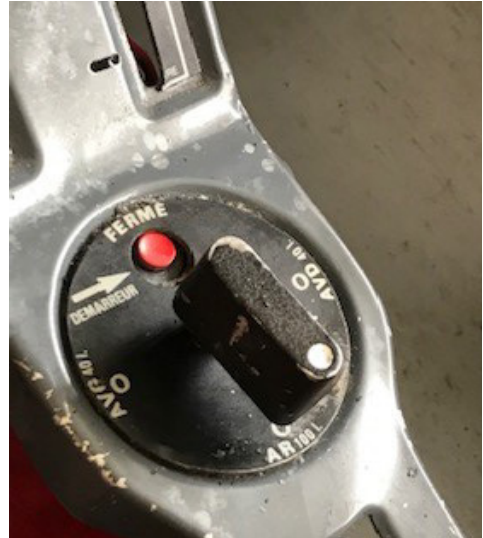
Figure 3: Fuel selector of F-GMRV

The tank selector was found blocked⁽³⁾ in the closed position. The LH wing tank contained 0.6 litres of fuel, the RH wing tank contained around 15 litres and the main tank contained 74 litres. The tanks were not deformed and were not leaking.

⁽³⁾ Due to the stresses and deformations suffered by the plane during forced landing.

The pilot stated that the fuel selector had been positioned on the main tank⁽⁴⁾ throughout the flight and that he had then selected the LH wing tank by activating the electric pump, then closed the fuel selector just before landing.
