Incident to the AIRBUS - A318 - 100 registered F-GUGM and operated by Air France on 12 September 2020 at Paris-Orly (Val-de-Marne)

This is a courtesy translation by the BEA of the Final Report on the Safety Investigation published in December 2021. As accurate as the translation may be, the original text in French is the work of reference.

Non-stabilized approach, activation of MSAW and Glideslope warnings

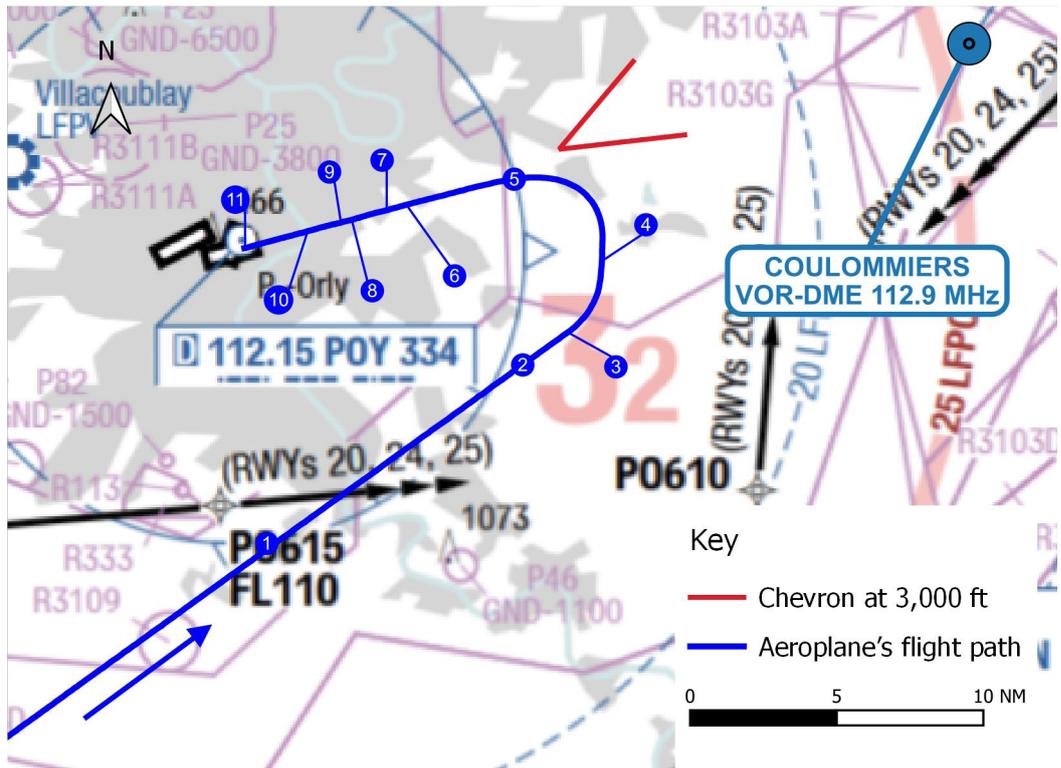
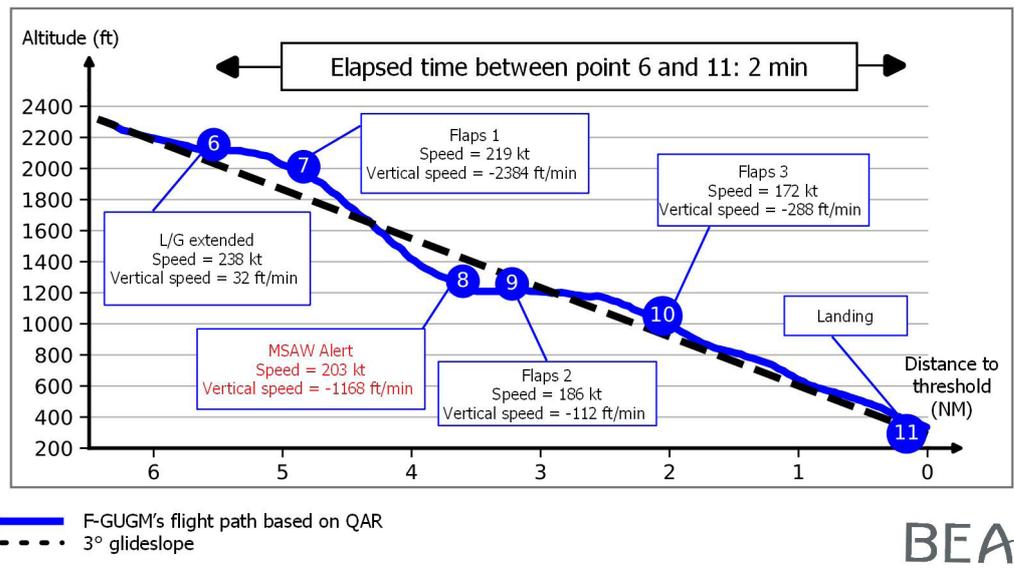
Figure 1: F-GUGM's flight path

At around FL 112 (point ① of [Figure 1](#)), the controller asked the crew if they were interested in having a shortened route. The co-pilot (PM) replied in the affirmative. The controller then asked the crew to take a direct heading to the CLM VOR and to descend to 3,000 ft QNH. At point ① of [Figure 1](#), autopilot AP1 was engaged in DES/NAV mode. The indicated airspeed of 250 kt was selected.

At around 8,700 ft (point ② of [Figure 1](#)), the controller told the crew to plan for a short circuit if they were interested, and to call back when ready for the base leg in around one minute's time. Approximately 30 seconds later (point ③ of [Figure 1](#)), the PM reported that they were ready to turn and the controller gave him an initial interception heading northwards. Then, at the PM's request (point ④ of [Figure 1](#)), the controller gave a second heading of 290°. The aeroplane's lateral guidance was then in HDG. The crew were cleared for the ILS approach for runway 25. The altitude of the aeroplane was 5,900 ft and the indicated airspeed 247 kt. The APPROACH (APP) mode and AP2 were then engaged. The Auto-THRust (A/THR) was in SPEED mode.

At 1,225 ft, around 940 ft AAL, at 3.2 NM from the threshold of runway 25, the PM selected CONF 2. At this point, he was in communication with the LOC controller who asked him to confirm that they were on the Glideslope. (Point ⑨ of [Figure 1](#)). He replied in the affirmative. Nine seconds later, at 1,185 ft, around 900 ft AAL, he selected configuration 3⁽¹⁰⁾. The indicated airspeed was 172 kt i.e. VAPP+46 kt (point ⑩ of [Figure 1](#)).

The indicated airspeed reached VAPP 180 m after flying over the runway threshold at a height of 10 ft. The thrust levers were put in the IDLE detent at 6 ft. The aeroplane landed on the runway, at 380 m from the threshold at an indicated airspeed of 123 kt (point ⑪ of [Figure 1](#)).

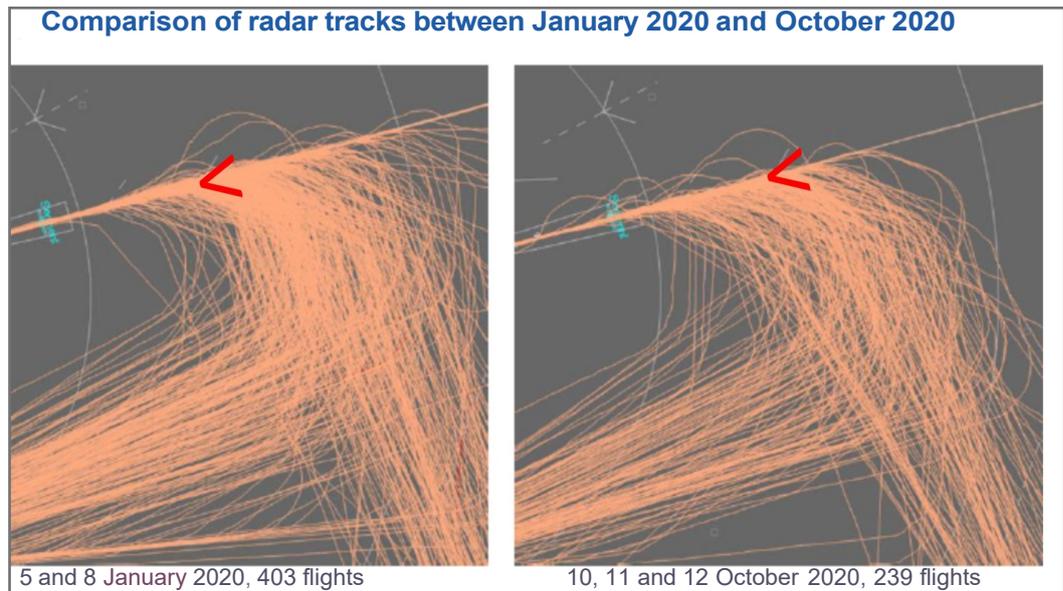
Figure 3: Comparison of radar tracks for Orly runway 25 in January 2020 (before health crisis) and in October 2020

The radar tracks below provided by the air navigation services at Paris-Orly airport, show that in the period of low traffic linked to the health crisis (see [Figure 3](#), right image, for 10, 11 and 12 October), the average vector brought the aeroplanes onto the ILS (Localizer) path of runway 25 closer to the interception point of the nominal Glideslope than in normal times (see [Figure 3](#), left image, for 5 and 8 January 2020).

Orly airport statistics indicate that for runway 25, the average Localizer interception speed was 166 kt in January 2020 (before health crisis period) and 194 kt in September 2020 (during health crisis period).

Lastly, 12 MSAW on final were recorded from January 2019 to February 2020 and 8 between March 2020 and December 2020, i.e. five times more warnings of this type (in relation to the number of flights) during the health crisis period.
