Accident to the CIRRUS - SR22 registered N918SE

on 28 September 2020
at La Chevillotte (Doubs)

Non-stabilized approach, loss of control during missed approach, collision with ground then fire

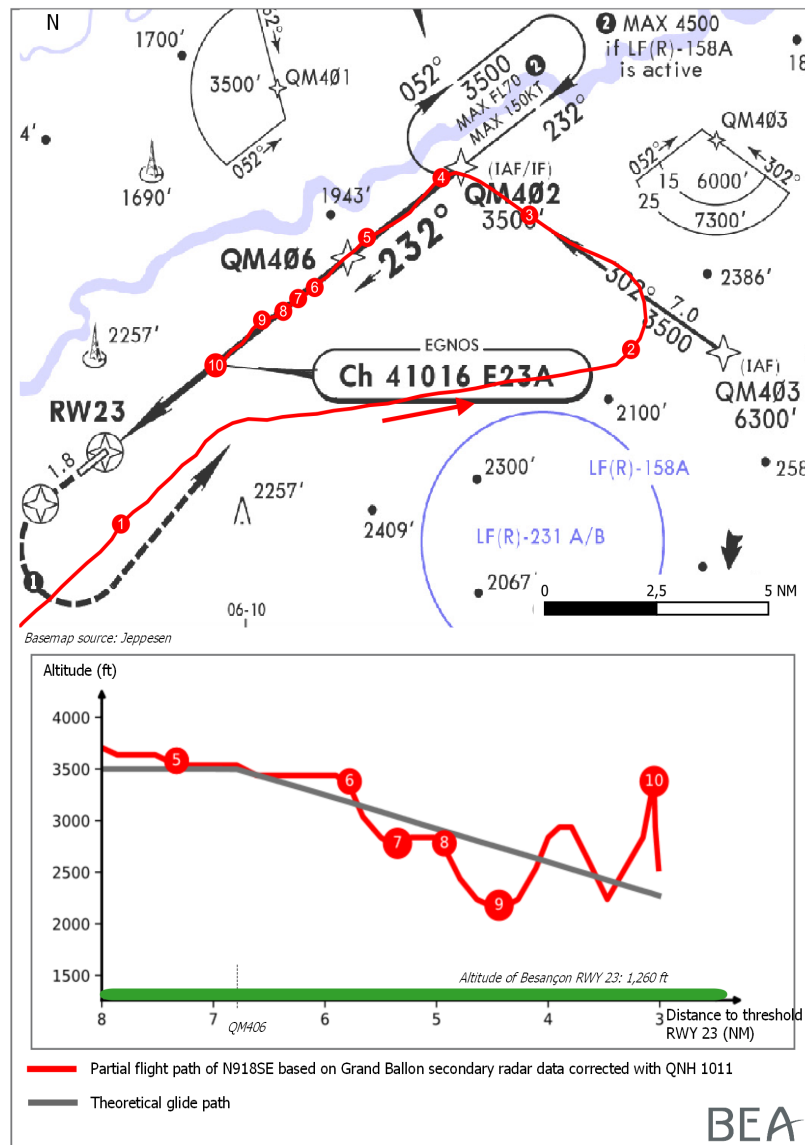
At 12 NM from QM403 (refer to [Figure 1](#), point ❶), the controller asked the pilot to head towards QM403 and to descend as he wishes. The vertical descent speed was 500 ft/min, the ground speed was around 180 kt. The aeroplane passed abeam QM403 at 6,500 ft (refer to [Figure 1](#), point ❷).

At around 2 NM from QM402 (refer to [Figure 1](#), point ❸), the rate of descent increased with a vertical speed of the order of 1,250 ft/min, the ground speed decreased to 130 kt. The aeroplane passed QM402 at 4,300 ft. A few seconds later, the vertical descent speed decreased to 500 ft/min (refer to [Figure 1](#), point ❹). The pilot then contacted the aerodrome's AFIS officer to give him his position. Around 30 seconds later, the AFIS officer told the pilot that he had switched on the lighting to maximum brightness (Precision Approach Path Indicator (PAPI) and runway). The pilot replied that he was going to finish with the "LVP"⁽²⁾.

At 10:16:03, at 0.6 NM from QM406 (corresponding to the final descent fix), the aeroplane levelled off at 3,500 ft (refer to [Figure 1](#), point ❺). Fifteen seconds later, the aeroplane exceeded QM406. The final descent was started 30 s later, with a vertical descent speed of 1,400 ft/min. The aeroplane was then around 1 NM beyond QM406 (refer to [Figure 1](#), point ❻). The ground speed decreased to 95 kt. At 5.5 NM from the threshold of runway 23 (refer to [Figure 1](#), point ❼), the aeroplane levelled off at approximately 2,800 ft; at this point it was

At approximately 10:17:25, at 5 NM from the runway threshold, the aeroplane intercepted the glideslope (refer to Figure 1, point 8). The aircraft resumed the descent with a vertical speed in the order of 2,000 ft/min.

At 10:18:35, at an altitude of 3,330 ft (approximate height of 2,000 ft) and at 3 NM from the runway threshold (refer to Figure 1, point 10), the aeroplane suddenly started losing altitude. The witnesses saw the aeroplane come out of the cloud layer, in a spin, and then disappear behind trees five seconds later. They saw the activation of the parachute rocket but the parachute did not have time to open.
