## Accident to the COMCO IKARUS C42 - C identified 64ADG

on 30 September 2020

at Itxassou (Pyrénées-Atlantiques)

## Evasive manoeuvre, loss of control, collision with terrain, fire, while being towed

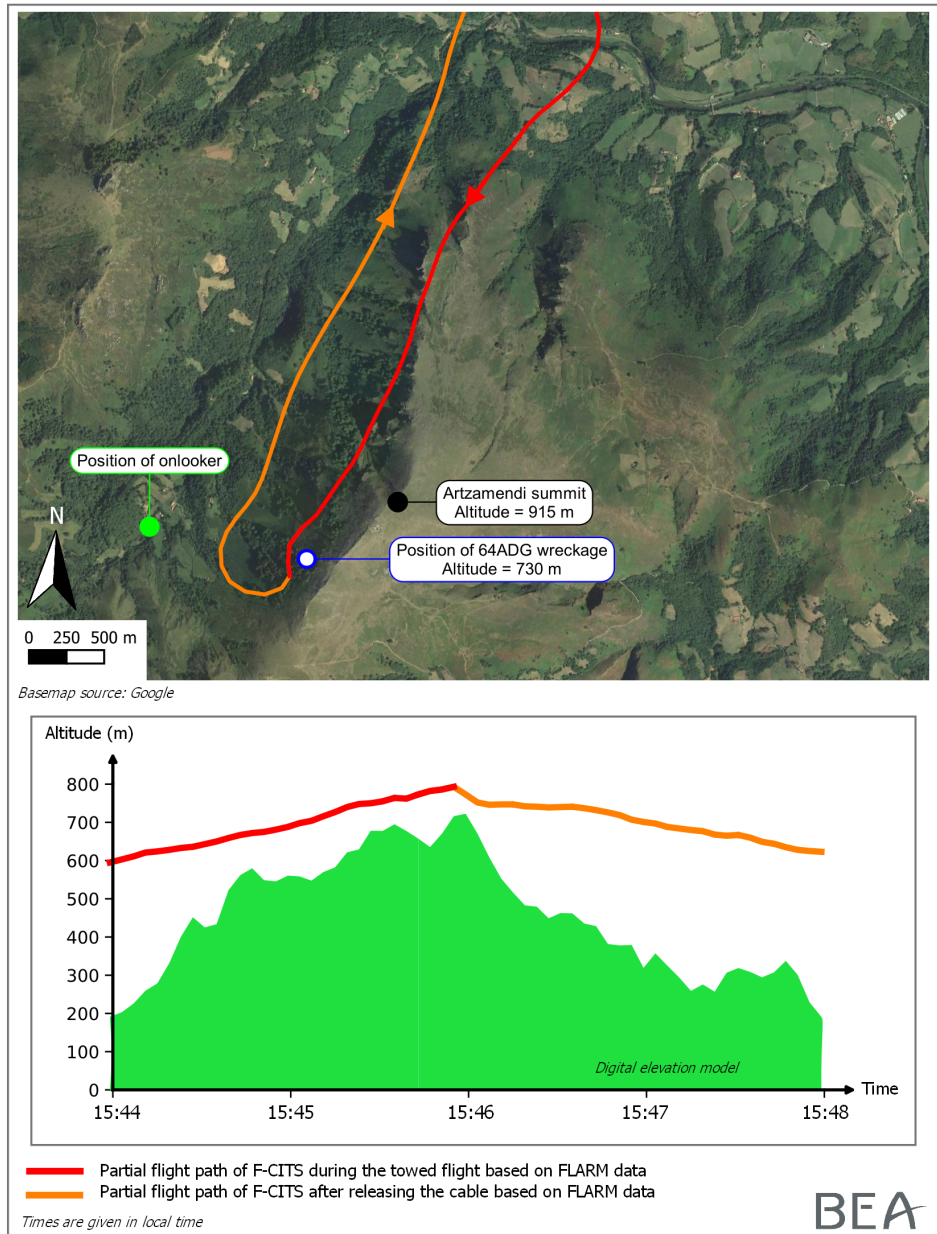
Glider's path

The glider was equipped with a FLARM computer. Reconstruction of its path was possible based on data from the computer read-out.
