## Accident to the Schweizer 269C-1 registered F-HAGO

on 12 January 2021  
at Bastelica (Corse-du-Sud)

### Decrease in main rotor speed, loss of altitude while crossing a mountain pass, forced landing on a snow- covered surface, helicopter tips forward

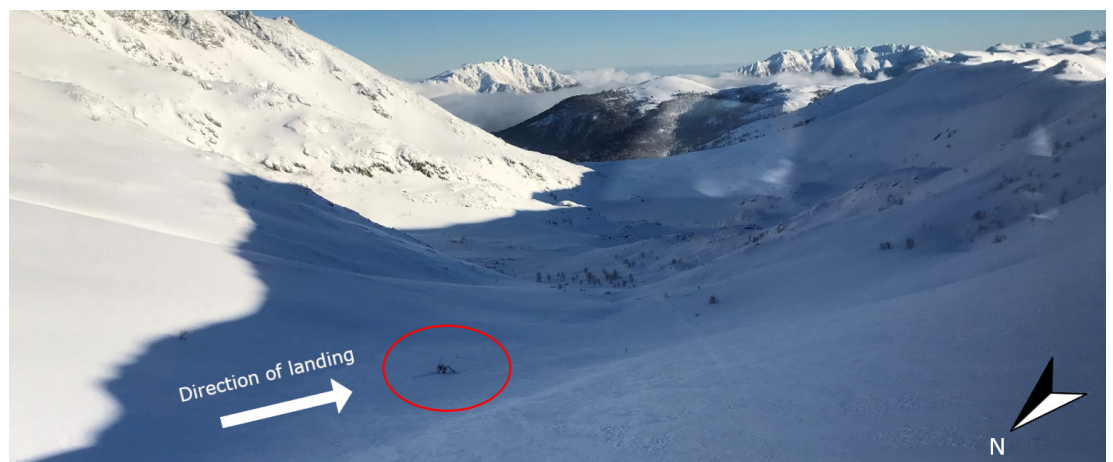
Figure 2: Photograph of accident site and wreckage

The wreckage was located at an altitude of 1,937 m, in the centre of the valley, which is roughly oriented along a northwest/southeast axis (see Figure 2). Marks were visible in the snow over a distance of around 10 metres before the airframe. The airframe was oriented south-southwest and its front section was sunk into the snow. The tail boom was broken, the rear stabiliser and the tail rotor had been torn off and were located several metres away in front of the airframe. The main rotor blades were bent and evidence of power was observed on one of the blades. The flight control linkages were continuous. No technical element was found that could explain the decrease in the main rotor speed.
