Accident to the TECNAM - P2008- JC registered F-ORVY

on 13 March 2021

off the coast of Tahiti (French Polynesia)

Pilot and aeroplane missing at sea

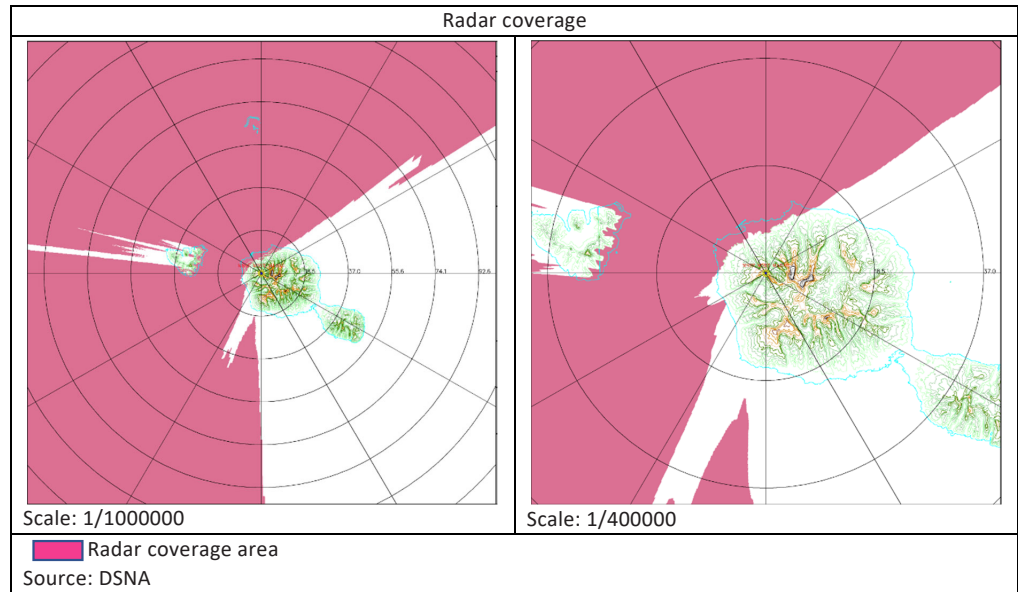
The radar coverage is unable to display the end of the aeroplane's path.

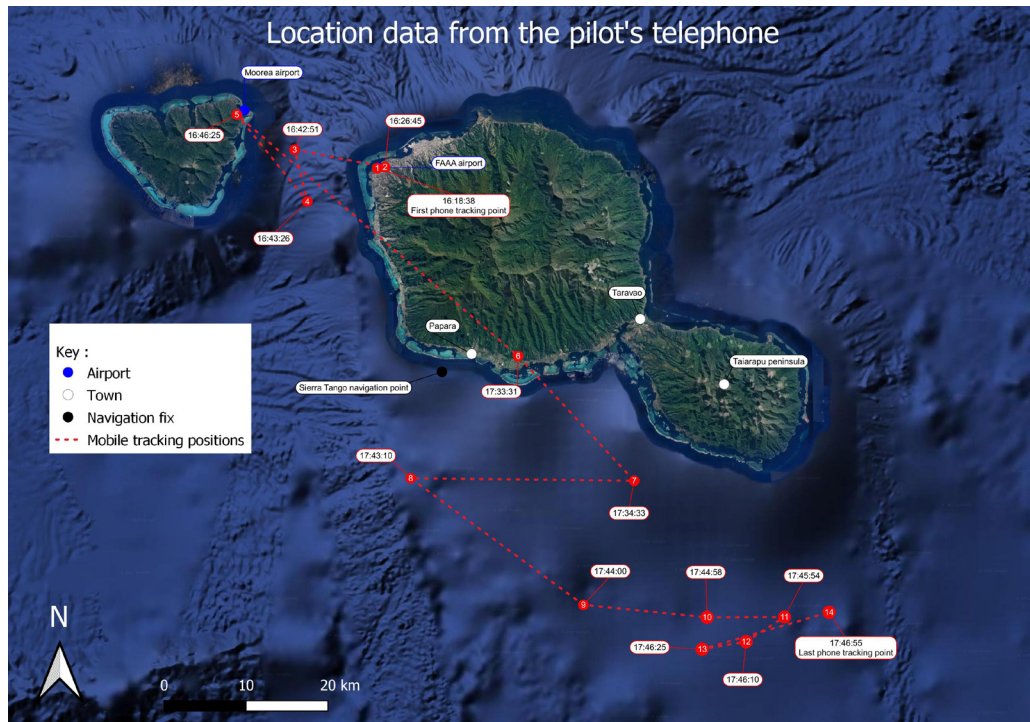
Location data from the pilot's telephone

The positions recorded between 16:26 and 17:33 were consistent with the flights made by the pilot. The last recorded positions show an outbound leg southwards, over the sea, moving away from Tairapu Peninsula.

The last recorded position, at 17:46, was located approximately 10 NM south of Tairapu Peninsula.
